Report No.: EED32O81825501

7 PHOTOGRAPHS OF TEST SETUP

Test Model No.: AESEM1S

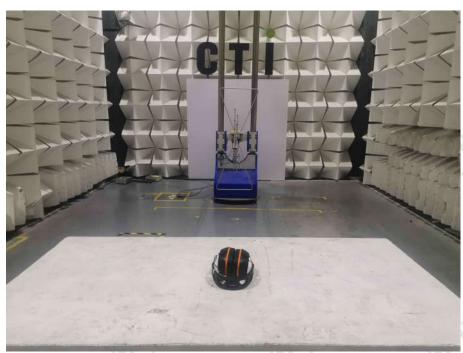
Radiated spurious emission Test Setup-1(Below 1GHz)

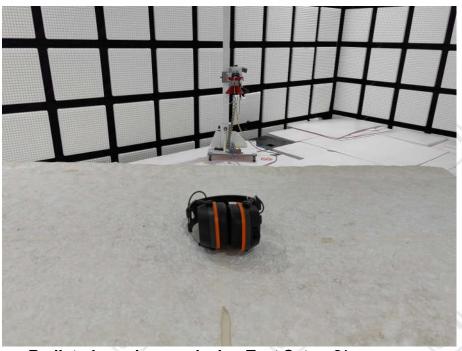
Radiated spurious emission Test Setup-2(Above 1GHz)
