### **APPENDIX 3: Photographs of test setup**

#### **Field strength of spurious radiation**

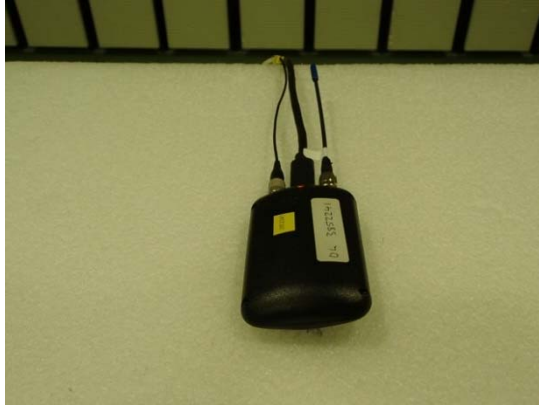
**X-axis**

### **Worst Case Position**

Below 1 GHz: (Horizontal: X-axis/ Vertical: X-axis)

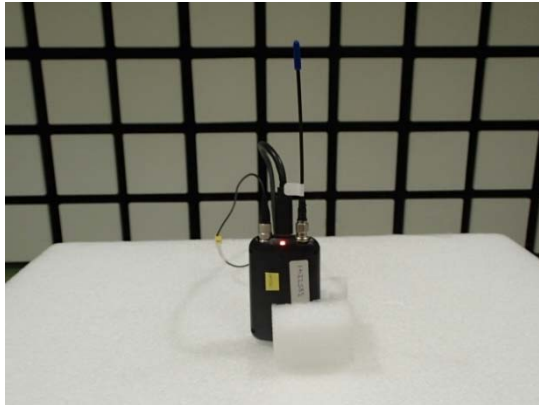
**Y-axis**

Above 1 GHz: (Horizontal: Z-axis/ Vertical: Y-axis)

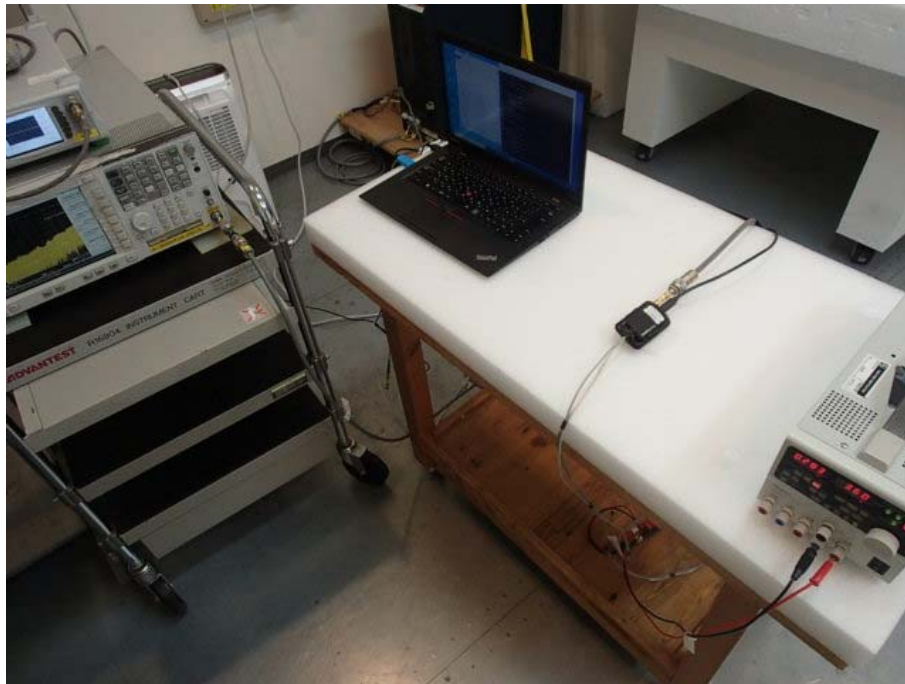
**Photo 1**

**RF Output Power, Occupied Bandwidth and Spurious emissions at antenna terminals**

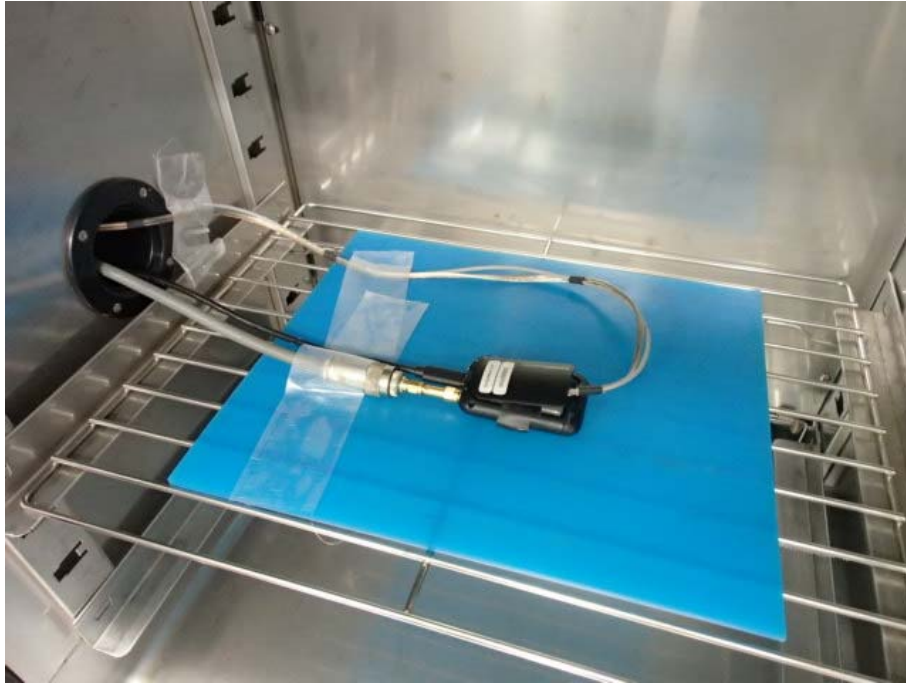
**Photo 1**

### **Frequency Stability**
