Appendix B  
CN24K76Q 003

Prüfbericht - Produkte  
Test Report - Products

### 1.3 Test Datas 99% Bandwidth (U-NII-3:)

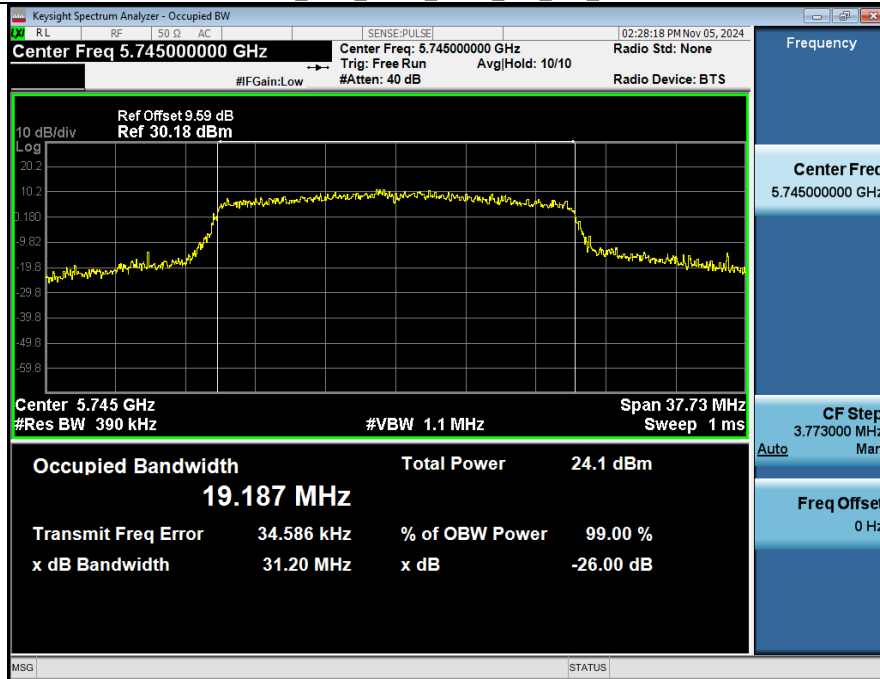
99% OCB NVNT ANT1 802 11a 5745

| Condition | Antenna | Modulation | Frequency(MHz) | Occupied Bandwidth(MHz) |
|---|---|---|---|---|
| NVNT | ANT1 | 802.11a | 5745.00 | 19.19 |

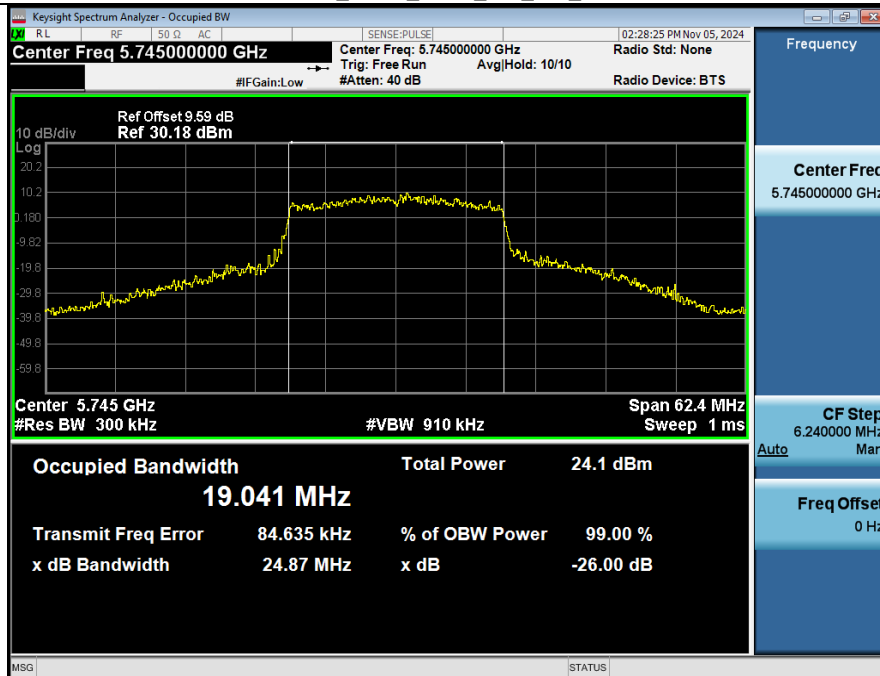
-26BW\_NVNT\_ANT1\_802\_11a\_5745

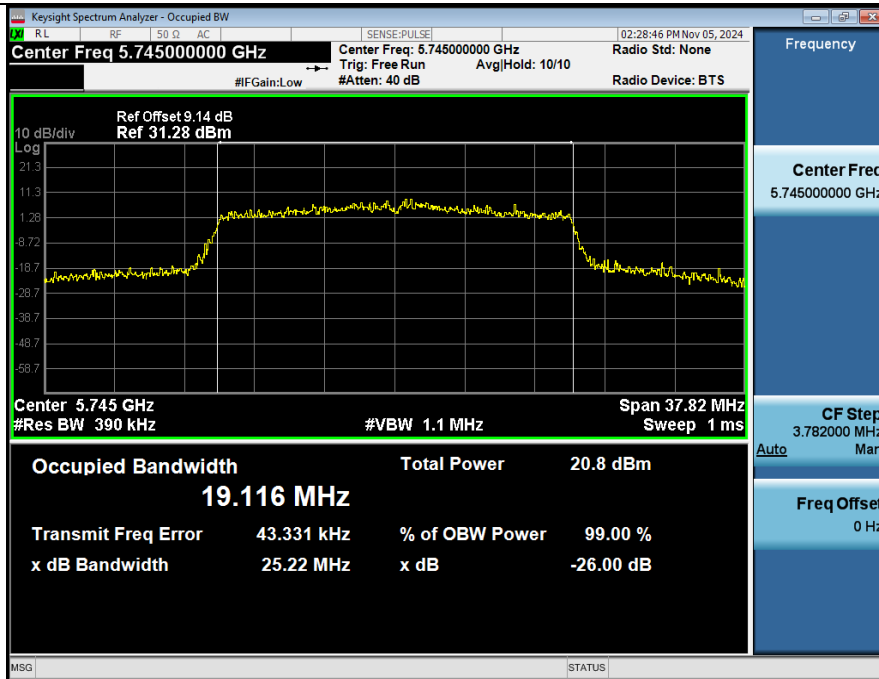
99% OCB NVNT ANT2 802 11a 5745

| Condition | Antenna | Modulation | Frequency(MHz) | Occupied Bandwidth(MHz) |
|---|---|---|---|---|
| NVNT | ANT2 | 802.11a | 5745.00 | 19.12 |

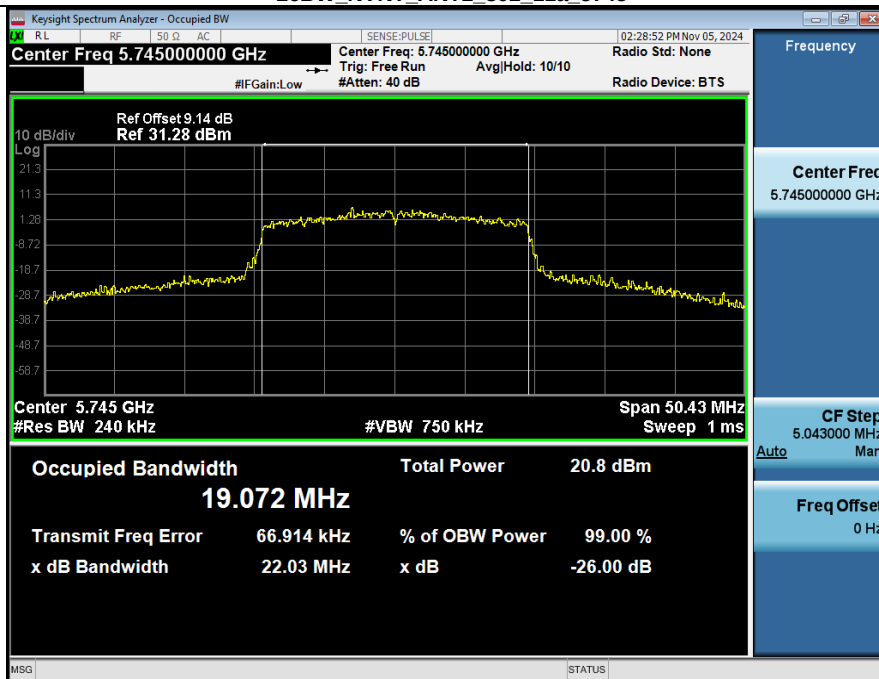
-26BW\_NVNT\_ANT2\_802\_11a\_5745

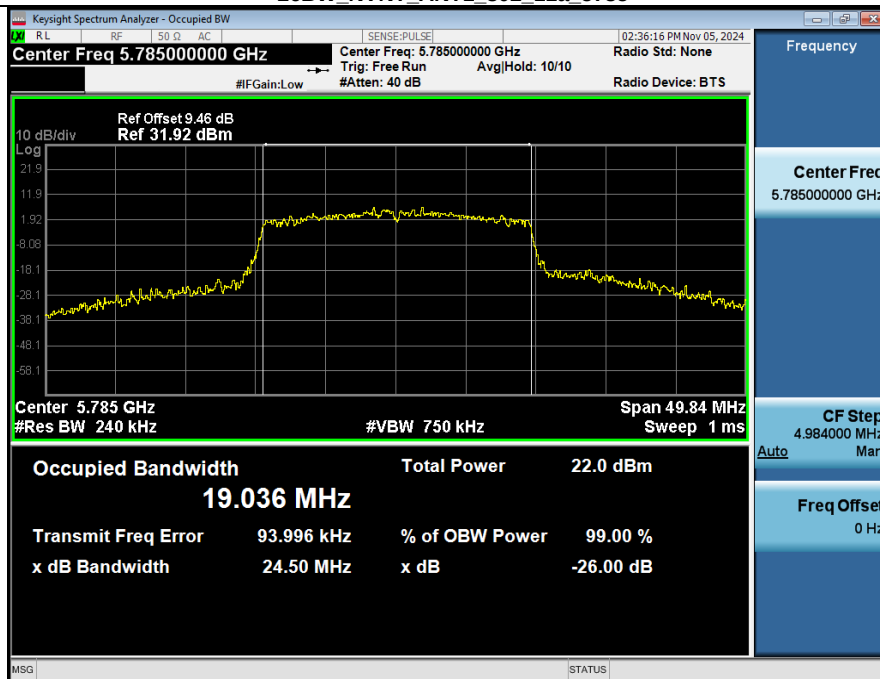
-26BW\_NVNT\_ANT1\_802\_11a\_5785

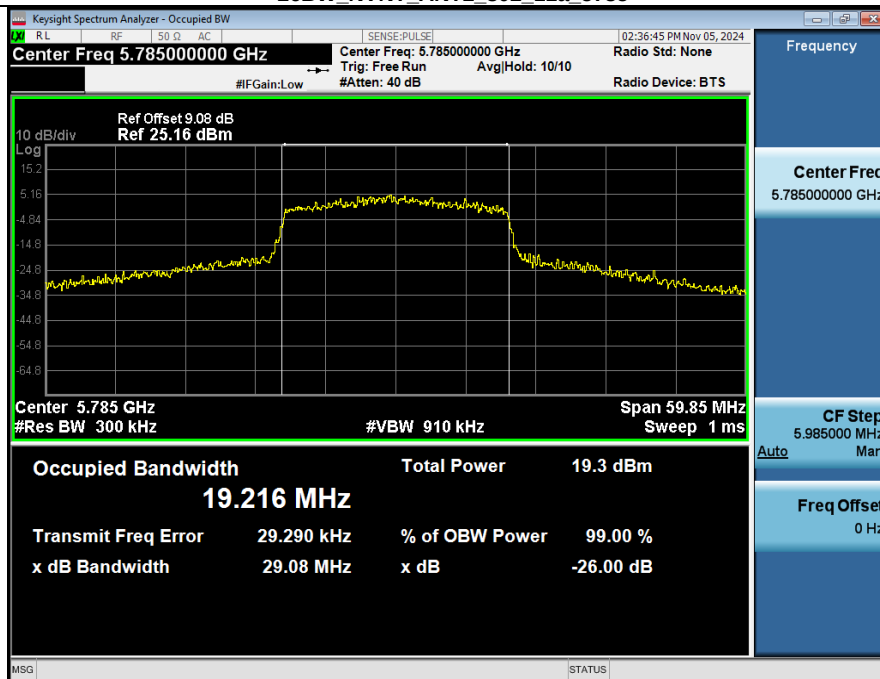
-26BW\_NVNT\_ANT2\_802\_11a\_5785

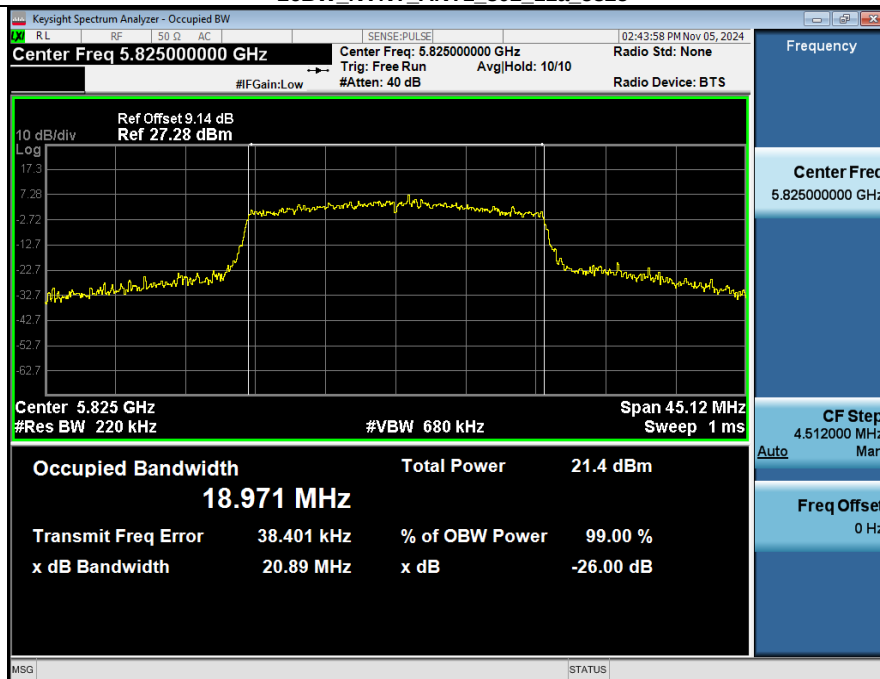
-26BW\_NVNT\_ANT1\_802\_11a\_5825

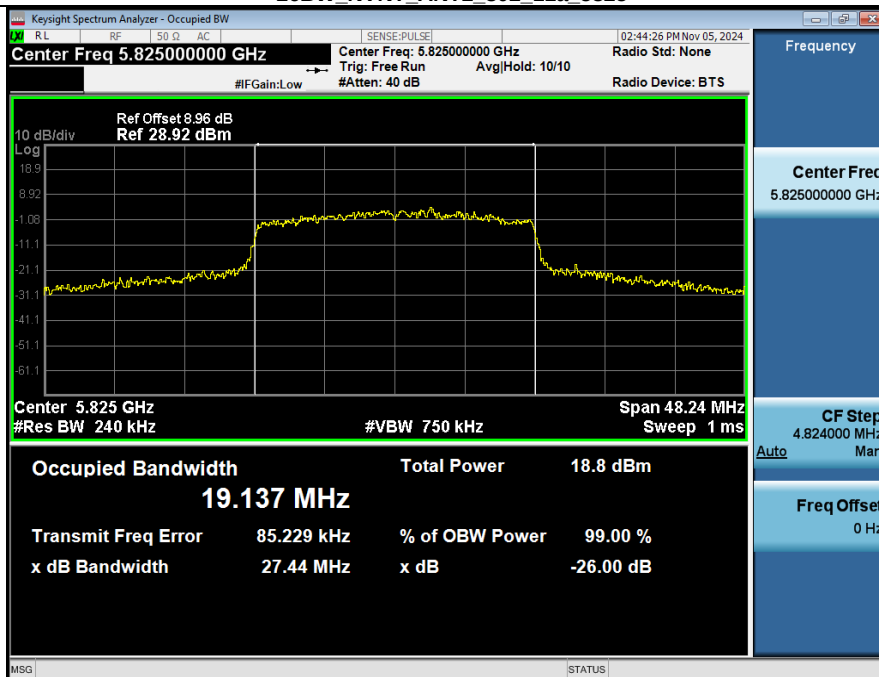
-26BW\_NVNT\_ANT2\_802\_11a\_5825

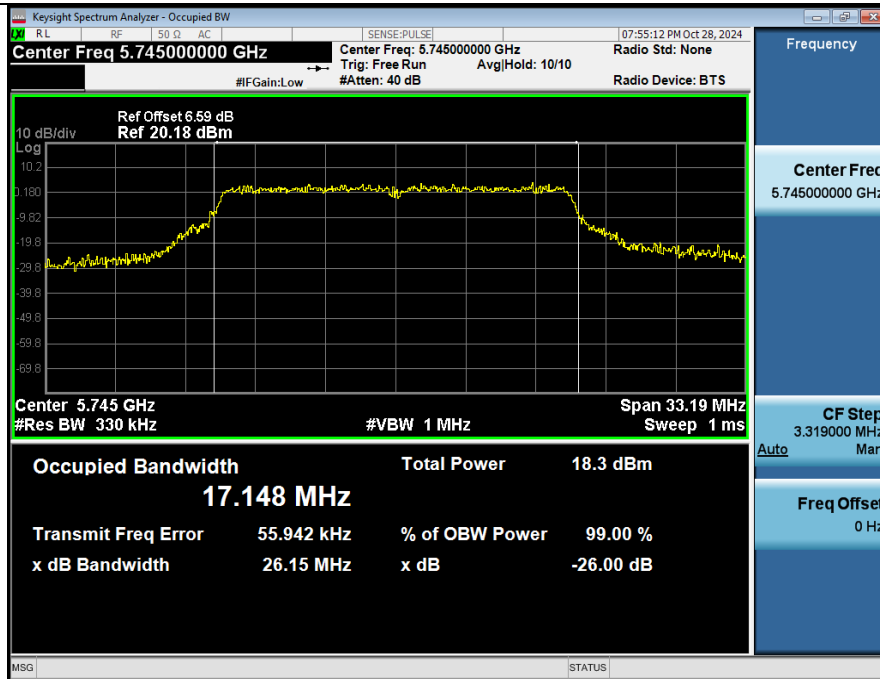
99% OCB\_NVNT\_ANT1\_802\_11n(HT20)\_5745

| Condition | Antenna | Modulation | Frequency(MHz) | Occupied Bandwidth(MHz) |
|---|---|---|---|---|
| NVNT | ANT1 | 802.11n(HT20) | 5745.00 | 17.15 |

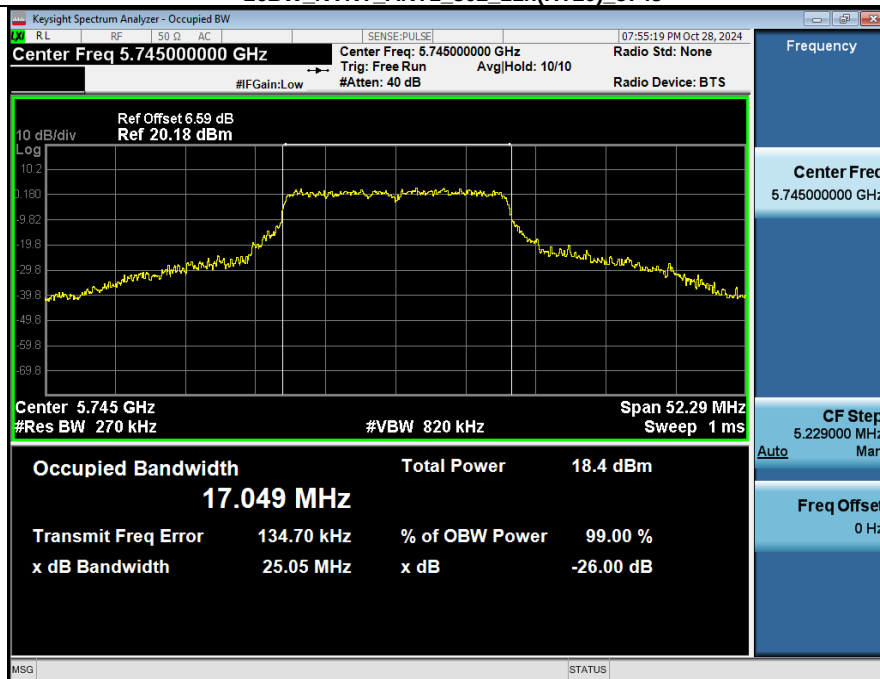
-26BW\_NVNT\_ANT1\_802\_11n(HT20)\_5745

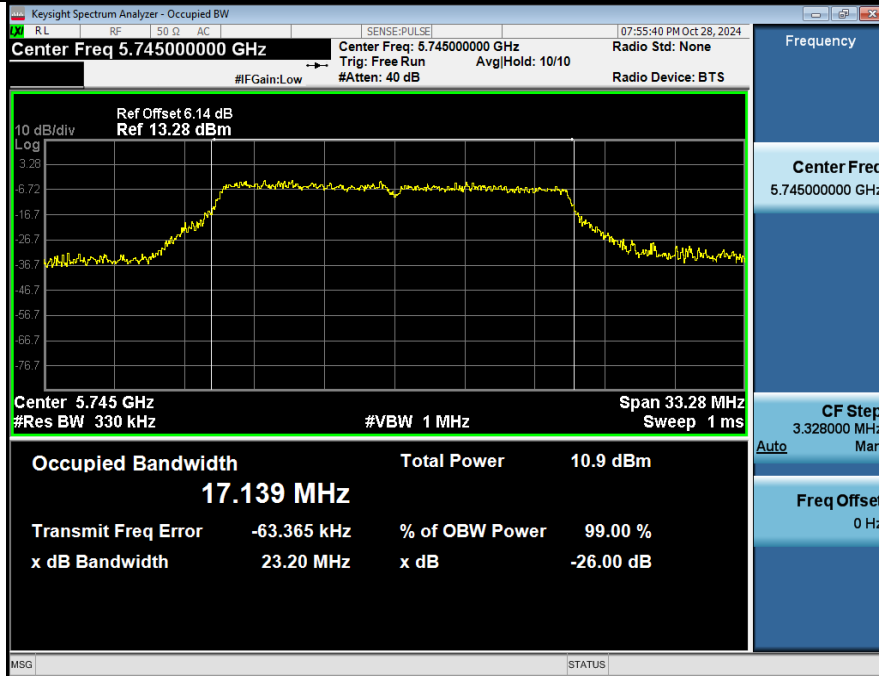
99%\_OCB\_NVNT\_ANT2\_802\_11n(HT20)\_5745

| Condition | Antenna | Modulation | Frequency(MHz) | Occupied Bandwidth(MHz) |
|---|---|---|---|---|
| NVNT | ANT2 | 802.11n(HT20) | 5745.00 | 17.14 |

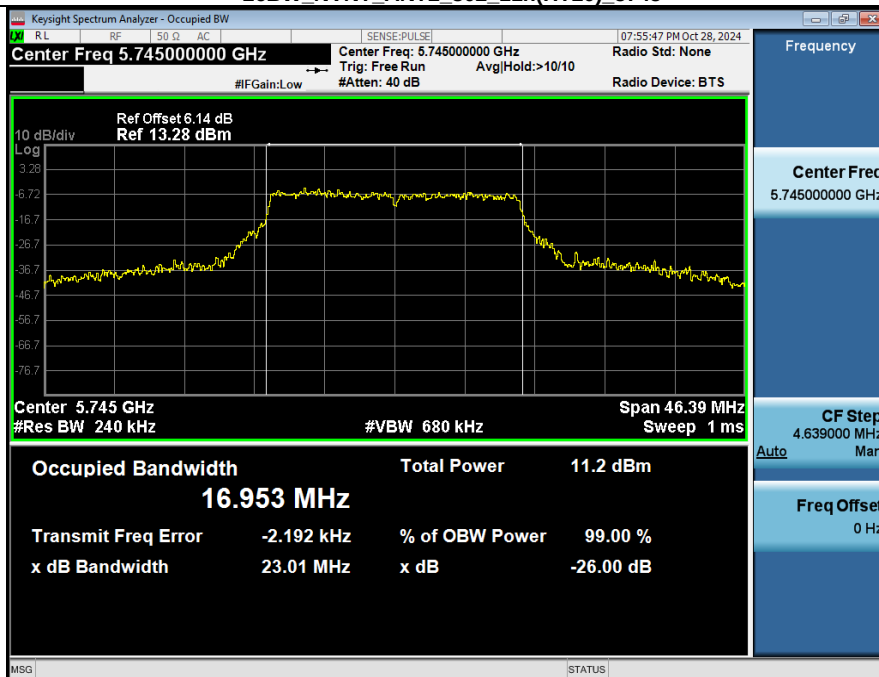
-26BW\_NVNT\_ANT2\_802\_11n(HT20)\_5745

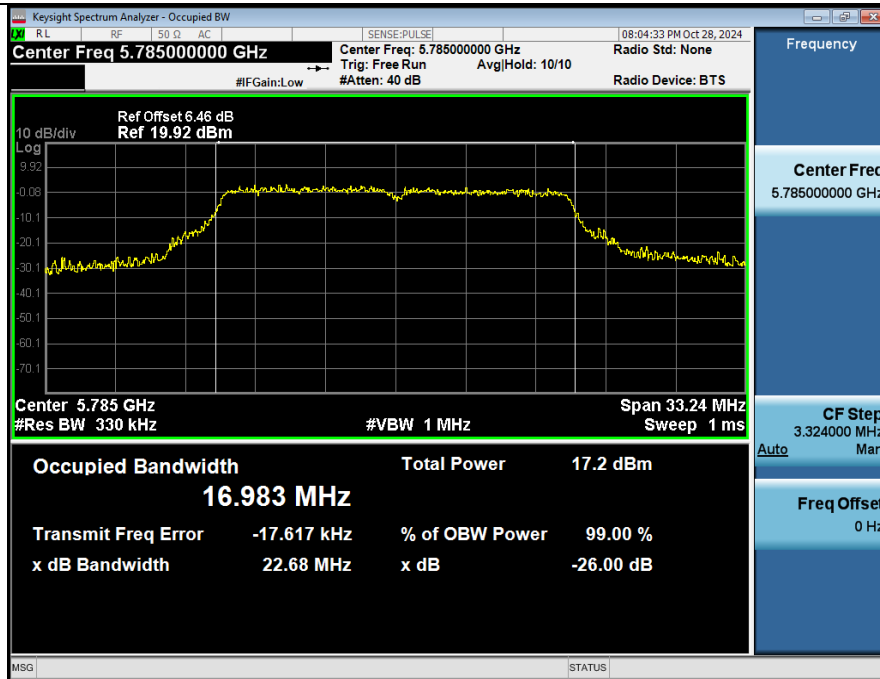
99% OCB\_NVNT\_ANT1\_802\_11n(HT20)\_5785

| Condition | Antenna | Modulation | Frequency(MHz) | Occupied Bandwidth(MHz) |
|---|---|---|---|---|
| NVNT | ANT1 | 802.11n(HT20) | 5785.00 | 16.98 |

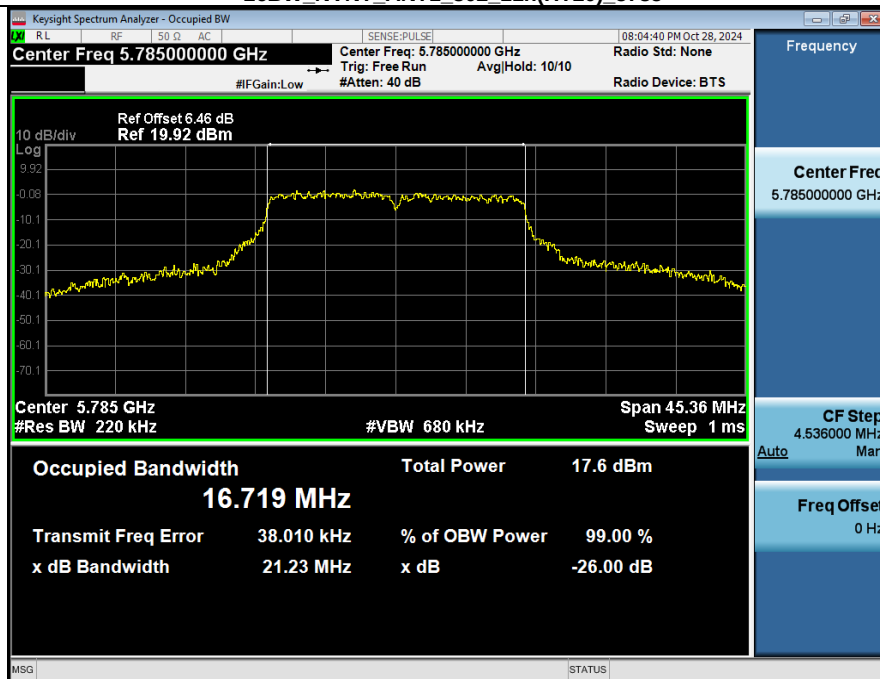
-26BW\_NVNT\_ANT1\_802\_11n(HT20)\_5785

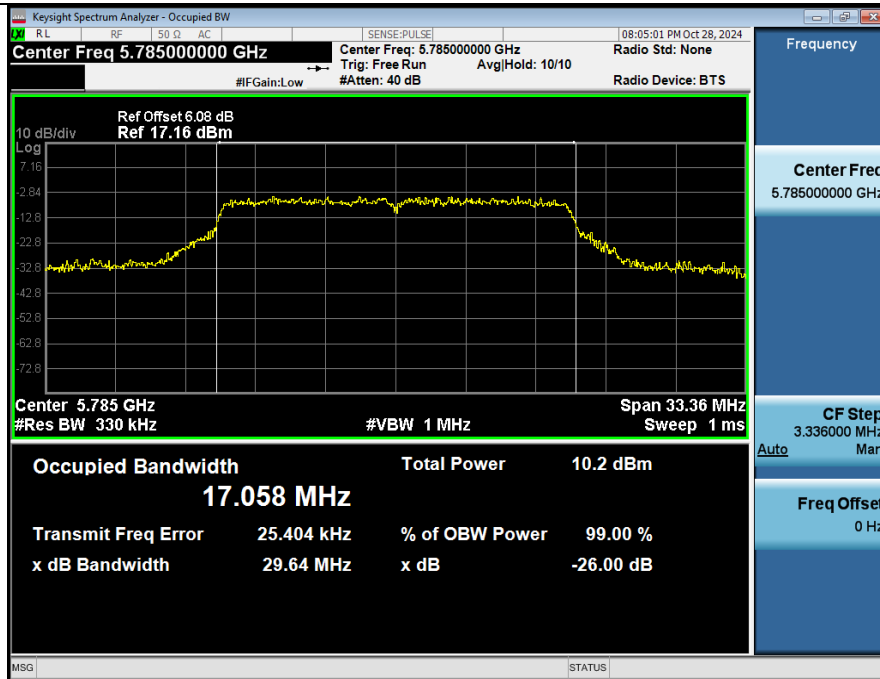
99%\_OCB\_NVNT\_ANT2\_802\_11n(HT20)\_5785

| Condition | Antenna | Modulation | Frequency(MHz) | Occupied Bandwidth(MHz) |
|---|---|---|---|---|
| NVNT | ANT2 | 802.11n(HT20) | 5785.00 | 17.06 |

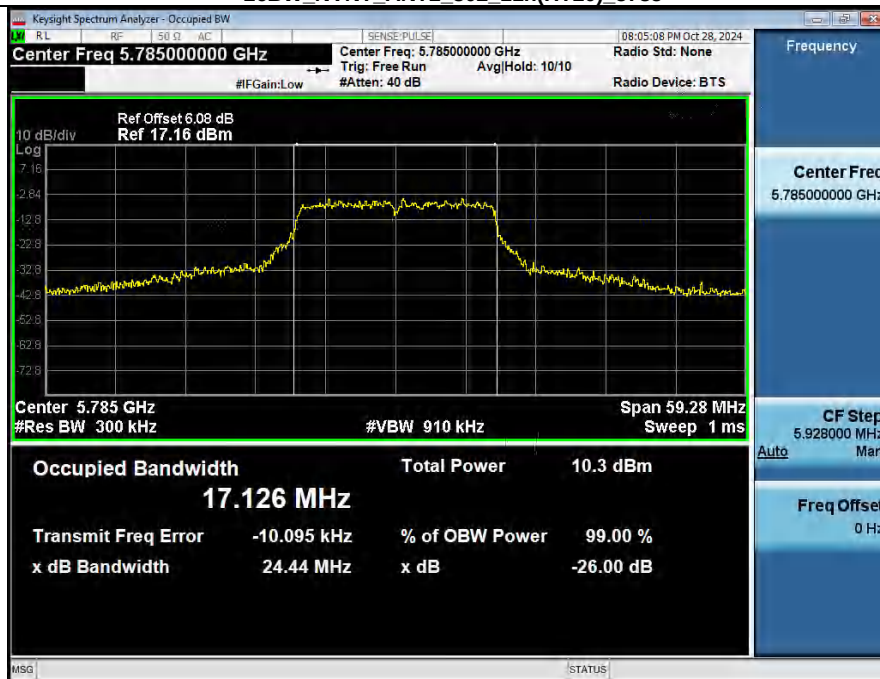
-26BW\_NVNT\_ANT2\_802\_11n(HT20)\_5785

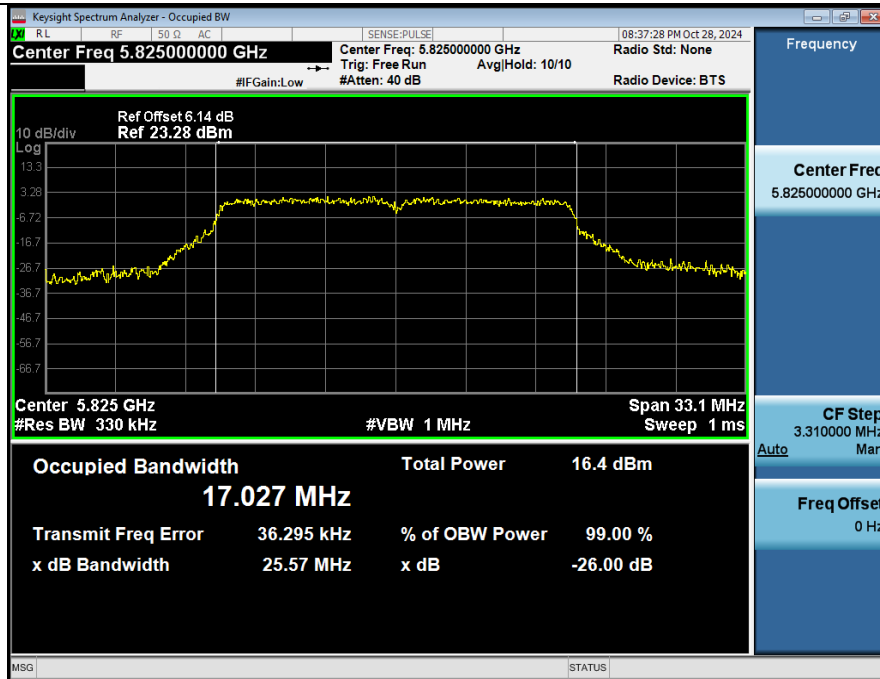
99% OCB\_NVNT\_ANT1\_802\_11n(HT20)\_5825

| Condition | Antenna | Modulation | Frequency(MHz) | Occupied Bandwidth(MHz) |
|---|---|---|---|---|
| NVNT | ANT1 | 802.11n(HT20) | 5825.00 | 17.03 |

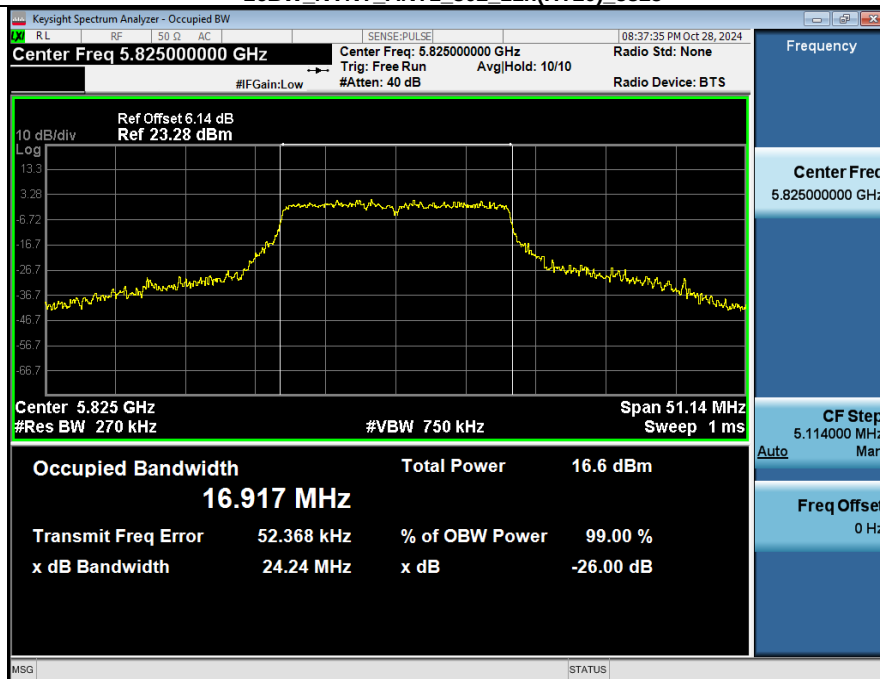
-26BW\_NVNT\_ANT1\_802\_11n(HT20)\_5825

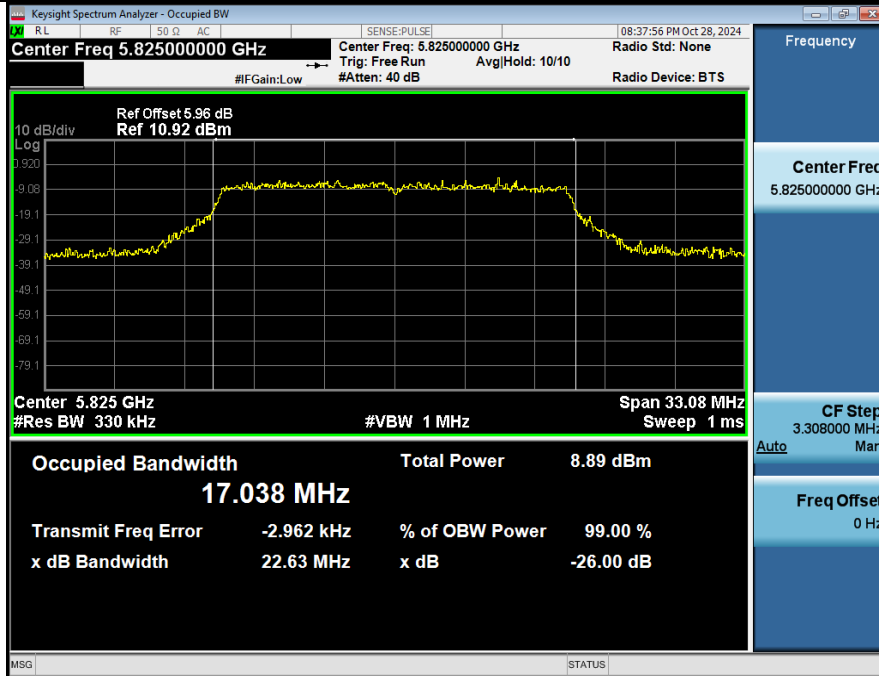
99%\_OCB\_NVNT\_ANT2\_802\_11n(HT20)\_5825

| Condition | Antenna | Modulation | Frequency(MHz) | Occupied Bandwidth(MHz) |
|---|---|---|---|---|
| NVNT | ANT2 | 802.11n(HT20) | 5825.00 | 17.04 |

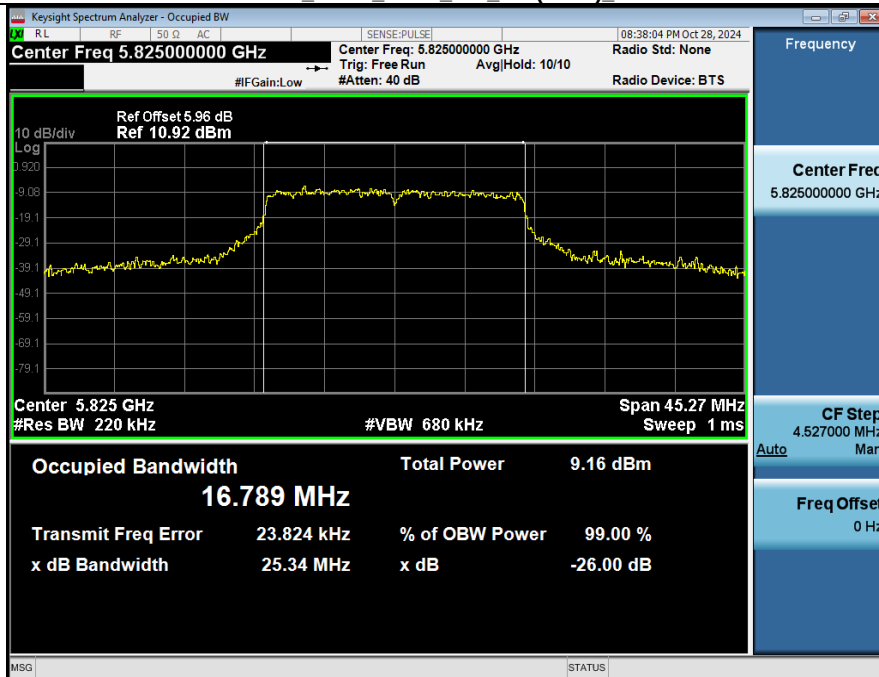
-26BW\_NVNT\_ANT2\_802\_11n(HT20)\_5825

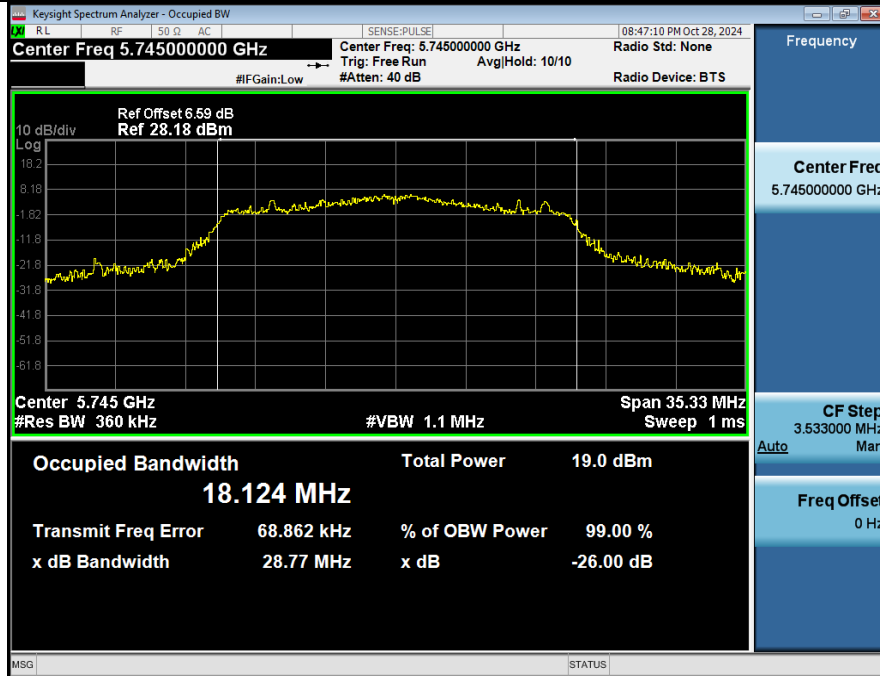
99%\_OCB\_NVNT\_ANT1\_802\_11ac(VHT20)\_5745

| Condition | Antenna | Modulation | Frequency(MHz) | Occupied Bandwidth(MHz) |
|---|---|---|---|---|
| NVNT | ANT1 | 802.11ac(VHT20) | 5745.00 | 18.12 |

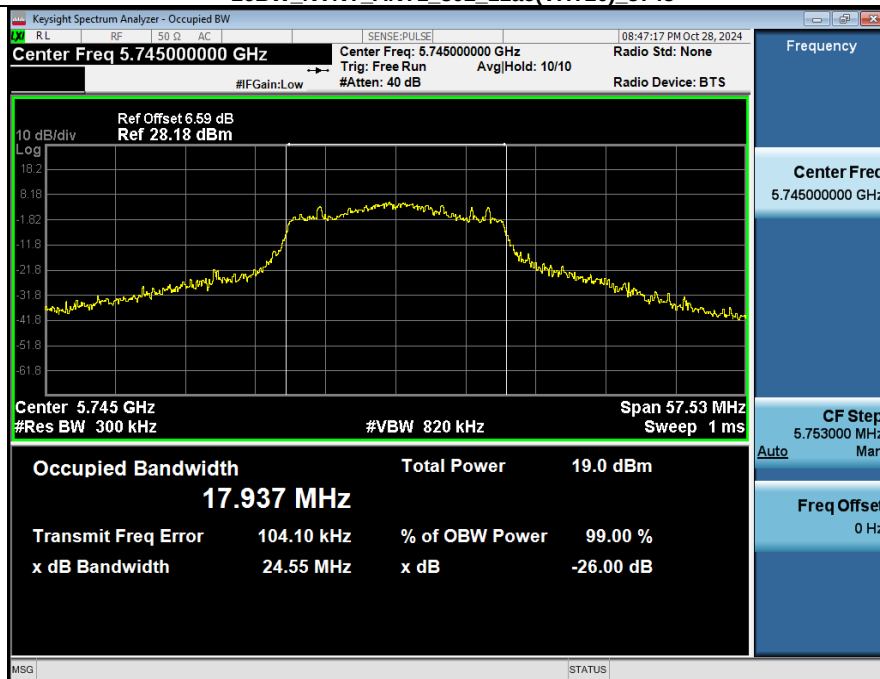
-26BW\_NVNT\_ANT1\_802\_11ac(VHT20)\_5745

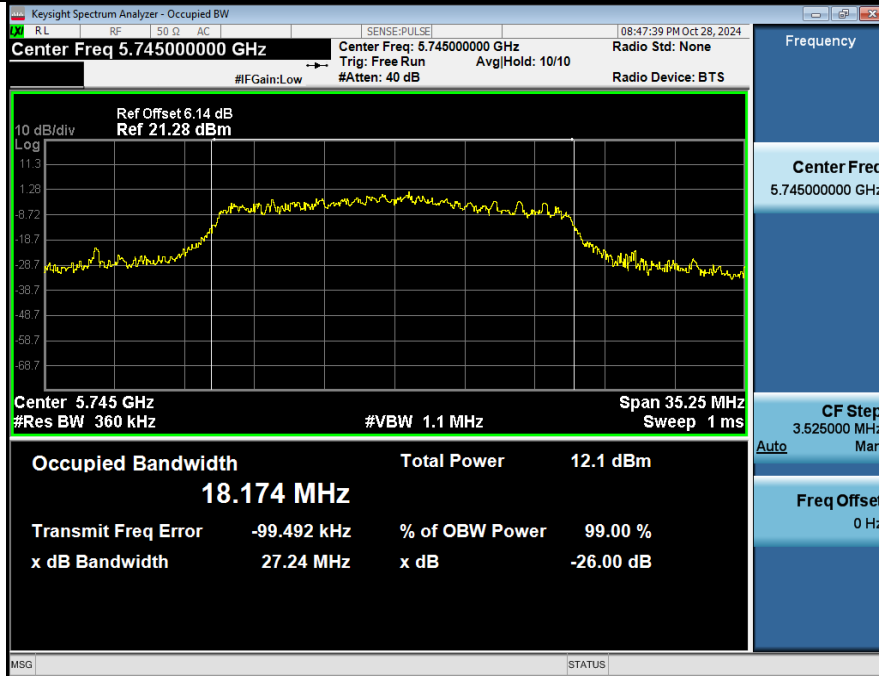
99%\_OCB\_NVNT\_ANT2\_802\_11ac(VHT20)\_5745

| Condition | Antenna | Modulation | Frequency(MHz) | Occupied Bandwidth(MHz) |
|---|---|---|---|---|
| NVNT | ANT2 | 802.11ac(VHT20) | 5745.00 | 18.17 |

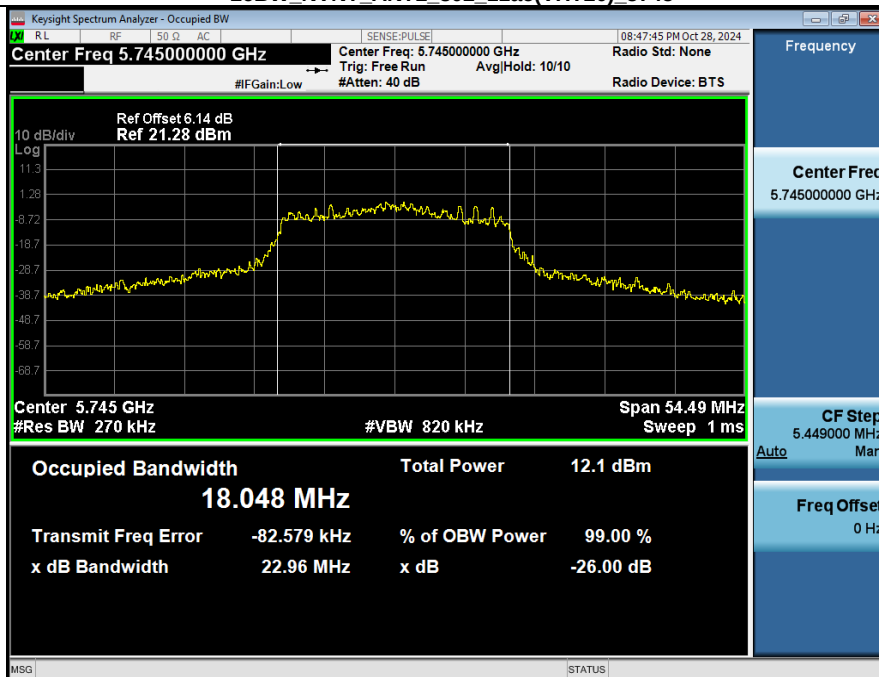
-26BW\_NVNT\_ANT2\_802\_11ac(VHT20)\_5745

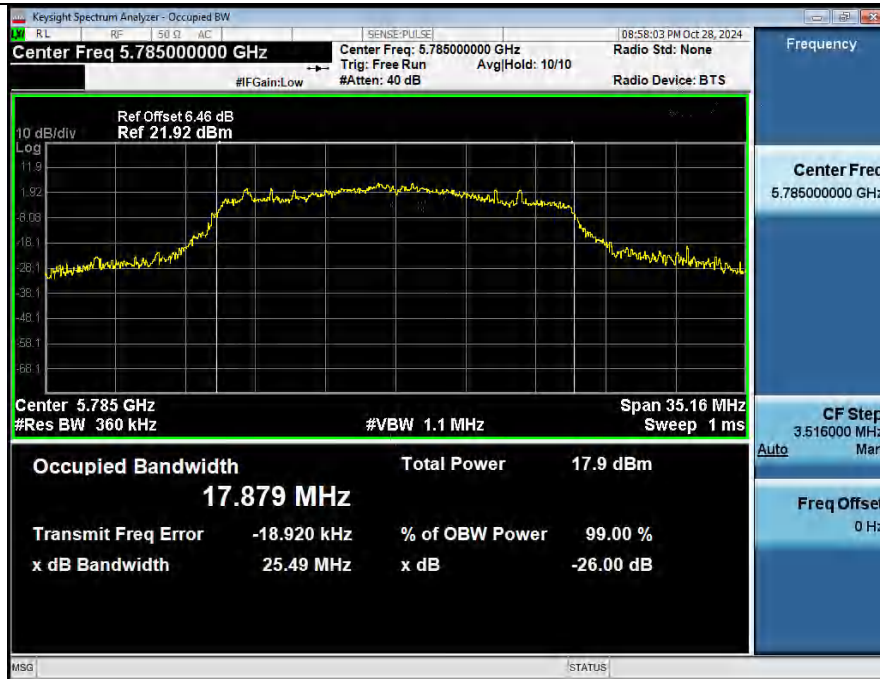
99%\_OCB\_NVNT\_ANT1\_802\_11ac(VHT20)\_5785

| Condition | Antenna | Modulation | Frequency(MHz) | Occupied Bandwidth(MHz) |
|---|---|---|---|---|
| NVNT | ANT1 | 802.11ac(VHT20) | 5785.00 | 17.88 |

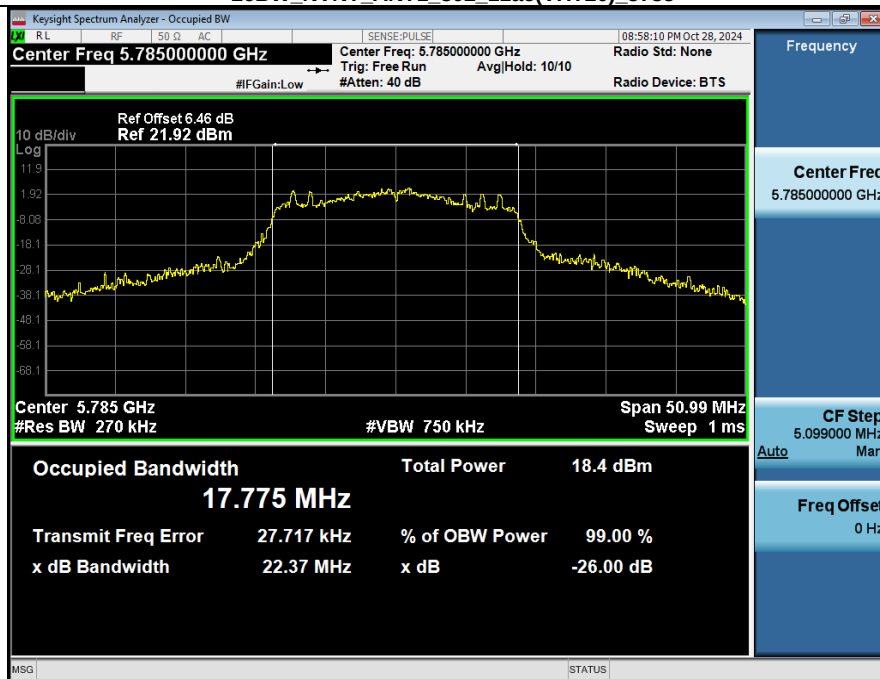
-26BW\_NVNT\_ANT1\_802\_11ac(VHT20)\_5785

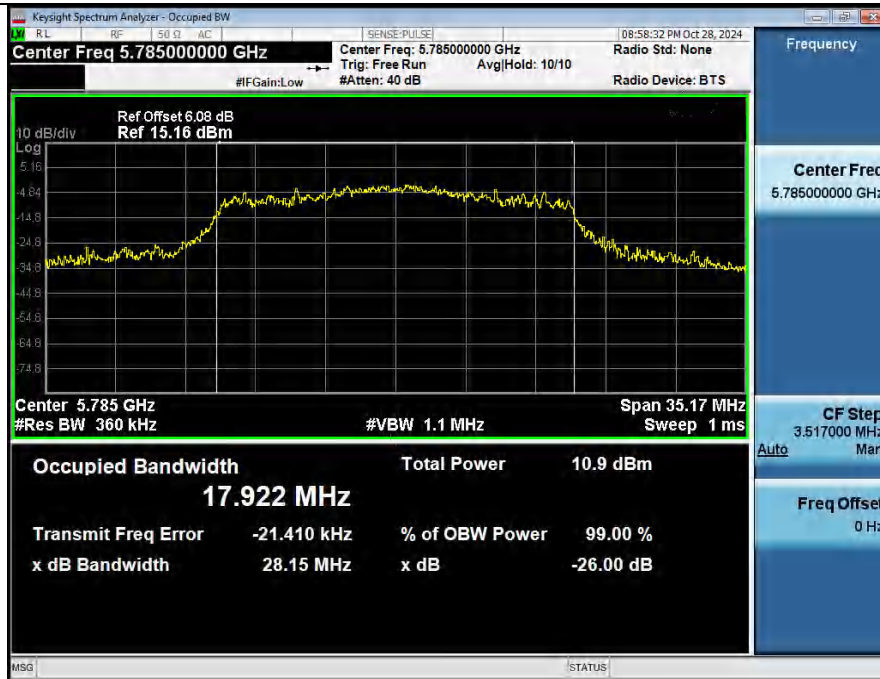
99%\_OCB\_NVNT\_ANT2\_802\_11ac(VHT20)\_5785

| Condition | Antenna | Modulation | Frequency(MHz) | Occupied Bandwidth(MHz) |
|---|---|---|---|---|
| NVNT | ANT2 | 802.11ac(VHT20) | 5785.00 | 17.92 |

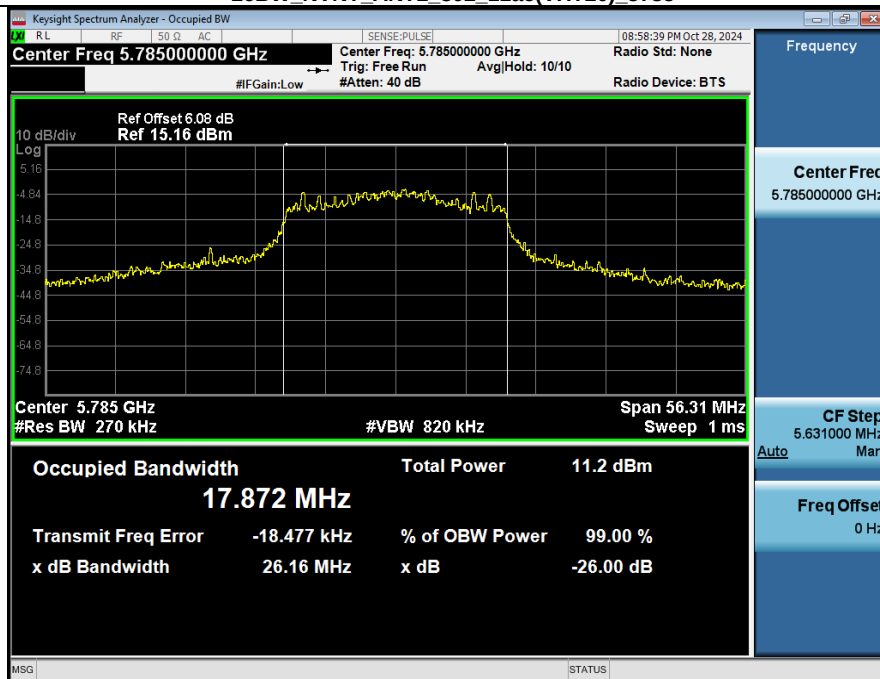
-26BW\_NVNT\_ANT2\_802\_11ac(VHT20)\_5785

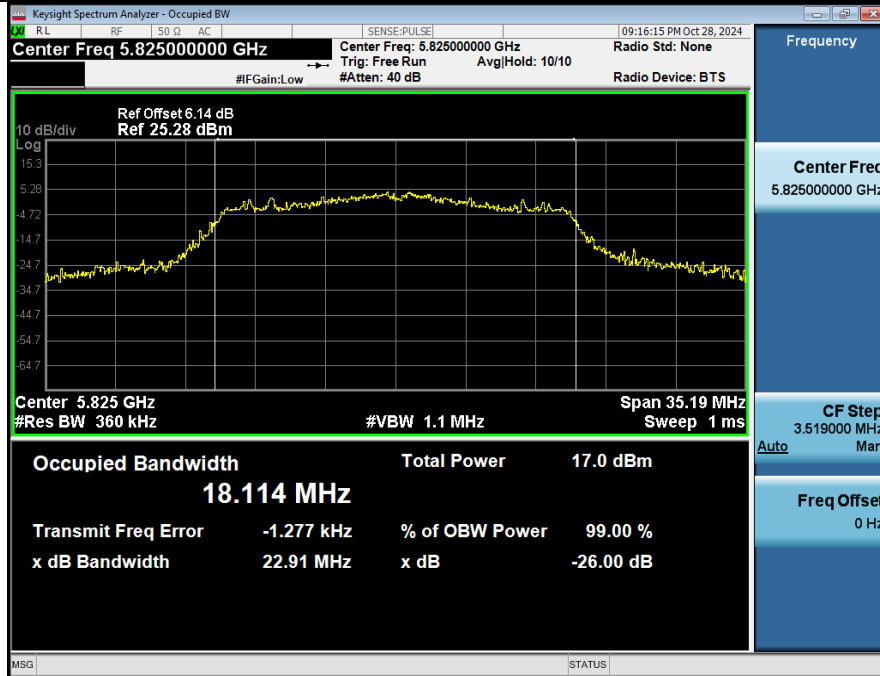
99%\_OCB\_NVNT\_ANT1\_802\_11ac(VHT20)\_5825

| Condition | Antenna | Modulation | Frequency(MHz) | Occupied Bandwidth(MHz) |
|---|---|---|---|---|
| NVNT | ANT1 | 802.11ac(VHT20) | 5825.00 | 18.11 |

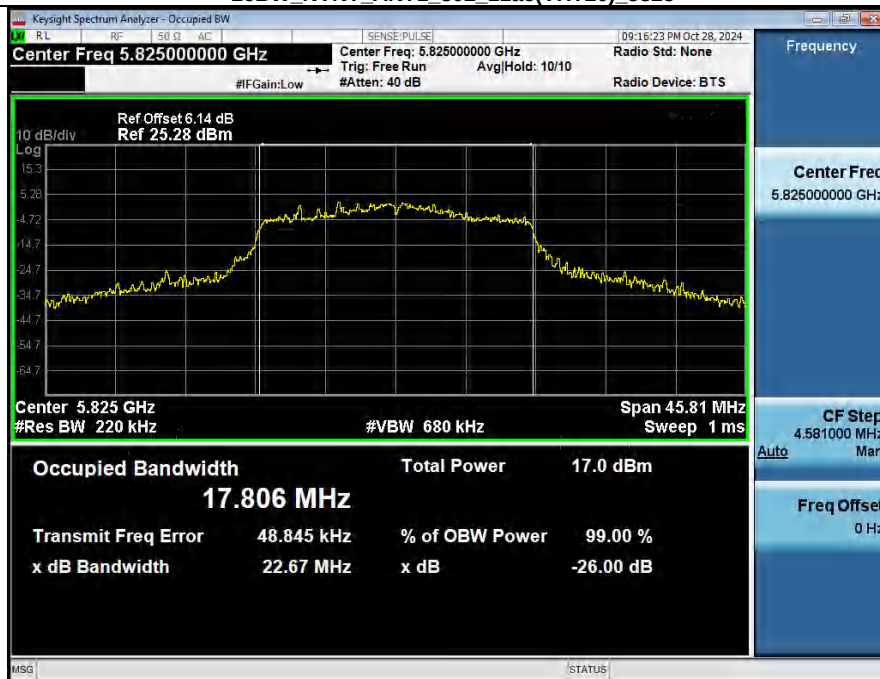
-26BW\_NVNT\_ANT1\_802\_11ac(VHT20)\_5825

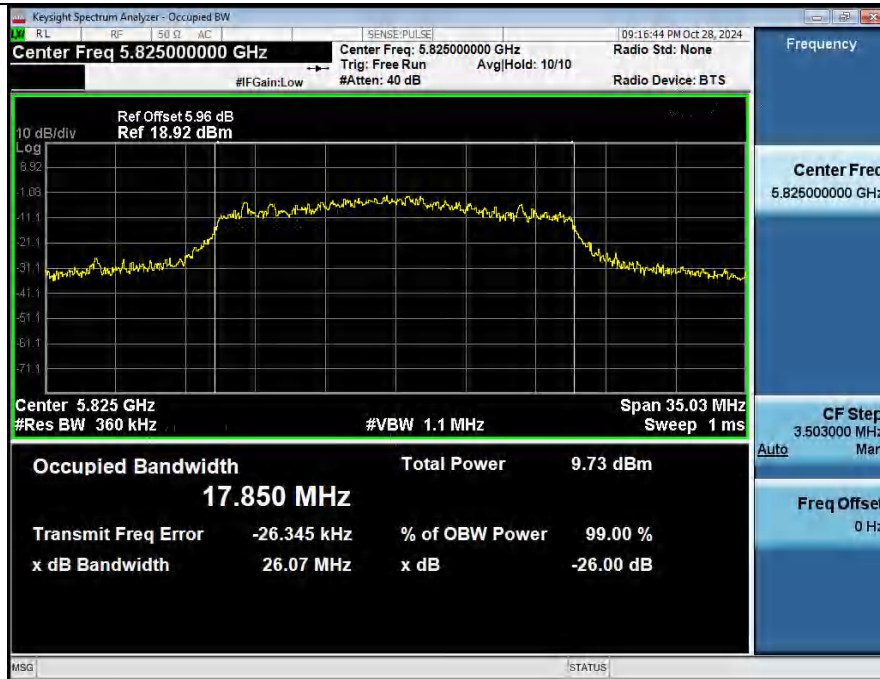
99%\_OCB\_NVNT\_ANT2\_802\_11ac(VHT20)\_5825

| Condition | Antenna | Modulation | Frequency(MHz) | Occupied Bandwidth(MHz) |
|---|---|---|---|---|
| NVNT | ANT2 | 802.11ac(VHT20) | 5825.00 | 17.85 |

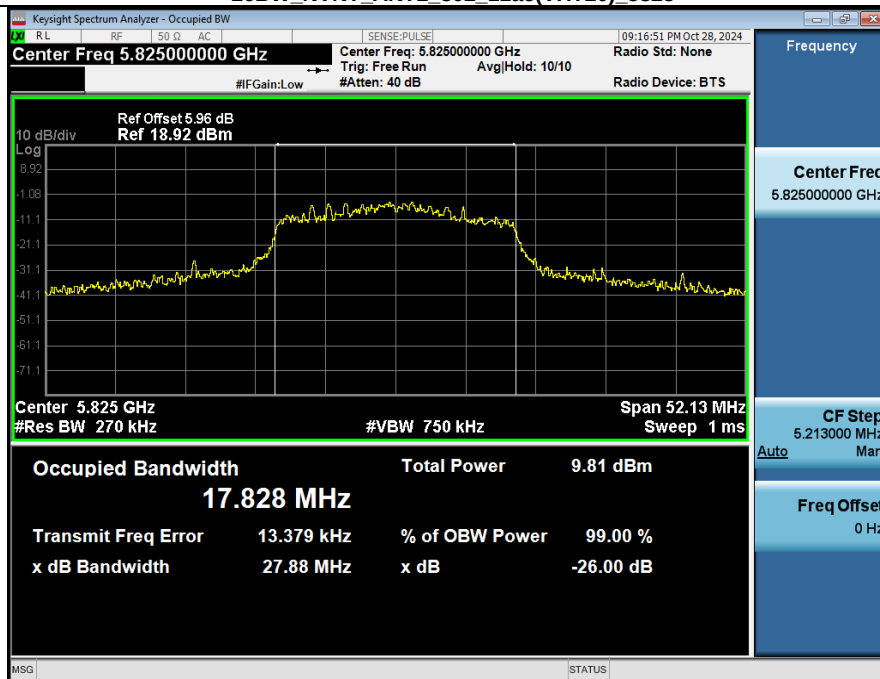
-26BW\_NVNT\_ANT2\_802\_11ac(VHT20)\_5825

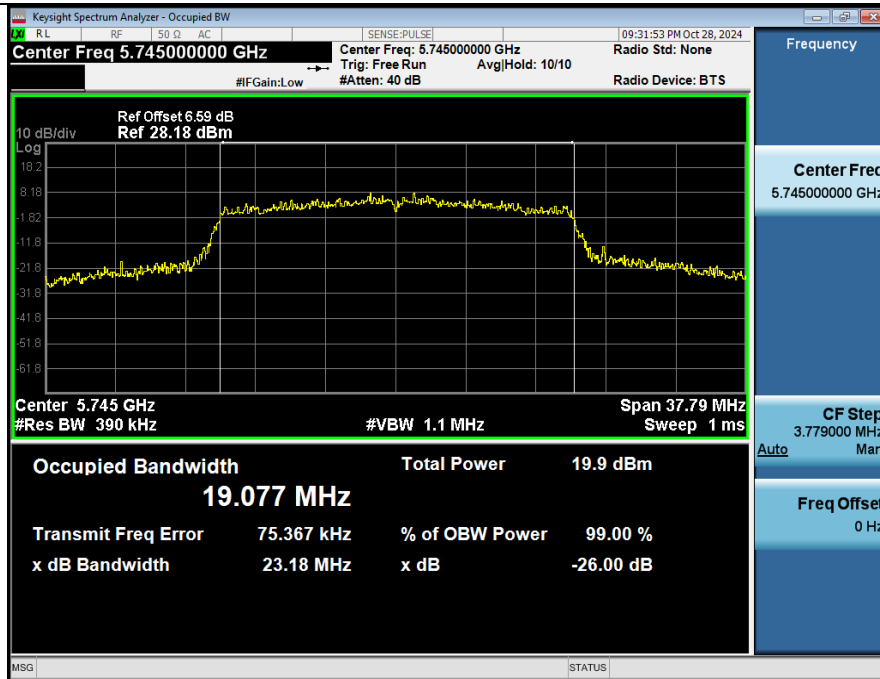
99%\_OCB\_NVNT\_ANT1\_802\_11ax(HE20)\_5745

| Condition | Antenna | Modulation | Frequency(MHz) | Occupied Bandwidth(MHz) |
|---|---|---|---|---|
| NVNT | ANT1 | 802.11ax(HE20) | 5745.00 | 19.08 |

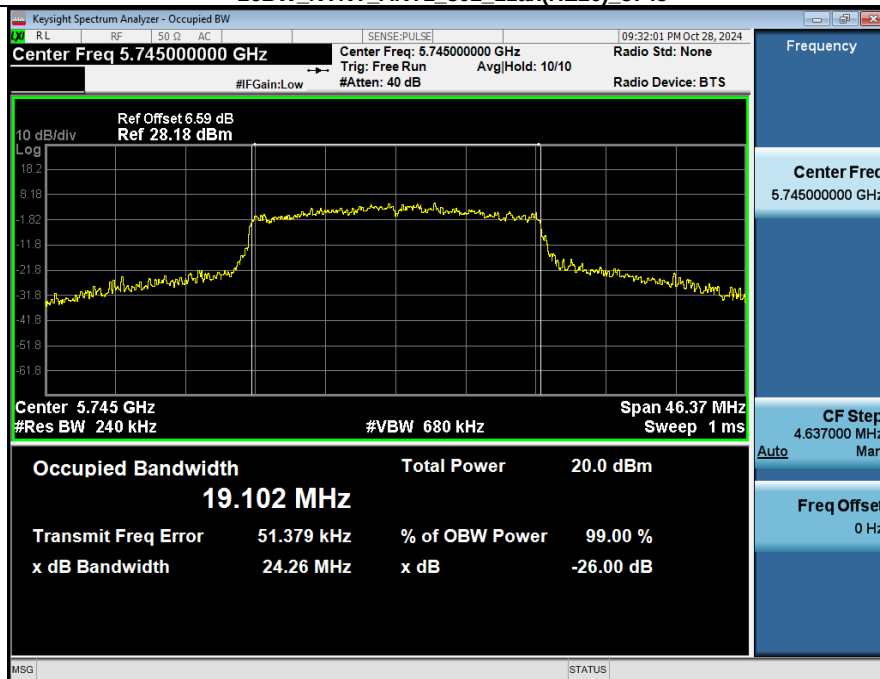
-26BW\_NVNT\_ANT1\_802\_11ax(HE20)\_5745

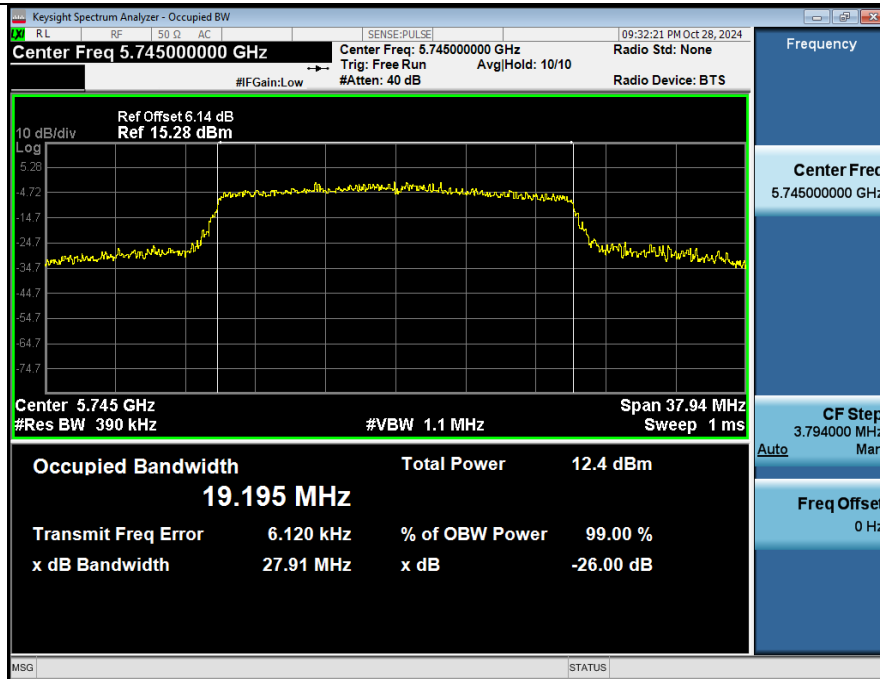
99% OCB NVNT\_ANT2\_802\_11ax(HE20)\_5745

| Condition | Antenna | Modulation | Frequency(MHz) | Occupied Bandwidth(MHz) |
|---|---|---|---|---|
| NVNT | ANT2 | 802.11ax(HE20) | 5745.00 | 19.19 |

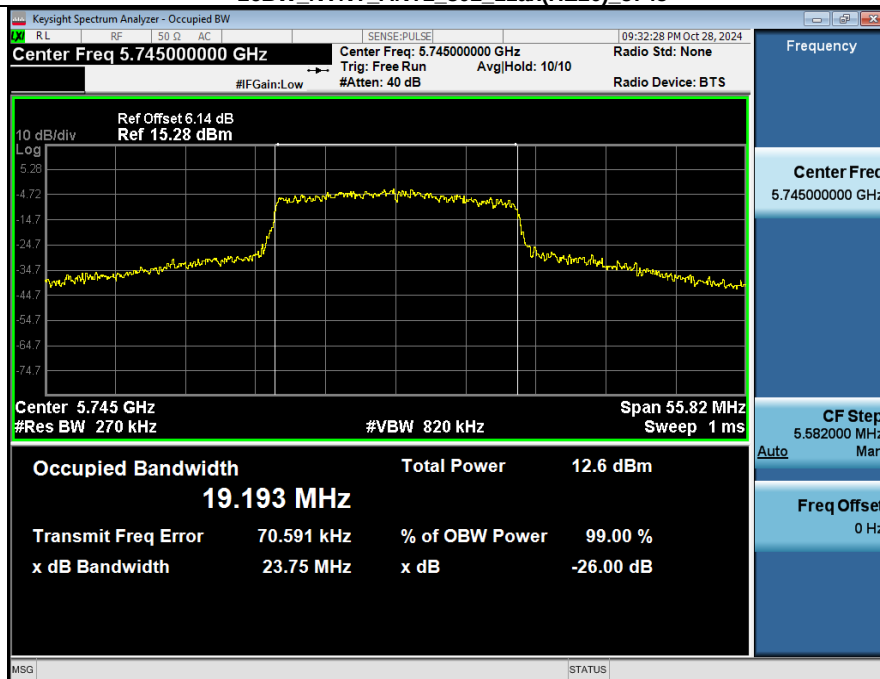
-26BW\_NVNT\_ANT2\_802\_11ax(HE20)\_5745

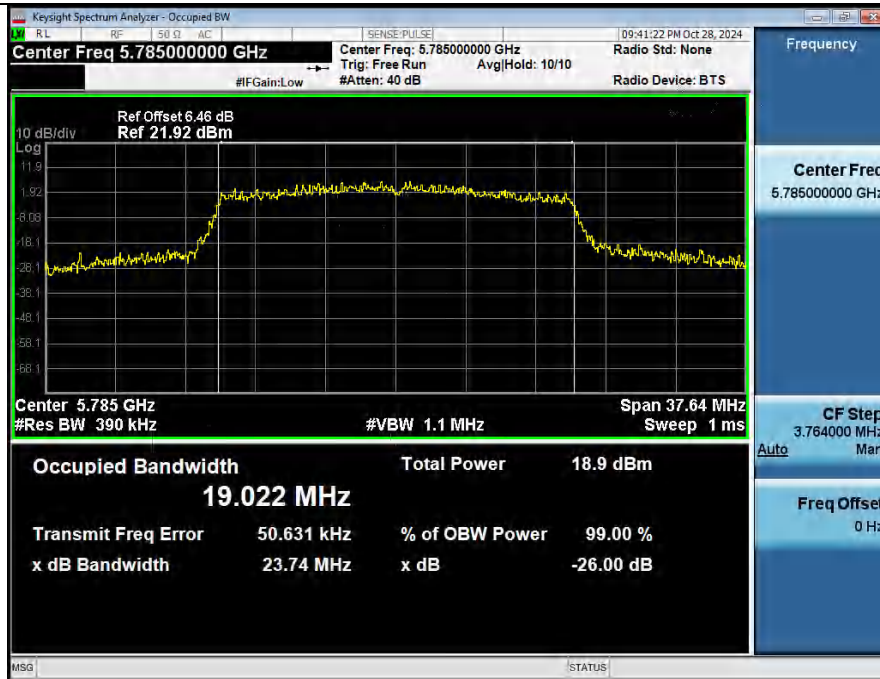
99% OCB\_NVNT\_ANT1\_802\_11ax(HE20)\_5785

| Condition | Antenna | Modulation | Frequency(MHz) | Occupied Bandwidth(MHz) |
|---|---|---|---|---|
| NVNT | ANT1 | 802.11ax(HE20) | 5785.00 | 19.02 |
