Appendix B  
CN24K76Q 003

Prüfbericht - Produkte  
Test Report - Products

### 1.3 Test Datas 99% Bandwidth (U-NII-3:)

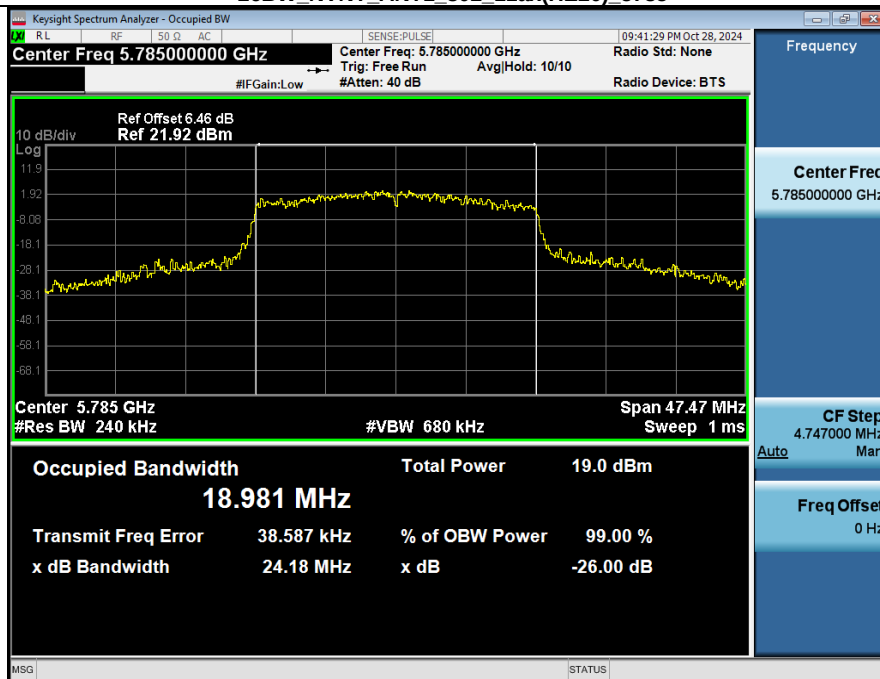
-26BW\_NVNT\_ANT1\_802\_11ax(HE20)\_5785

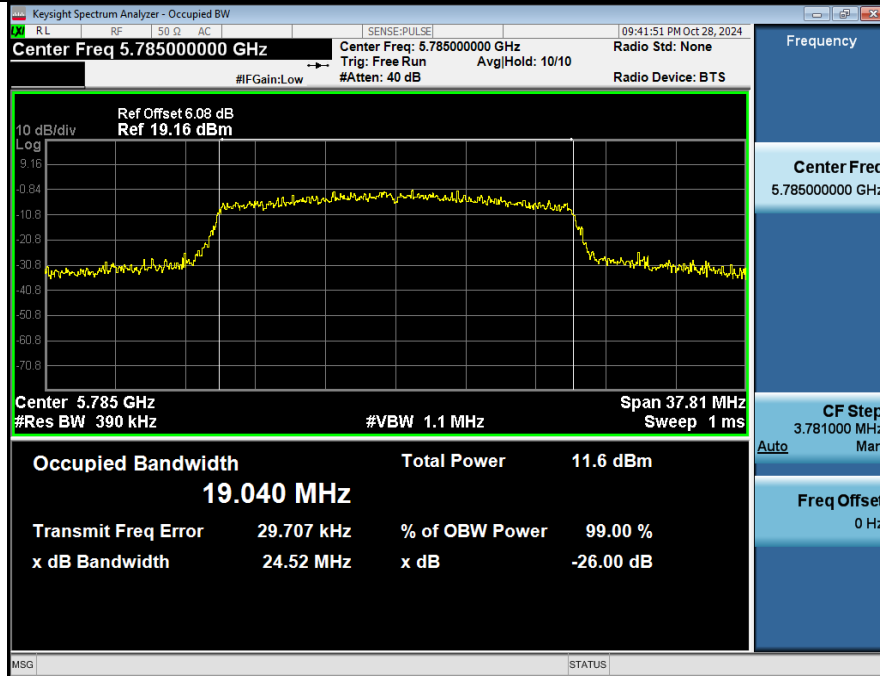
99% OCB NVNT\_ANT2\_802\_11ax(HE20)\_5785

| Condition | Antenna | Modulation | Frequency(MHz) | Occupied Bandwidth(MHz) |
|---|---|---|---|---|
| NVNT | ANT2 | 802.11ax(HE20) | 5785.00 | 19.04 |

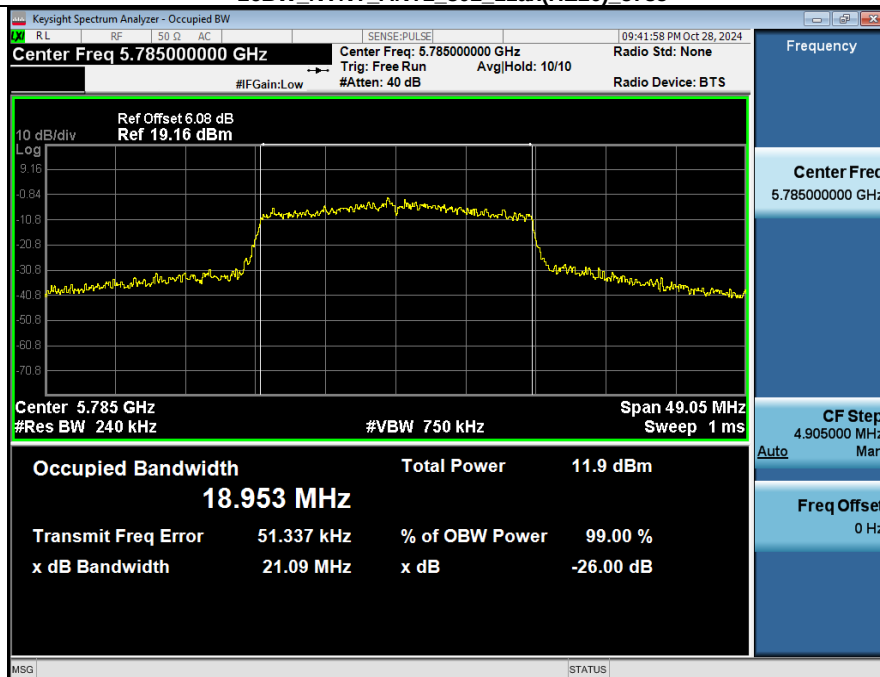
-26BW\_NVNT\_ANT2\_802\_11ax(HE20)\_5785

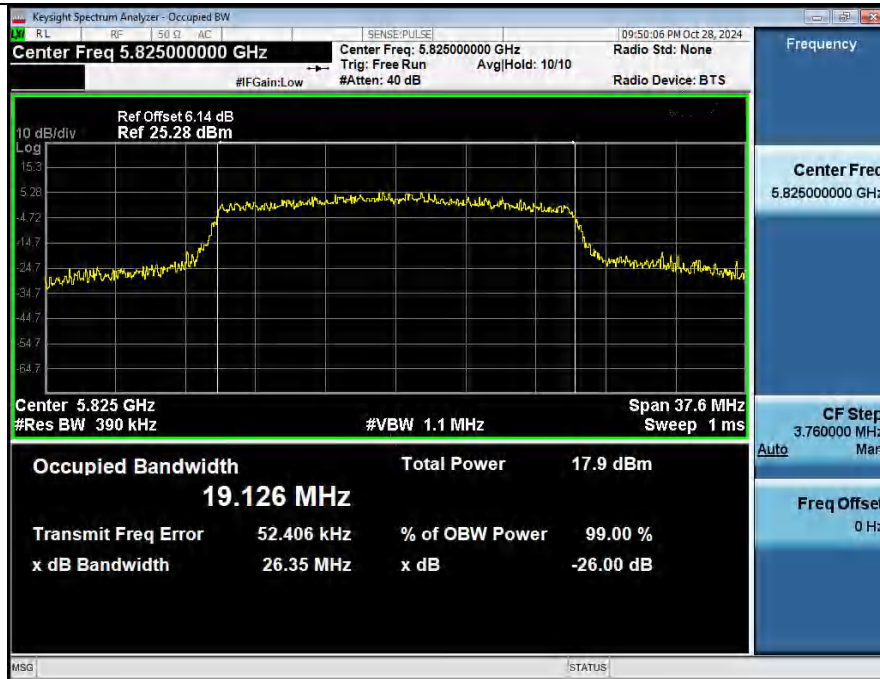
99% OCB\_NVNT\_ANT1\_802\_11ax(HE20)\_5825

| Condition | Antenna | Modulation | Frequency(MHz) | Occupied Bandwidth(MHz) |
|---|---|---|---|---|
| NVNT | ANT1 | 802.11ax(HE20) | 5825.00 | 19.13 |

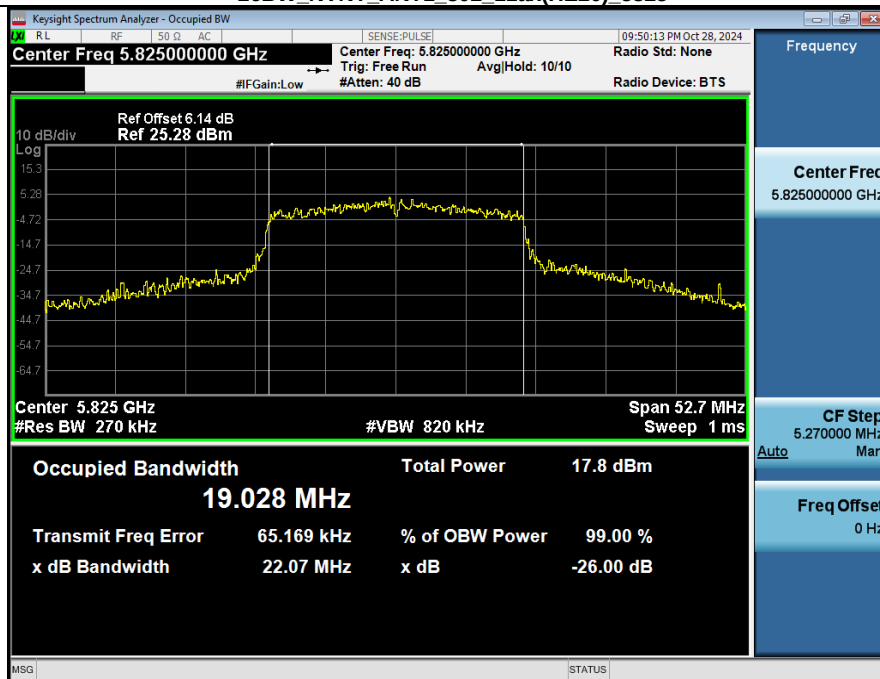
-26BW\_NVNT\_ANT1\_802\_11ax(HE20)\_5825

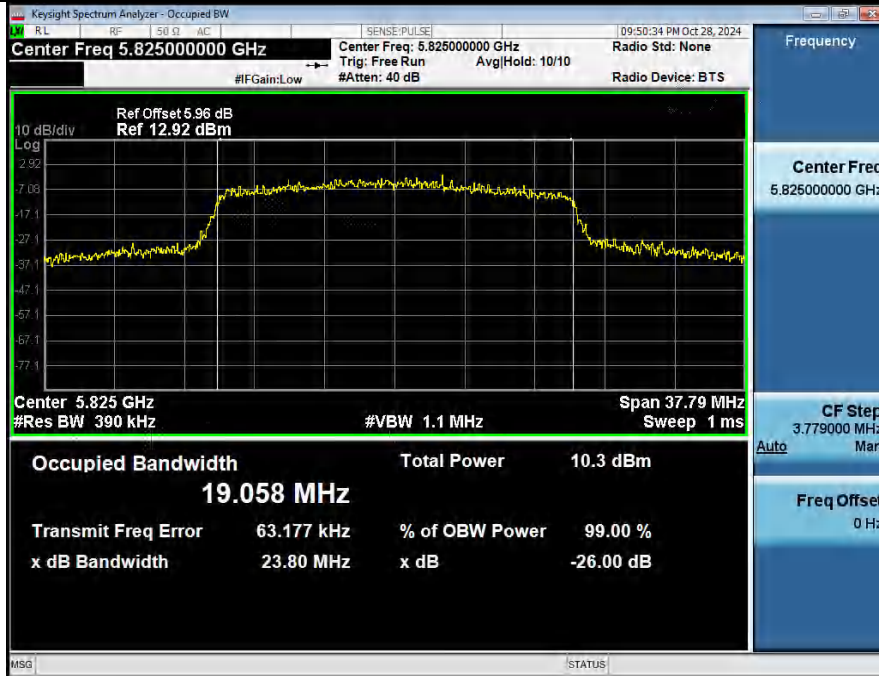
99% OCB\_NVNT\_ANT2\_802\_11ax(HE20)\_5825

| Condition | Antenna | Modulation | Frequency(MHz) | Occupied Bandwidth(MHz) |
|---|---|---|---|---|
| NVNT | ANT2 | 802.11ax(HE20) | 5825.00 | 19.06 |

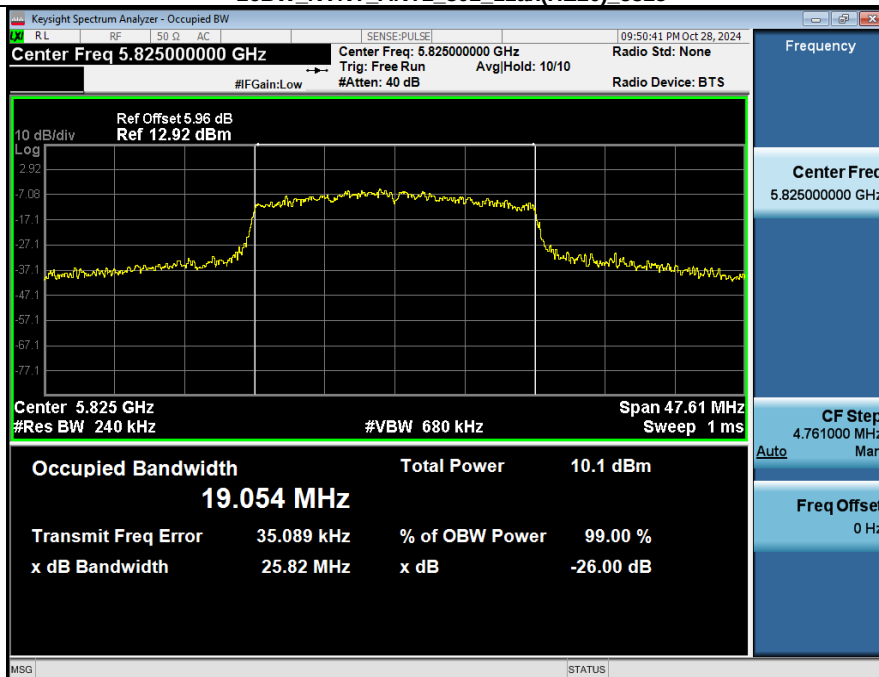
-26BW\_NVNT\_ANT2\_802\_11ax(HE20)\_5825

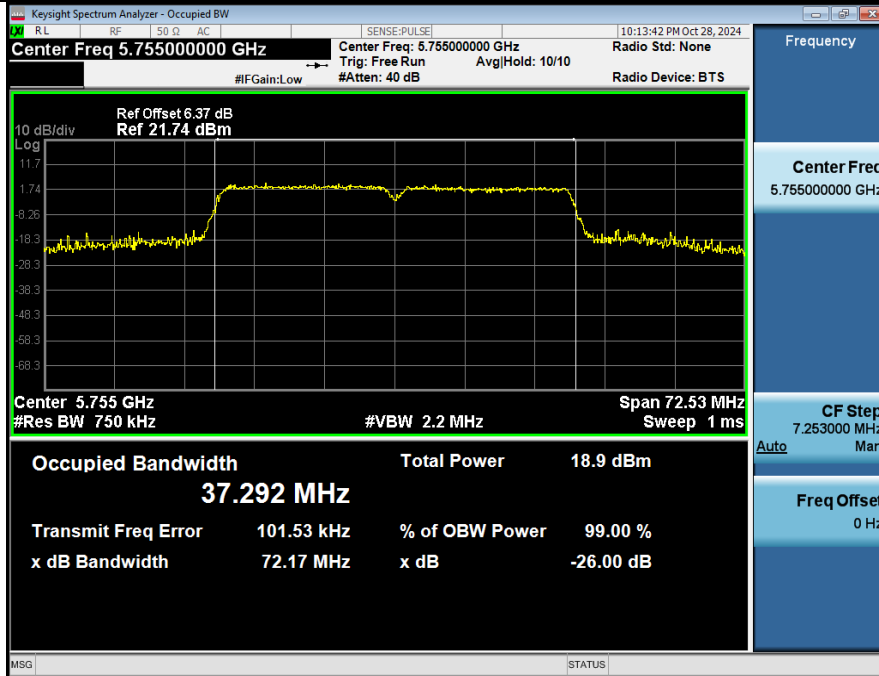
99% OCB\_NVNT\_ANT1\_802\_11n(HT40)\_5755

| Condition | Antenna | Modulation | Frequency(MHz) | Occupied Bandwidth(MHz) |
|---|---|---|---|---|
| NVNT | ANT1 | 802.11n(HT40) | 5755.00 | 37.29 |

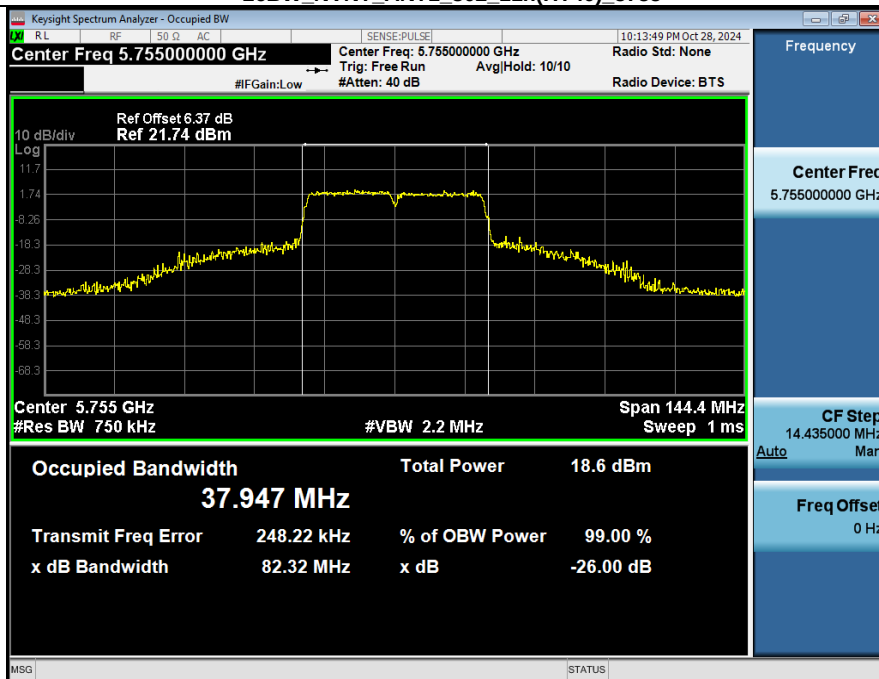
-26BW\_NVNT\_ANT1\_802\_11n(HT40)\_5755

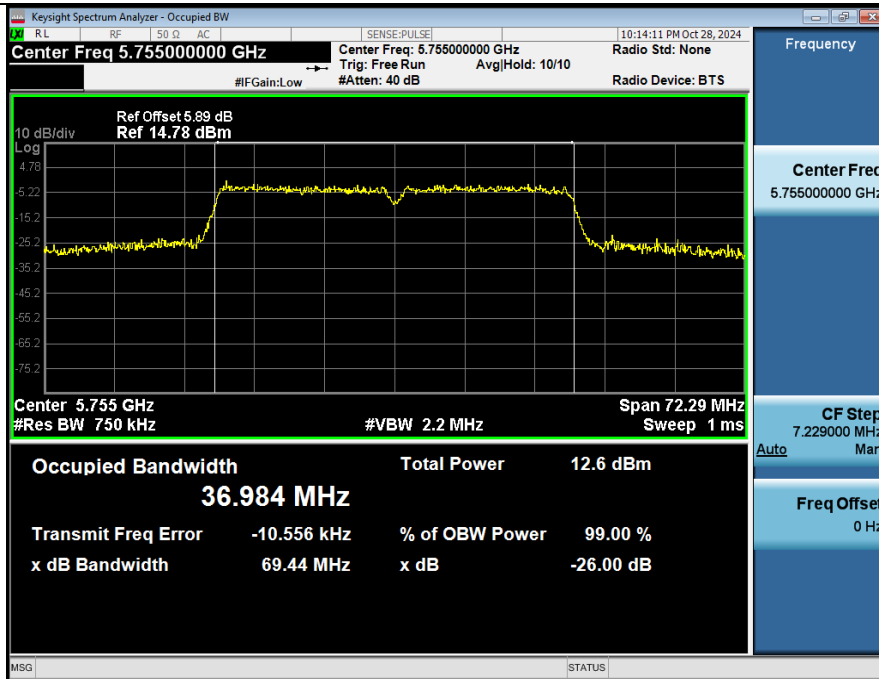
99%\_OCB\_NVNT\_ANT2\_802\_11n(HT40)\_5755

| Condition | Antenna | Modulation | Frequency(MHz) | Occupied Bandwidth(MHz) |
|---|---|---|---|---|
| NVNT | ANT2 | 802.11n(HT40) | 5755.00 | 36.98 |

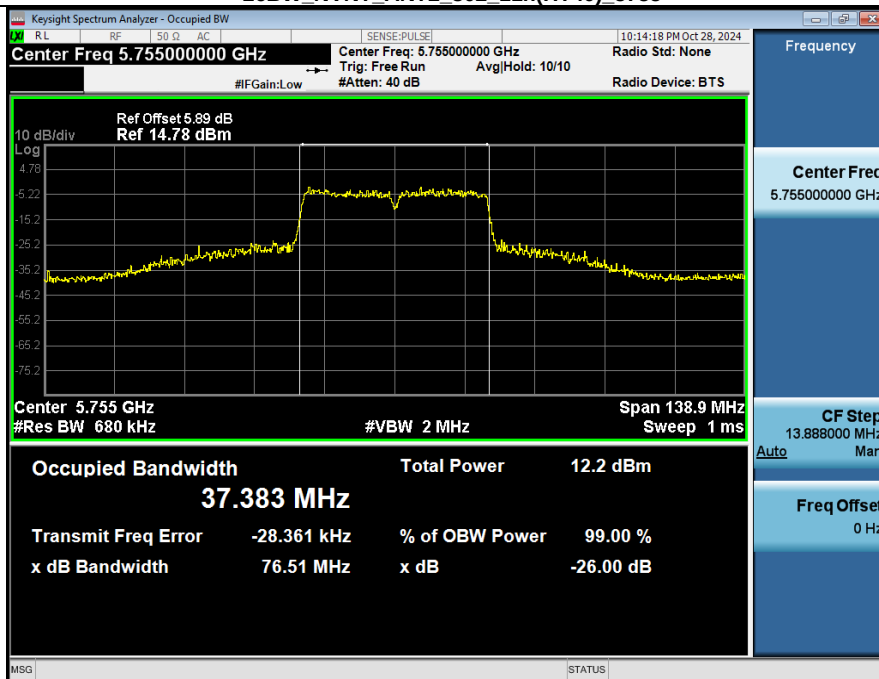
-26BW\_NVNT\_ANT2\_802\_11n(HT40)\_5755

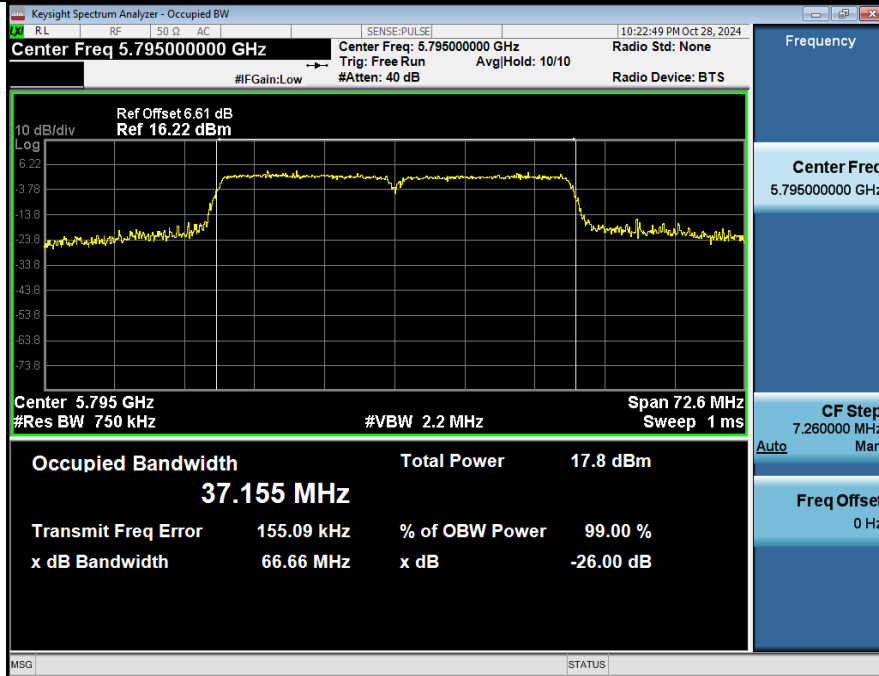
99%\_OCB\_NVNT\_ANT1\_802\_11n(HT40)\_5795

| Condition | Antenna | Modulation | Frequency(MHz) | Occupied Bandwidth(MHz) |
|---|---|---|---|---|
| NVNT | ANT1 | 802.11n(HT40) | 5795.00 | 37.16 |

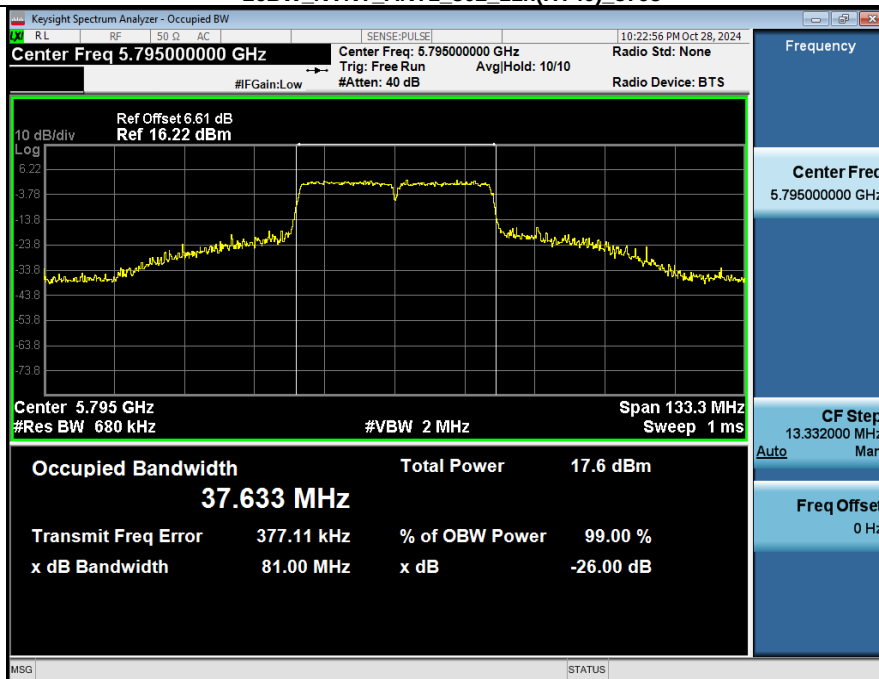
-26BW\_NVNT\_ANT1\_802\_11n(HT40)\_5795

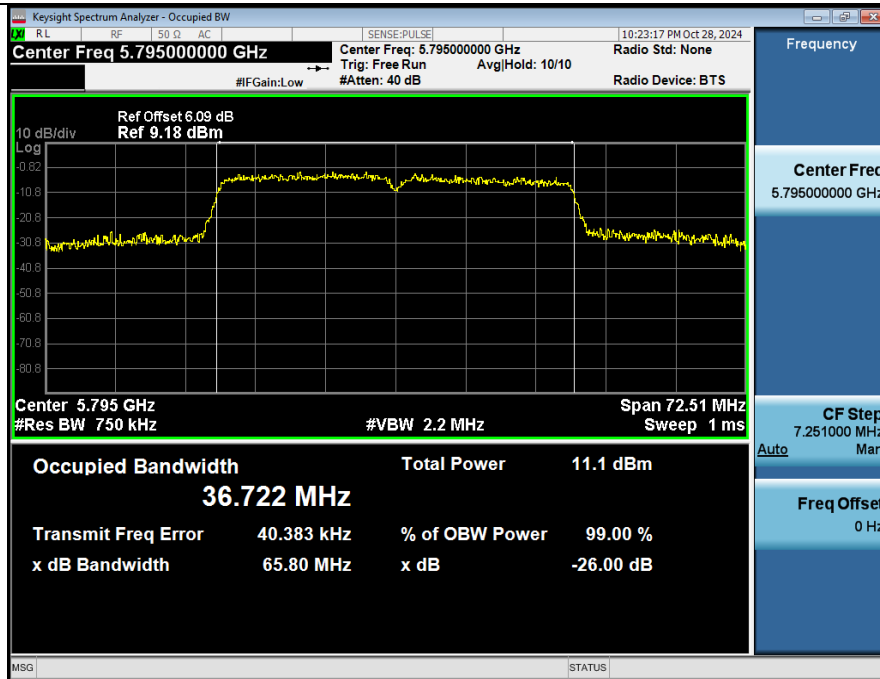
99%\_OCB\_NVNT\_ANT2\_802\_11n(HT40)\_5795

| Condition | Antenna | Modulation | Frequency(MHz) | Occupied Bandwidth(MHz) |
|---|---|---|---|---|
| NVNT | ANT2 | 802.11n(HT40) | 5795.00 | 36.72 |

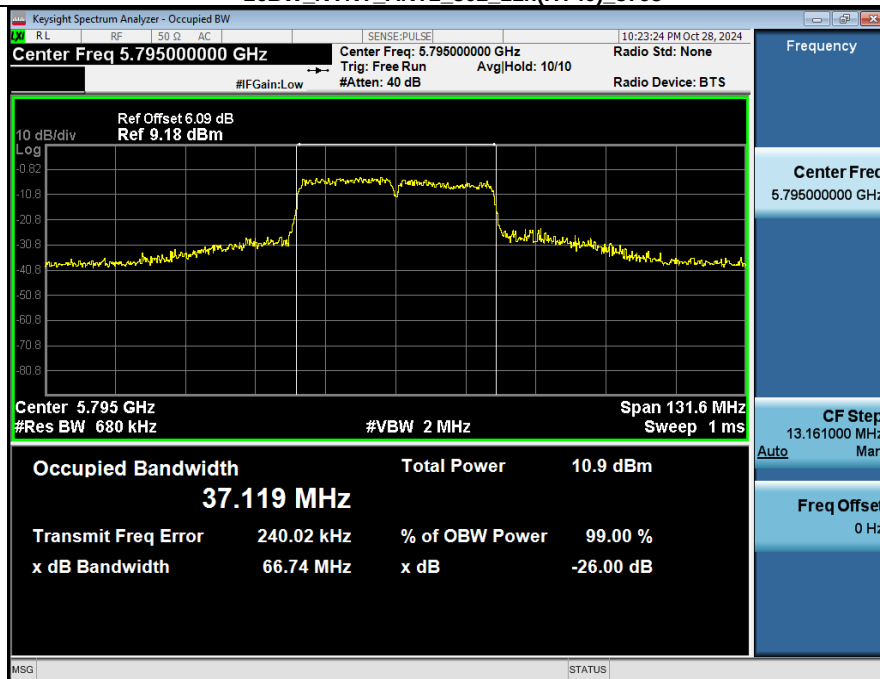
-26BW\_NVNT\_ANT2\_802\_11n(HT40)\_5795

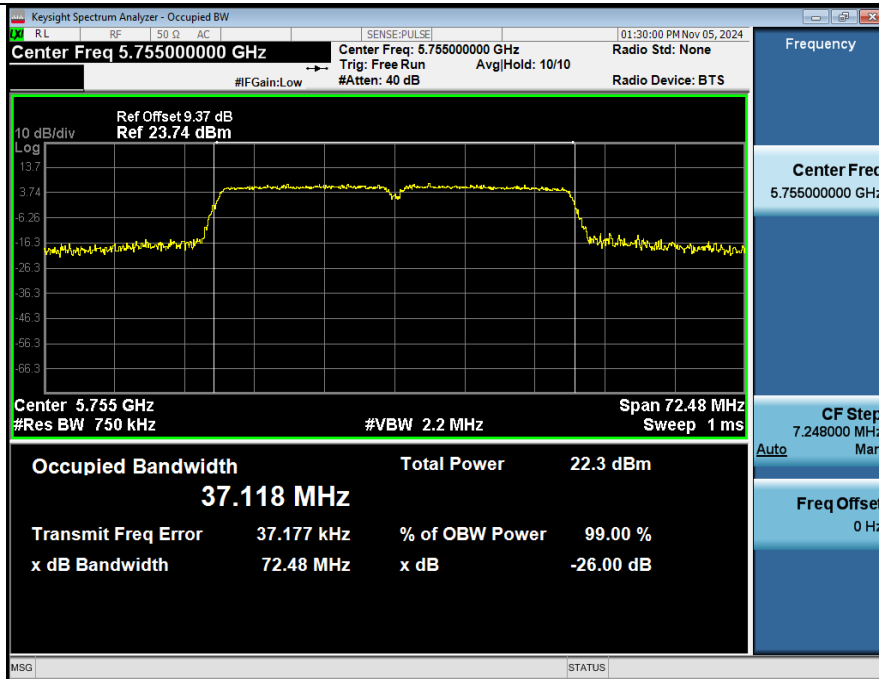
99%\_OCB\_NVNT\_ANT1\_802\_11ac(VHT40)\_5755

| Condition | Antenna | Modulation | Frequency(MHz) | Occupied Bandwidth(MHz) |
|---|---|---|---|---|
| NVNT | ANT1 | 802.11ac(VHT40) | 5755.00 | 37.12 |

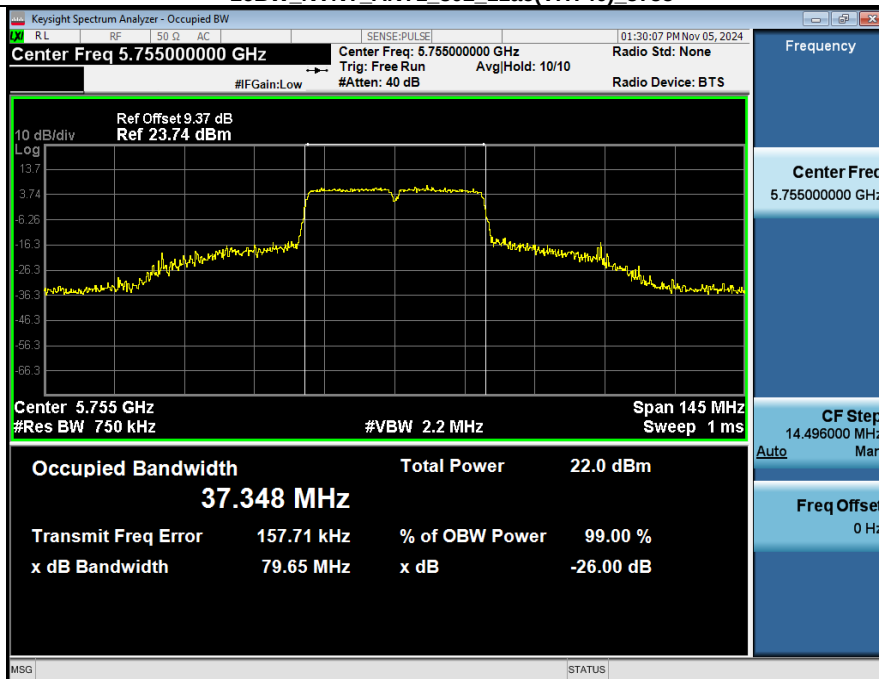
-26BW\_NVNT\_ANT1\_802\_11ac(VHT40)\_5755
