## 12.7 APPENDIX : CONDUCTED SPURIOUS EMISSION

### Test Result

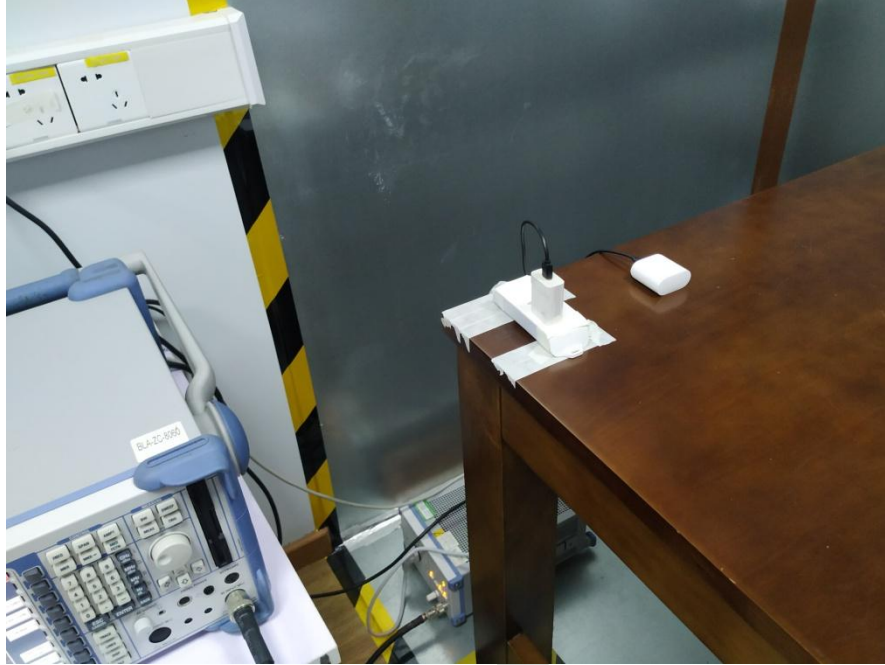
### Conducted Emissions at AC Power Line (150kHz-30MHz)

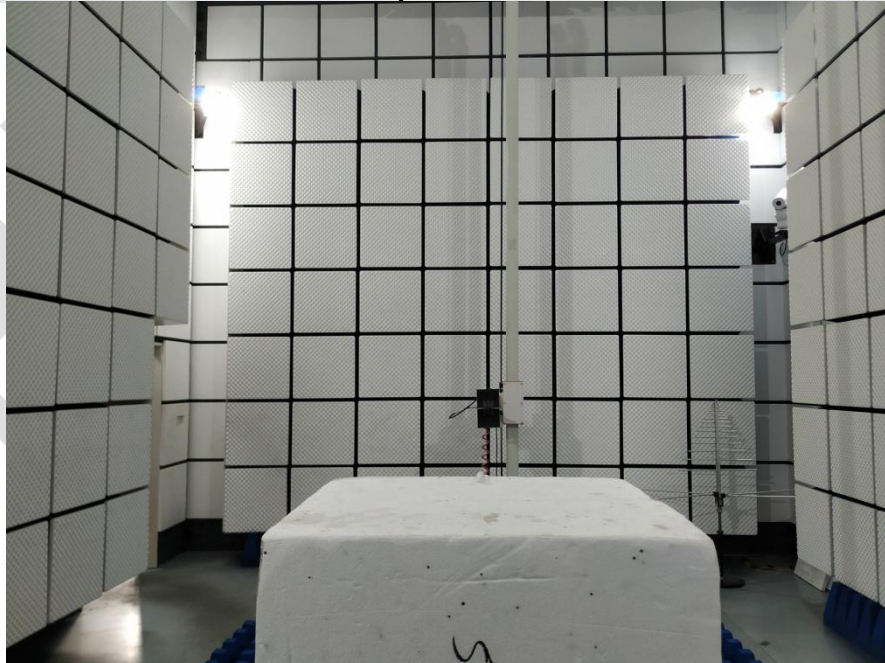
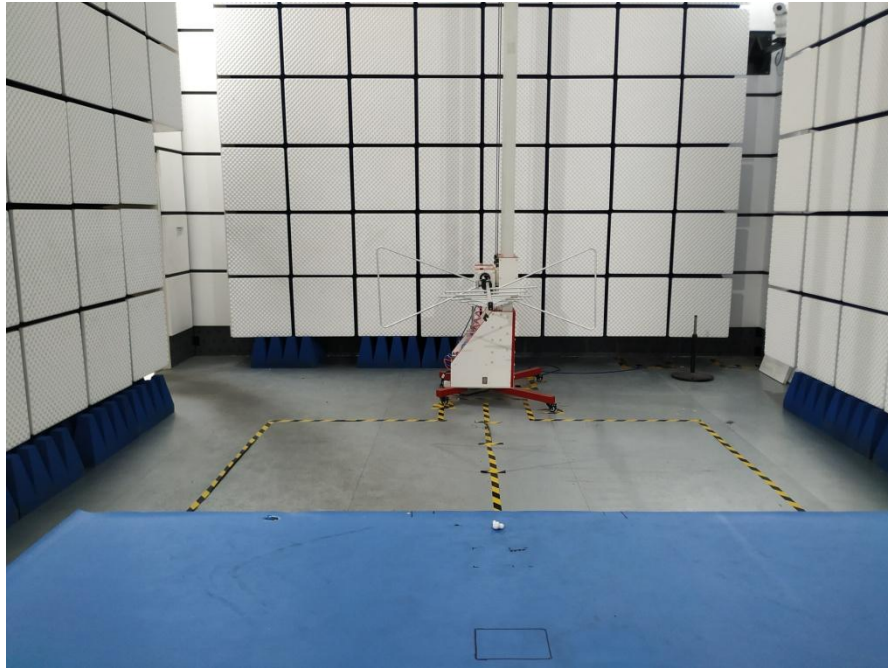
### Radiated Spurious Emissions
