Registration number:W6M21703-16691-C-54
FCC ID: 2ANKPW3-R9013

Appendix

Measurement diagrams

1. Spurious Emissions radiated
2. Mask

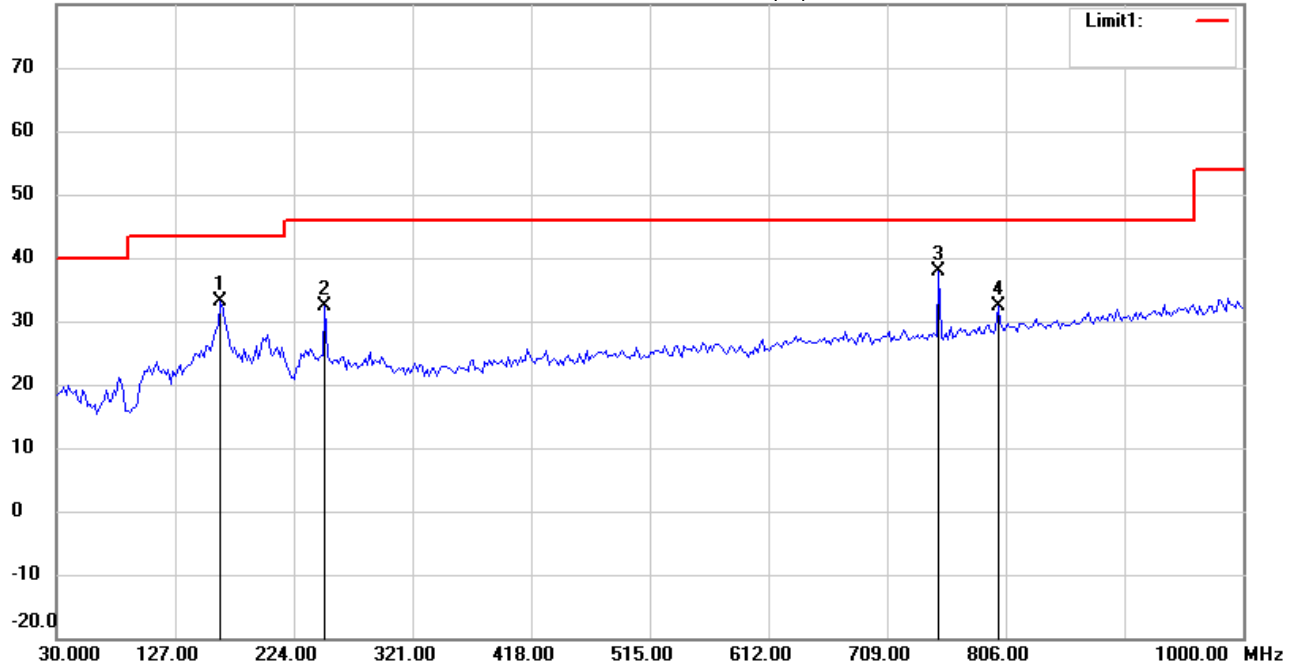
Radiated Emission Measurement

Condition : FCC_part 15 RE-Class E_30-1000MHz

Polarization: *Horizontal*

Test Mode : TX 802.11a CH36

Mk.	Frequency (MHz)	Reading (dBuV)	Detector	Corr. factor (dB/m)	Result (dBuV/m)	Limit (dBuV/m)	Ant.Pos (cm)	Tab.Pos (deg.)	Margin (dB)	Comment
	164.1282	42.76	peak	-9.63	33.13	43.50	100	90	-10.37	
	249.6593	40.10	peak	-7.81	32.29	46.00	100	10	-13.71	
*	751.1824	37.32	peak	0.54	37.86	46.00	100	80	-8.14	
	799.7795	31.03	peak	1.39	32.42	46.00	100	65	-13.58

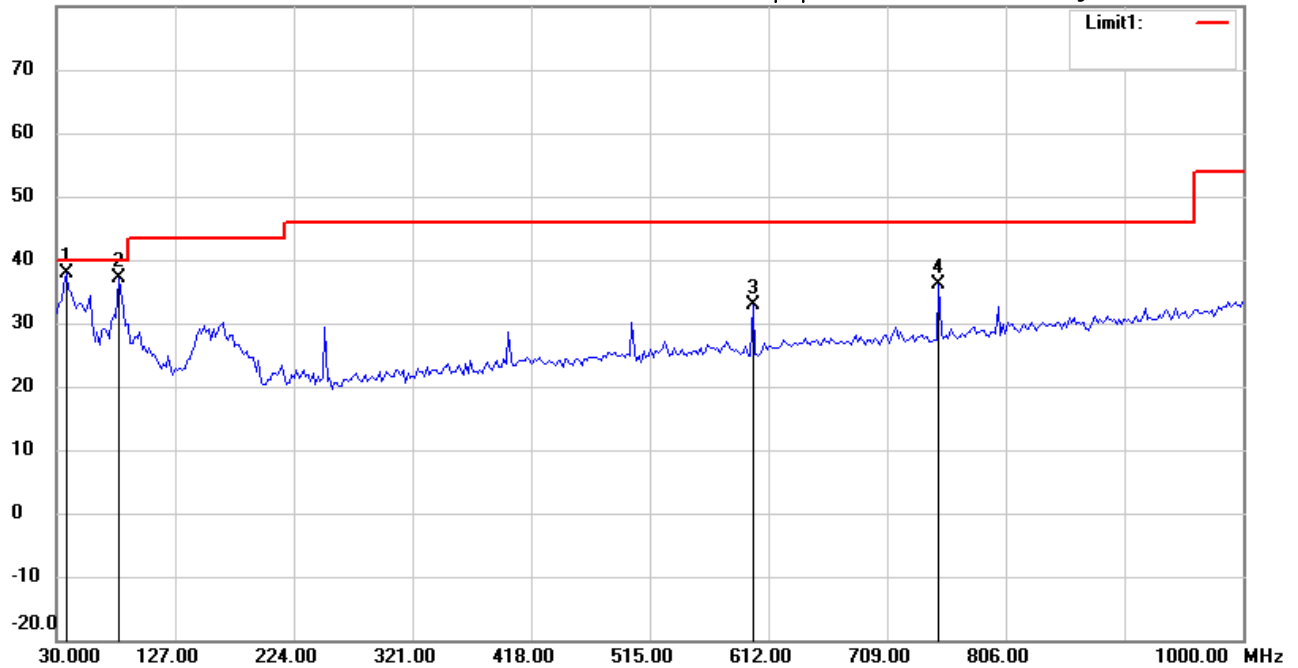
Condition : FCC_part 15 RE-Class E_30-1000MHz

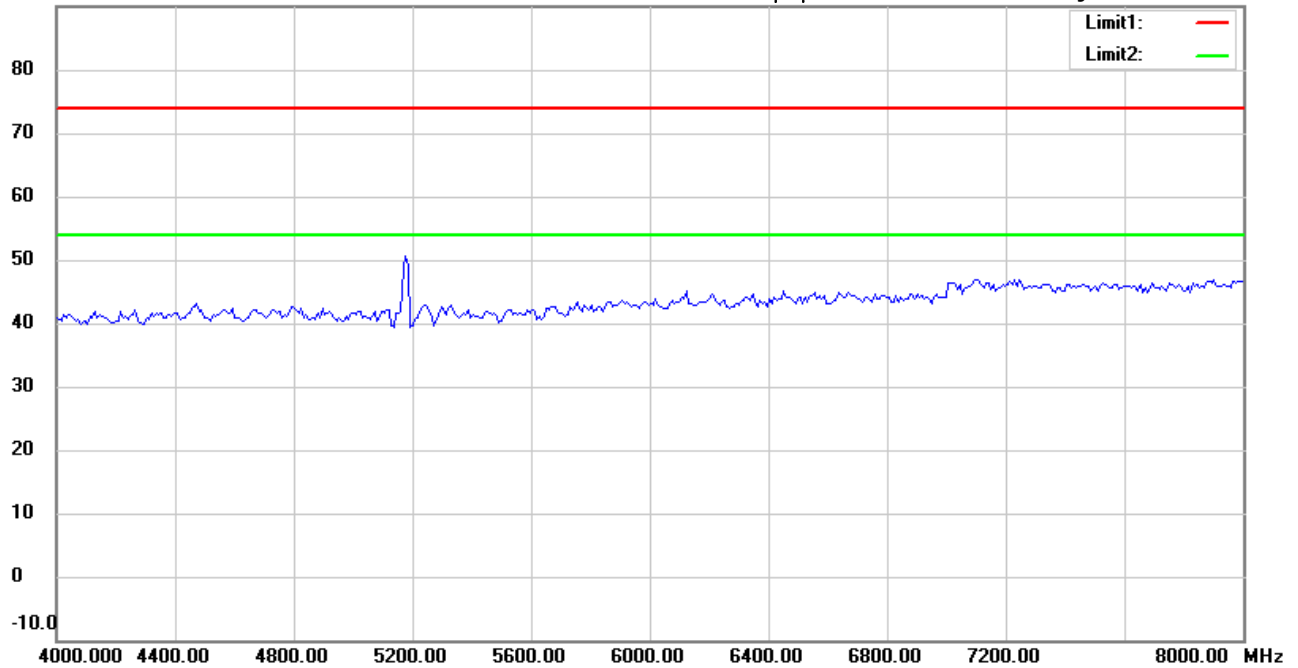
Condition : FCC_part 15E RE_Above 1GHz_PK

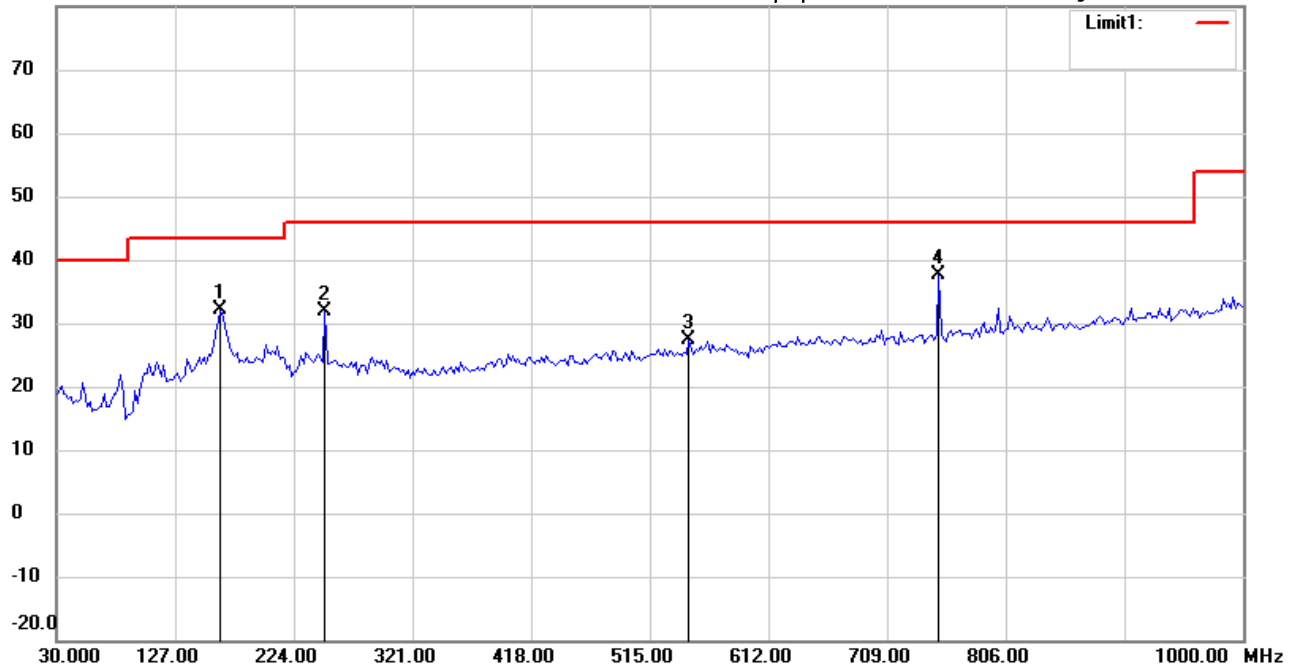
Condition : FCC_part 15 RE-Class E_30-1000MHz

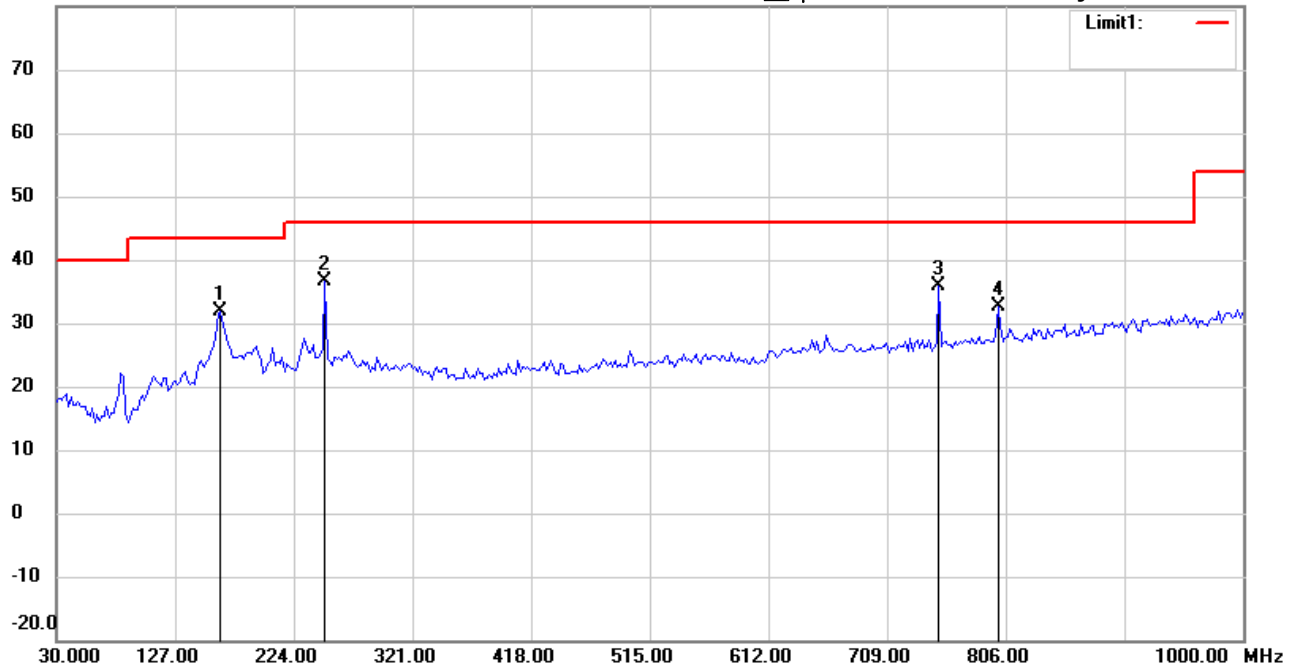
Condition : FCC_part 15 RE-Class C_30-1000MHz
