Radiated Emission Measurement

Condition : FCC_part 15E RE_Above 1GHz_PK

EUT : W6M22311-23090

Test Mode : TX 802.11a CH165

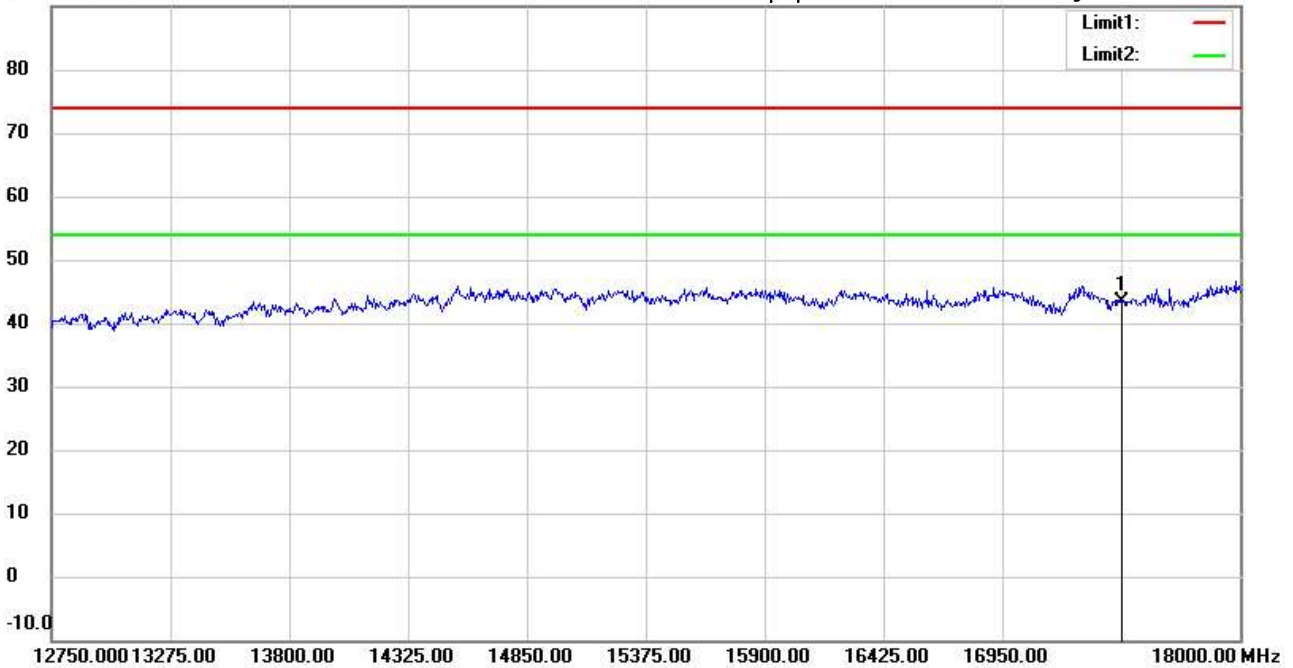
Data :#10

Polarization: **Vertical**

Mk.	Frequency (MHz)	Reading (dBuV)	Detector	Corr. factor (dB/m)	Result (dBuV/m)	Limit (dBuV/m)	Ant.Pos (cm)	Tab.Pos (deg.)	Margin (dB)	Comment
*	17475.000	20.26	peak	23.21	43.47	74.00	150	27	-30.53

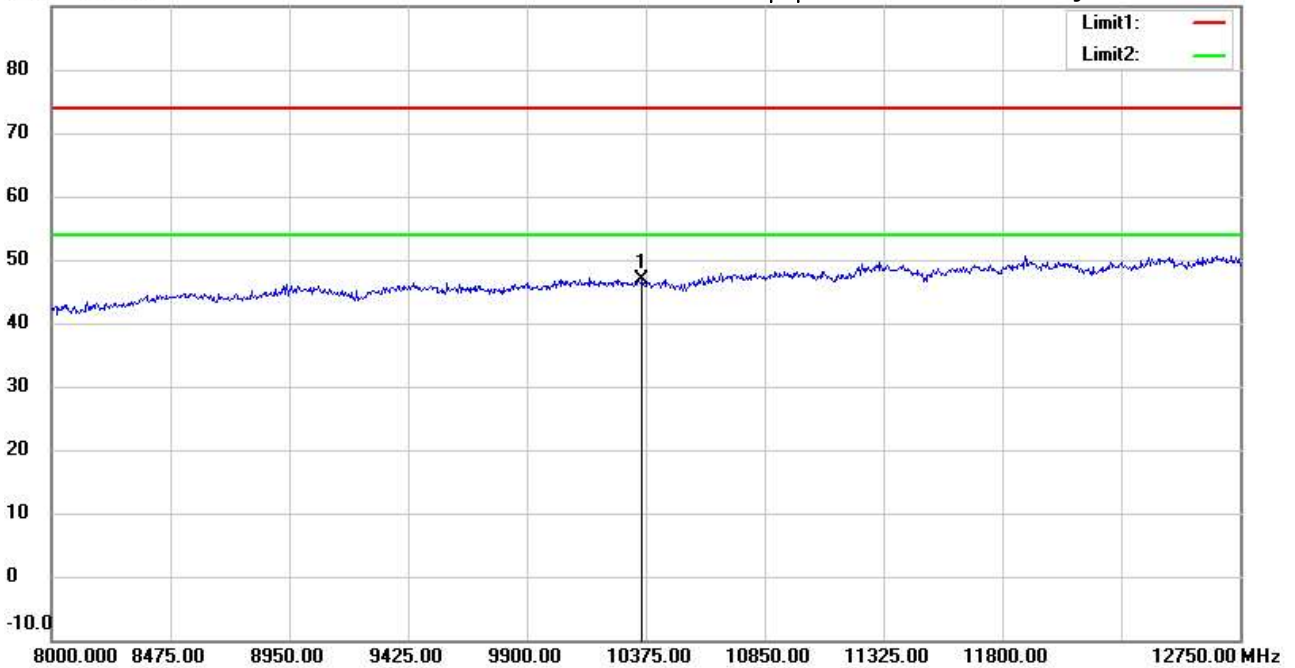
Data :#3

Condition : FCC_part 15E RE_Above 1GHz_PK

Polarization: *Horizontal*

Test Mode : TX 802.11n20 CH36

Mk.	Frequency (MHz)	Reading (dBuV)	Detector	Corr. factor (dB/m)	Result (dBuV/m)	Limit (dBuV/m)	Ant.Pos (cm)	Tab.Pos (deg.)	Margin (dB)	Comment
*	10360.000	32.77	peak	14.15	46.92	74.00	150	342	-27.08

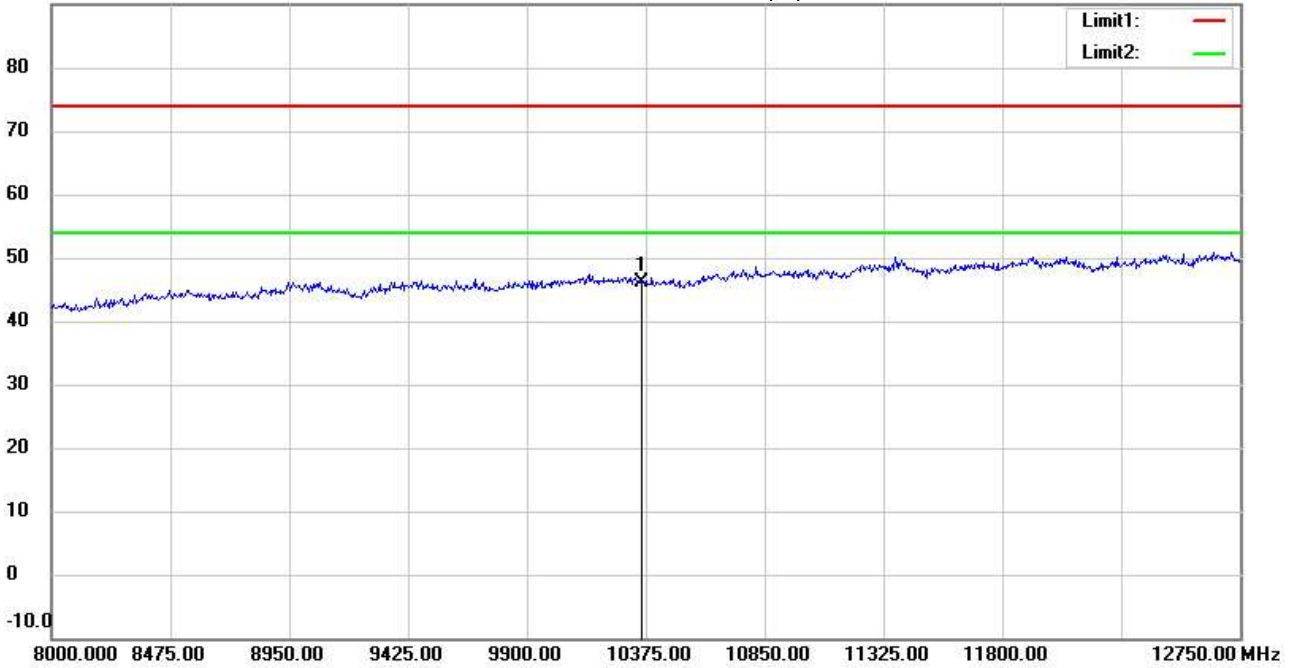
Data :#9

Condition : FCC_part 15E RE_Above 1GHz_PK

Polarization: *Vertical*

Test Mode : TX 802.11n20 CH36

Mk.	Frequency (MHz)	Reading (dBuV)	Detector	Corr. factor (dB/m)	Result (dBuV/m)	Limit (dBuV/m)	Ant.Pos (cm)	Tab.Pos (deg.)	Margin (dB)	Comment
*	10360.000	31.88	peak	14.15	46.03	74.00	150	213	-27.97

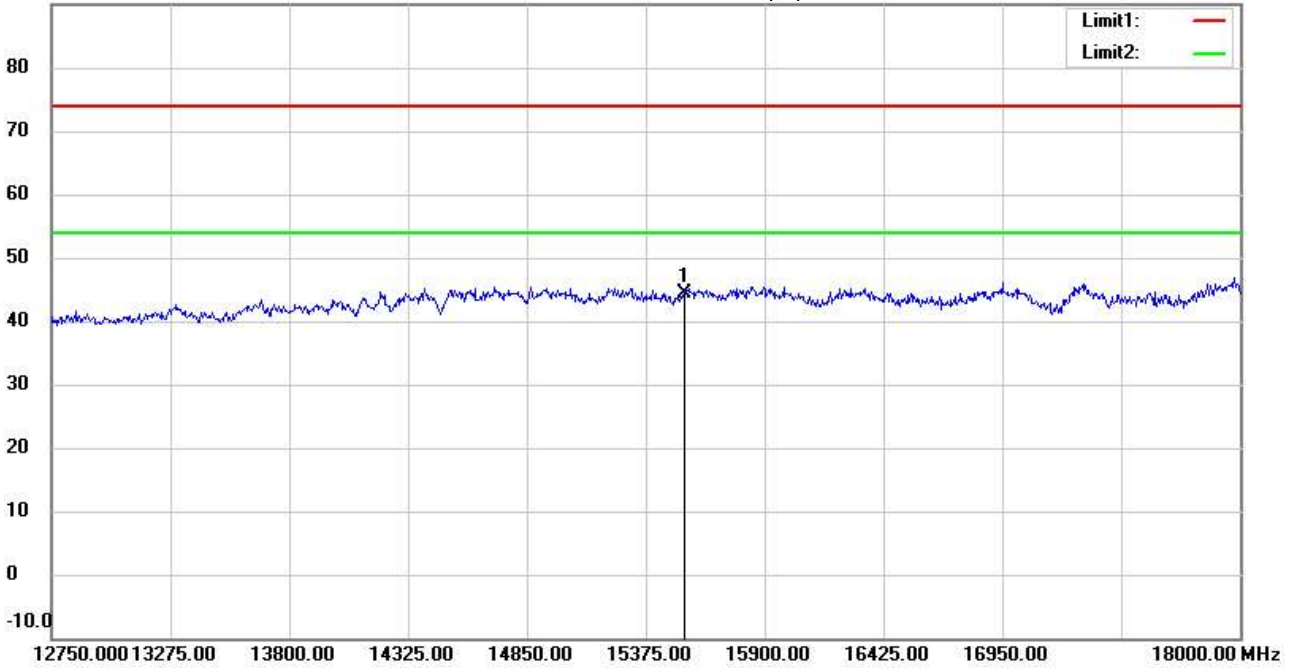
Data :#4

Condition : FCC_part 15E RE_Above 1GHz_PK

Polarization: *Horizontal*

Test Mode : TX 802.11n20 CH36

Mk.	Frequency (MHz)	Reading (dBuV)	Detector	Corr. factor (dB/m)	Result (dBuV/m)	Limit (dBuV/m)	Ant.Pos (cm)	Tab.Pos (deg.)	Margin (dB)	Comment
*	15540.000	21.07	peak	23.41	44.48	74.00	150	93	-29.52

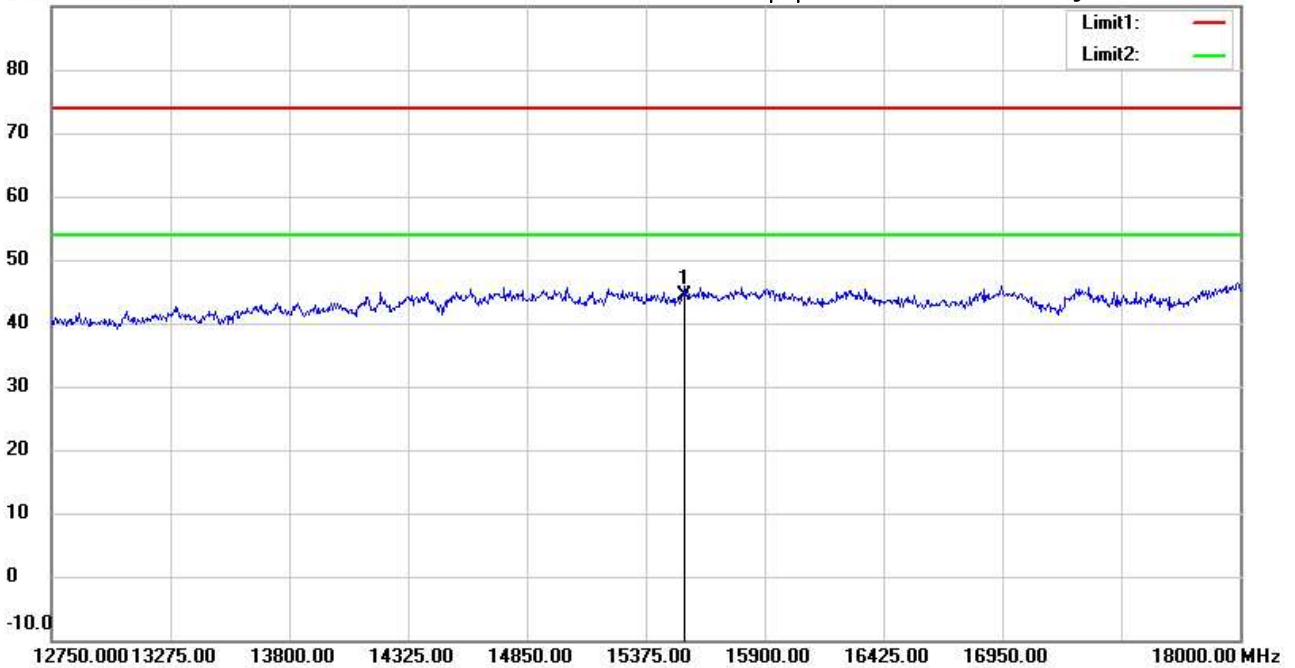
Data :#10

Condition : FCC_part 15E RE_Above 1GHz_PK

Polarization: *Vertical*

Test Mode : TX 802.11n20 CH36

Mk.	Frequency (MHz)	Reading (dBuV)	Detector	Corr. factor (dB/m)	Result (dBuV/m)	Limit (dBuV/m)	Ant.Pos (cm)	Tab.Pos (deg.)	Margin (dB)	Comment
*	15540.000	21.04	peak	23.41	44.45	74.00	150	287	-29.55

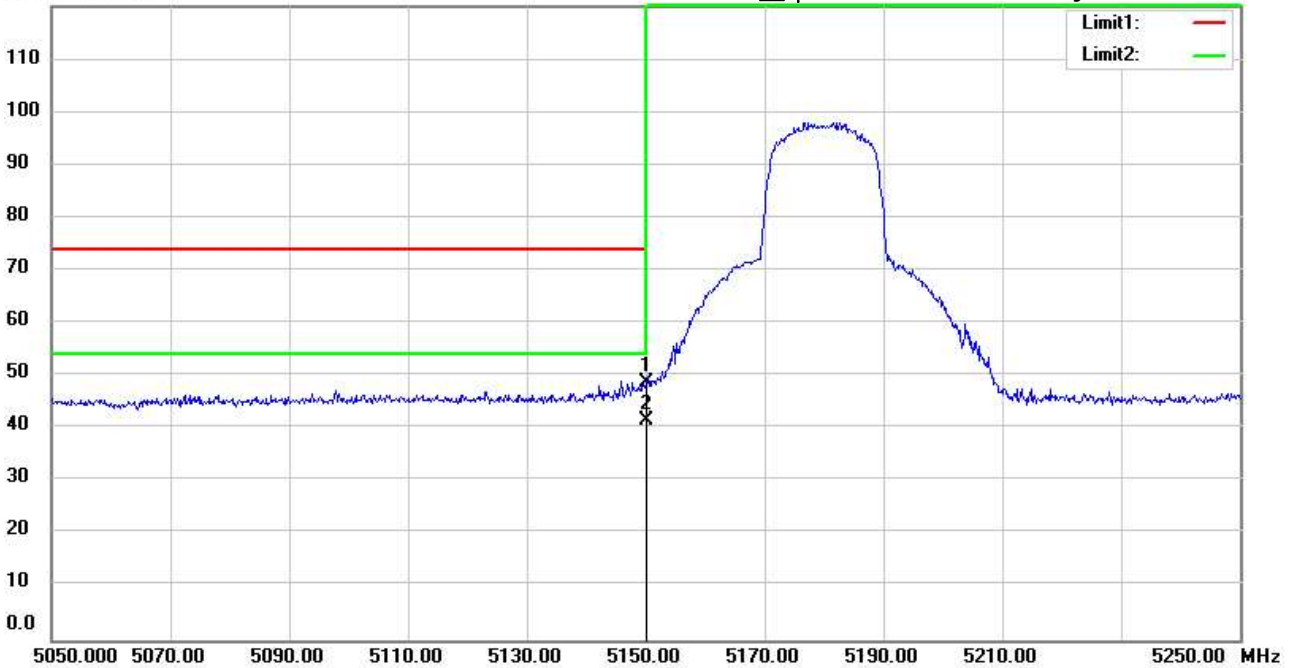
Data :#1

Condition : FCC 15.407 PK (Bandedge)(B1_5150_5250)

Polarization: *Horizontal*

Test Mode : TX 802.11n20 CH36

Mk.	Frequency (MHz)	Reading (dBuV)	Detector	Corr. factor (dB/m)	Result (dBuV/m)	Limit (dBuV/m)	Ant.Pos (cm)	Tab.Pos (deg.)	Margin (dB)	Comment
	5150.000	43.41	peak	5.31	48.72	74.00	150	312	-25.28	
*	5150.000	36.25	AVG	5.31	41.56	54.00	150	312	-12.44

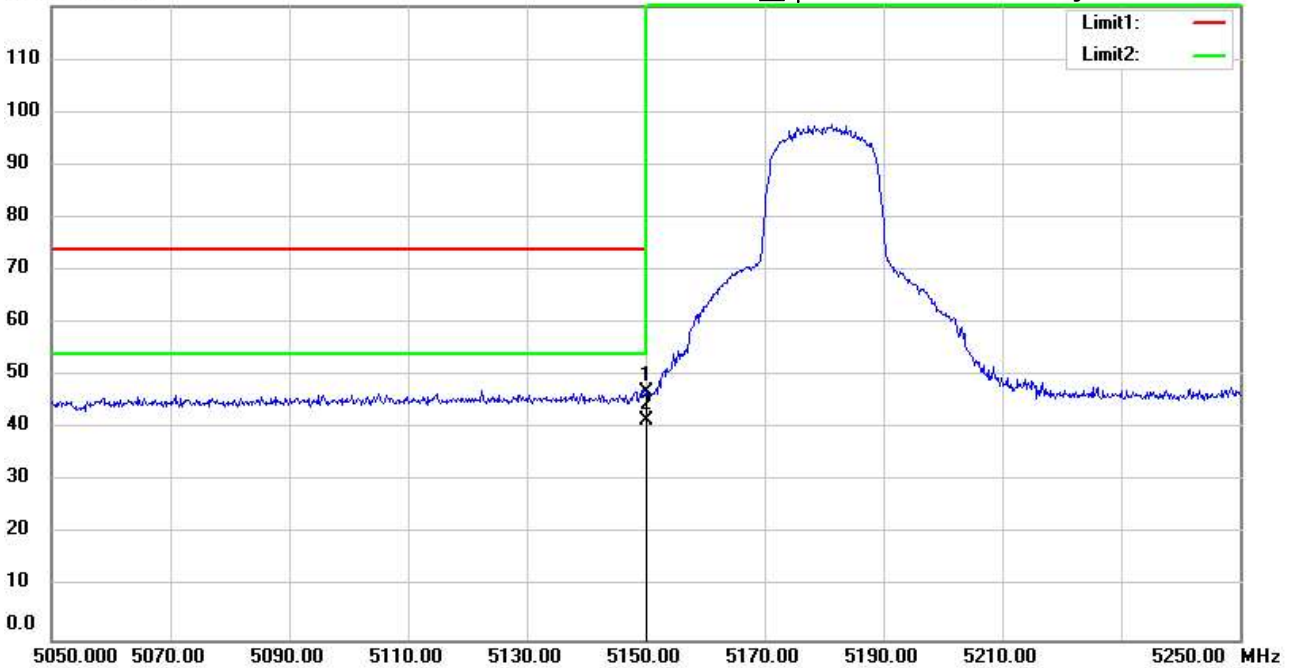
Data :#2

Condition : FCC 15.407 PK (Bandedge)(B1_5150_5250)

Polarization: *Vertical*

Test Mode : TX 802.11n20 CH36

Mk.	Frequency (MHz)	Reading (dBuV)	Detector	Corr. factor (dB/m)	Result (dBuV/m)	Limit (dBuV/m)	Ant.Pos (cm)	Tab.Pos (deg.)	Margin (dB)	Comment
	5150.000	41.76	peak	5.31	47.07	74.00	150	82	-26.93	
*	5150.000	36.21	AVG	5.31	41.52	54.00	150	82	-12.48

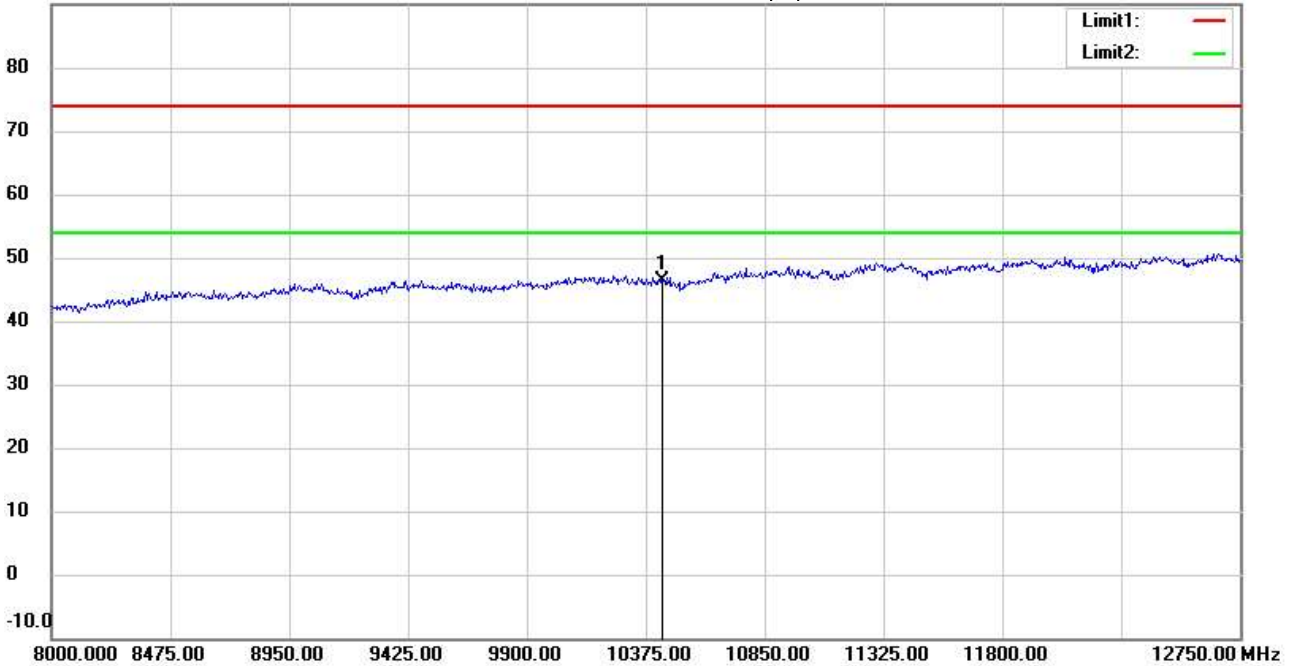
Data :#3

Condition : FCC_part 15E RE_Above 1GHz_PK

Polarization: **Horizontal**

Test Mode : TX 802.11n20 CH44

Mk.	Frequency (MHz)	Reading (dBuV)	Detector	Corr. factor (dB/m)	Result (dBuV/m)	Limit (dBuV/m)	Ant.Pos (cm)	Tab.Pos (deg.)	Margin (dB)	Comment
*	10440.000	32.34	peak	14.11	46.45	74.00	150	76	-27.55

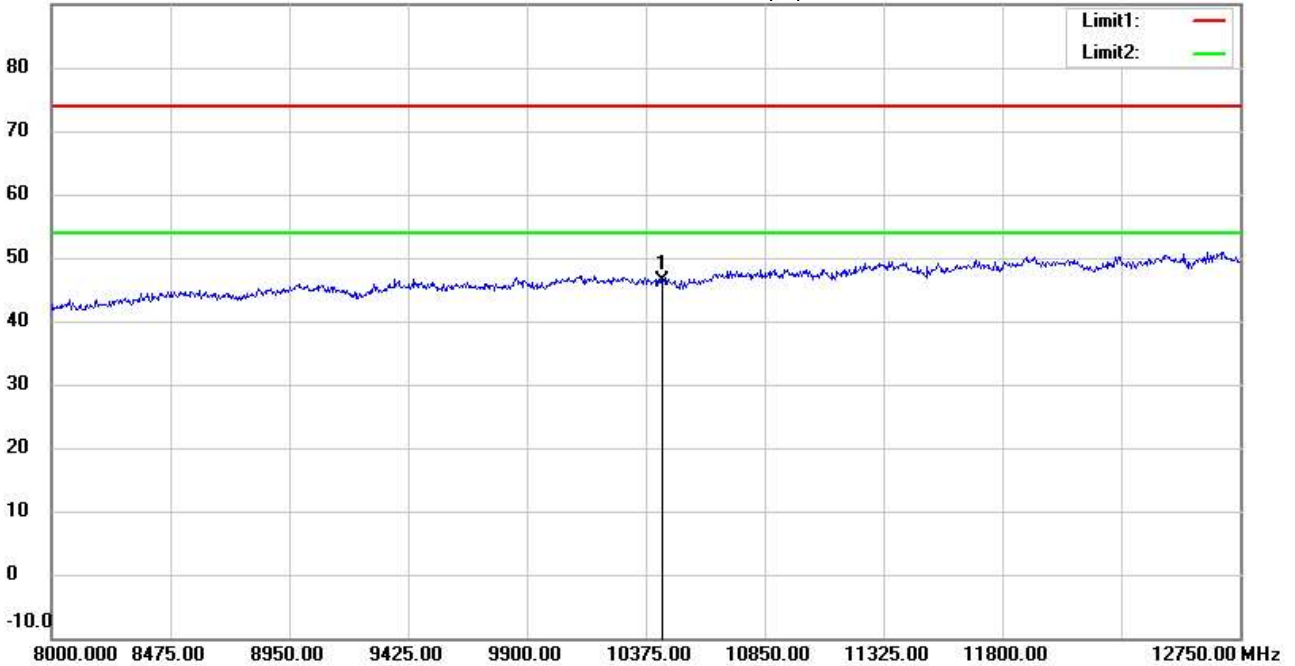
Data :#9

Condition : FCC_part 15E RE_Above 1GHz_PK

Polarization: *Vertical*

Test Mode : TX 802.11n20 CH44

Mk.	Frequency (MHz)	Reading (dBuV)	Detector	Corr. factor (dB/m)	Result (dBuV/m)	Limit (dBuV/m)	Ant.Pos (cm)	Tab.Pos (deg.)	Margin (dB)	Comment
*	10440.000	32.23	peak	14.11	46.34	74.00	150	237	-27.66

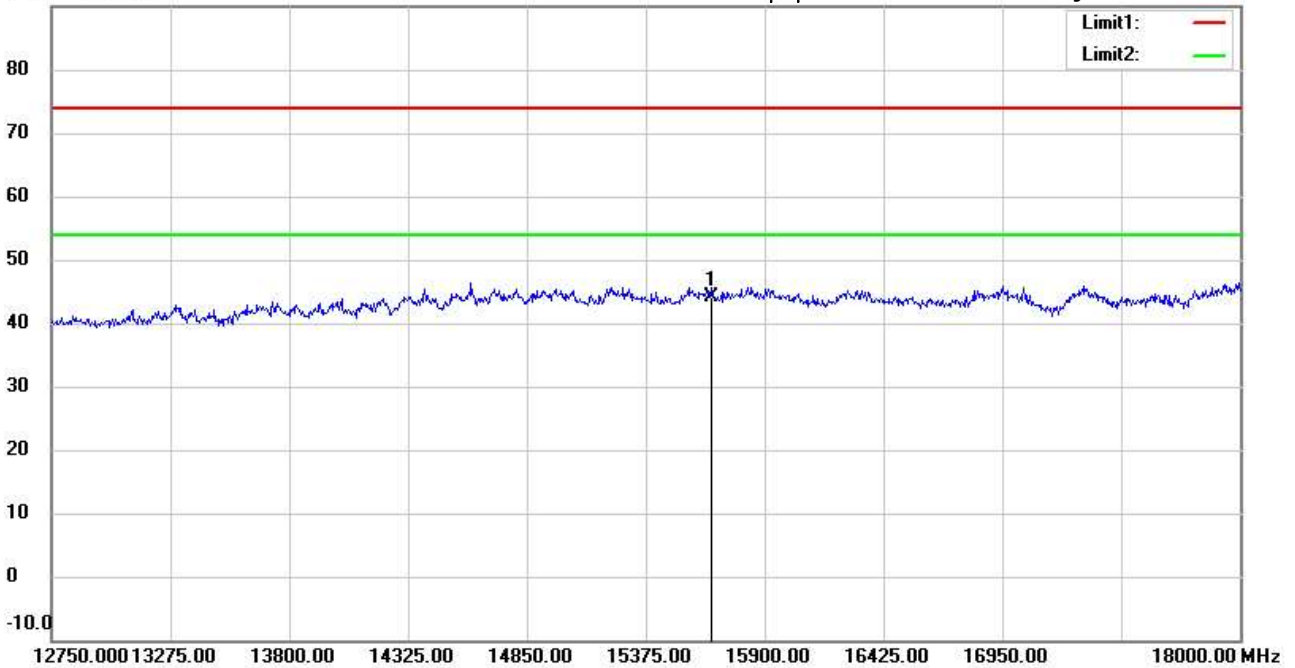
Data :#4

Condition : FCC_part 15E RE_Above 1GHz_PK

Polarization: *Horizontal*

Test Mode : TX 802.11n20 CH44

Mk.	Frequency (MHz)	Reading (dBuV)	Detector	Corr. factor (dB/m)	Result (dBuV/m)	Limit (dBuV/m)	Ant.Pos (cm)	Tab.Pos (deg.)	Margin (dB)	Comment
*	15660.000	21.07	peak	23.15	44.22	74.00	150	119	-29.78

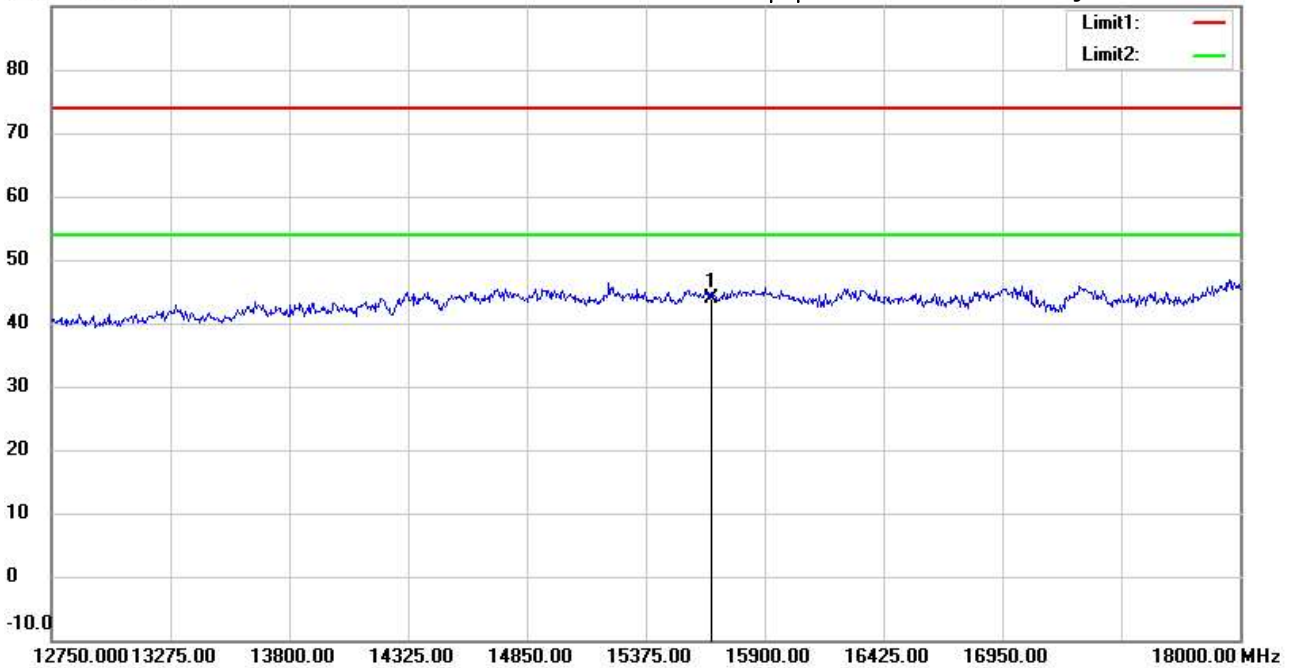
Data :#10

Condition : FCC_part 15E RE_Above 1GHz_PK

Polarization: *Vertical*

Test Mode : TX 802.11n20 CH44

Mk.	Frequency (MHz)	Reading (dBuV)	Detector	Corr. factor (dB/m)	Result (dBuV/m)	Limit (dBuV/m)	Ant.Pos (cm)	Tab.Pos (deg.)	Margin (dB)	Comment
*	15660.000	20.83	peak	23.15	43.98	74.00	150	230	-30.02
