Radiated Emission Measurement

Condition : FCC_part 15E RE_Above 1GHz_PK

EUT : W6M22311-23090

Test Mode : TX 802.11n20 CH44

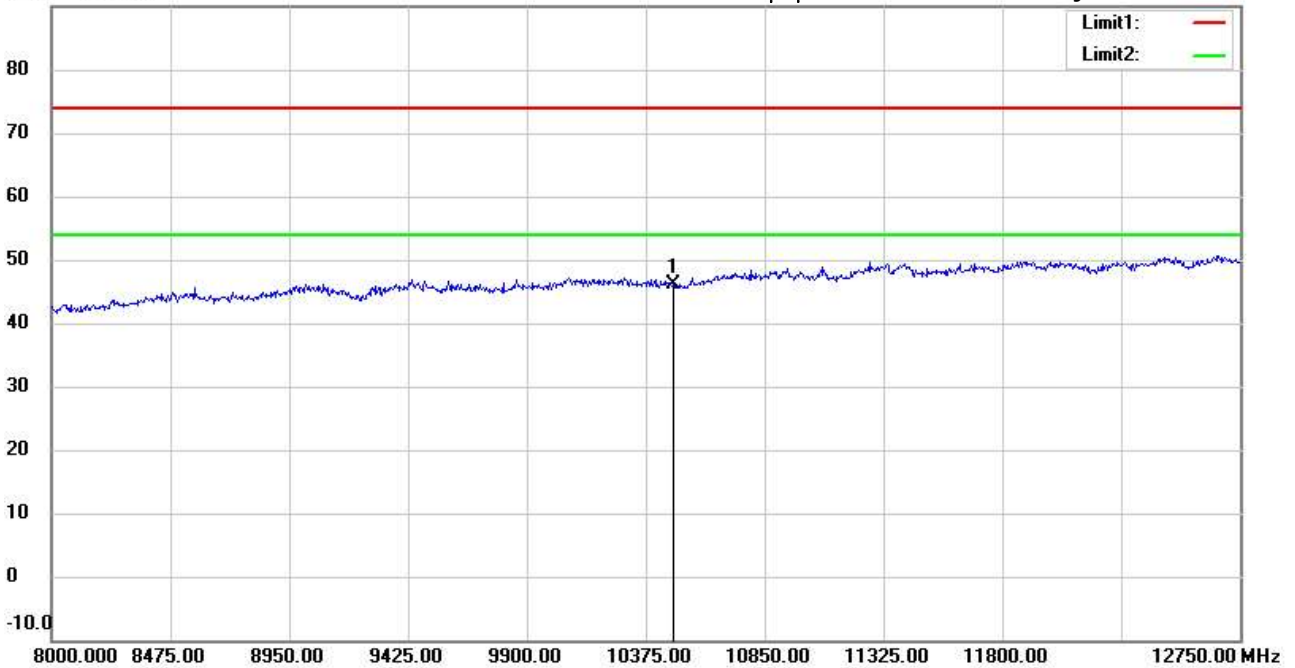
Polarization: *Horizontal*

Test Mode : TX 802.11n20 CH48

Mk.	Frequency (MHz)	Reading (dBuV)	Detector	Corr. factor (dB/m)	Result (dBuV/m)	Limit (dBuV/m)	Ant.Pos (cm)	Tab.Pos (deg.)	Margin (dB)	Comment
*	10480.000	32.10	peak	14.08	46.18	74.00	150	45	-27.82

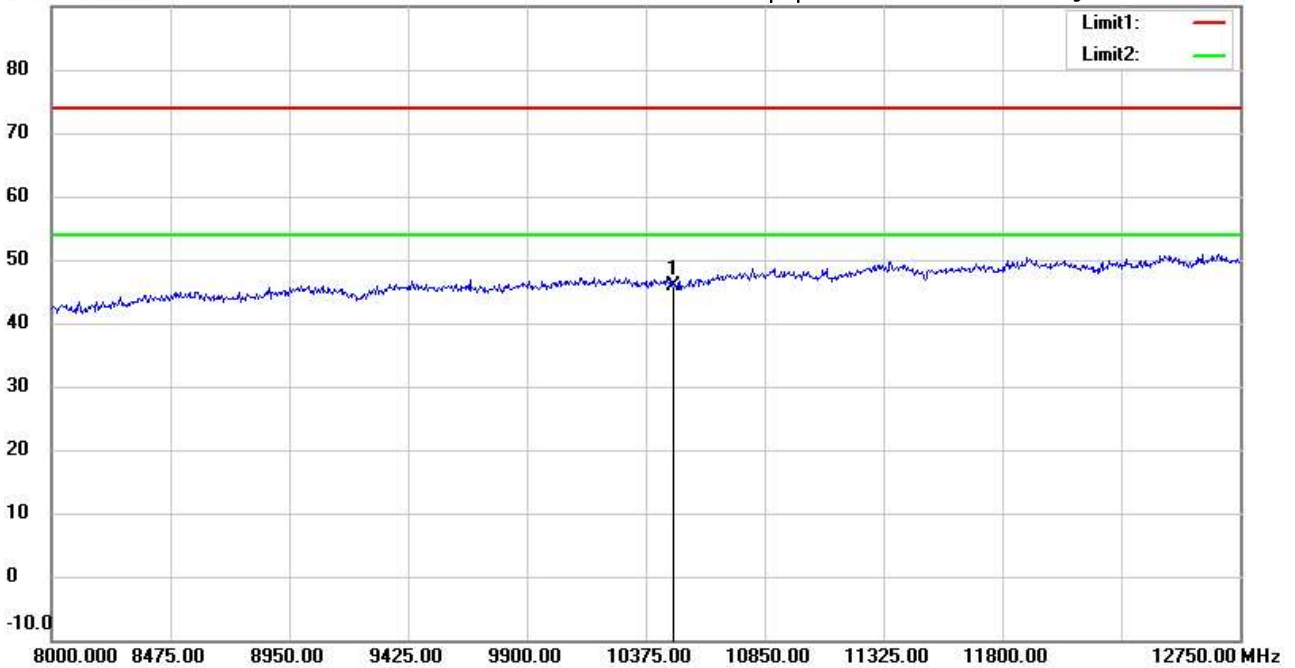
Polarization: **Vertical**

Test Mode : TX 802.11n20 CH48

Mk.	Frequency (MHz)	Reading (dBuV)	Detector	Corr. factor (dB/m)	Result (dBuV/m)	Limit (dBuV/m)	Ant.Pos (cm)	Tab.Pos (deg.)	Margin (dB)	Comment
*	10480.000	31.87	peak	14.08	45.95	74.00	150	10	-28.05

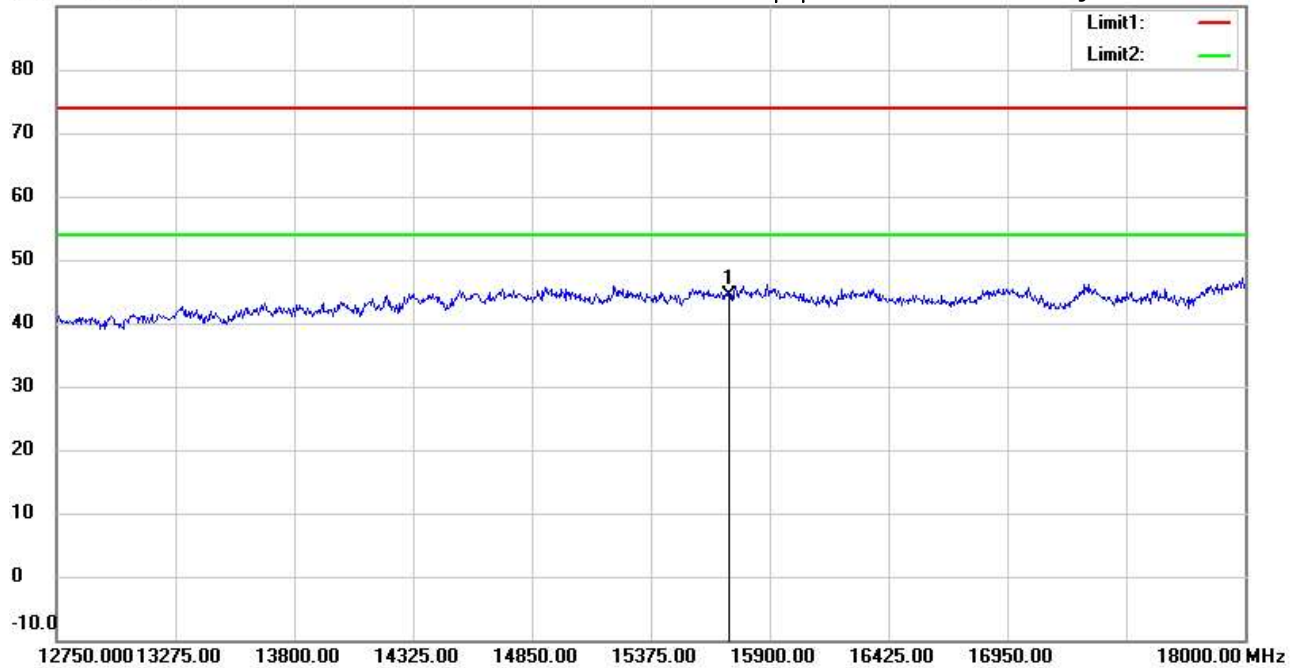
Polarization: *Horizontal*

Test Mode : TX 802.11n20 CH48

Mk.	Frequency (MHz)	Reading (dBuV)	Detector	Corr. factor (dB/m)	Result (dBuV/m)	Limit (dBuV/m)	Ant.Pos (cm)	Tab.Pos (deg.)	Margin (dB)	Comment
*	15720.000	21.19	peak	23.09	44.28	74.00	150	285	-29.72

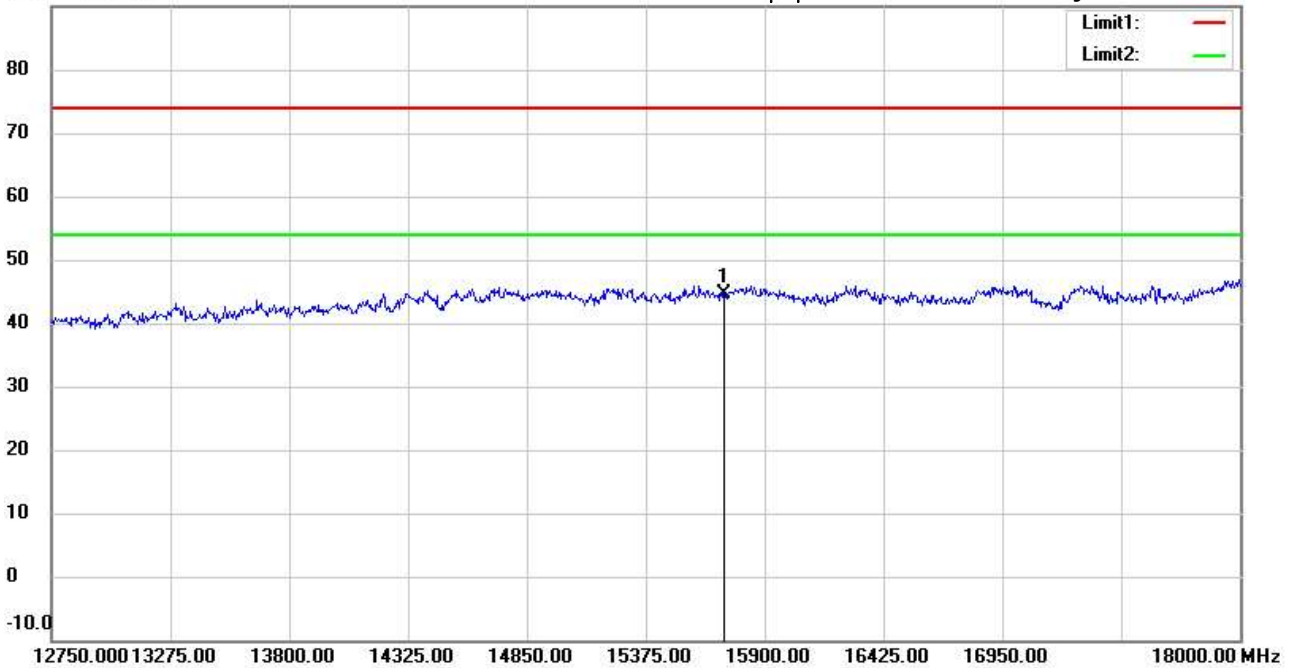
Polarization: *Vertical*

Test Mode : TX 802.11n20 CH48

Mk.	Frequency (MHz)	Reading (dBuV)	Detector	Corr. factor (dB/m)	Result (dBuV/m)	Limit (dBuV/m)	Ant.Pos (cm)	Tab.Pos (deg.)	Margin (dB)	Comment
*	15720.000	21.45	peak	23.09	44.54	74.00	150	285	-29.46

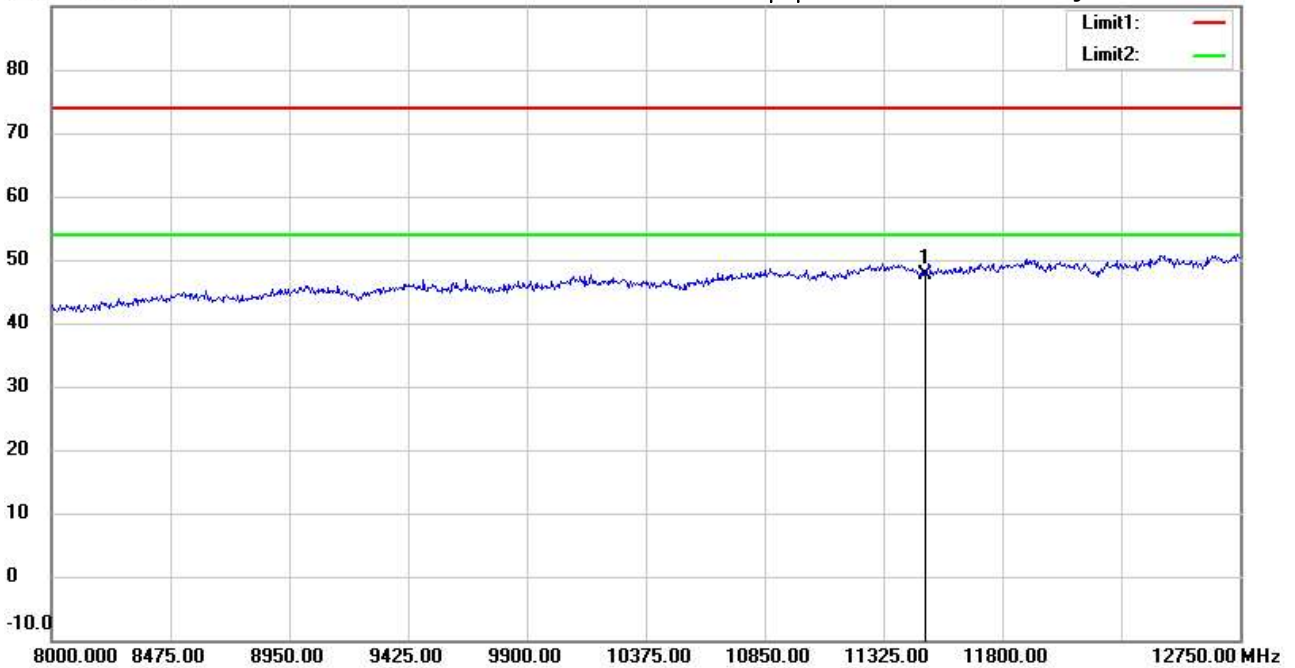
Polarization: *Horizontal*

Test Mode : TX 802.11n20 CH149

Mk.	Frequency (MHz)	Reading (dBuV)	Detector	Corr. factor (dB/m)	Result (dBuV/m)	Limit (dBuV/m)	Ant.Pos (cm)	Tab.Pos (deg.)	Margin (dB)	Comment
*	11490.000	31.11	peak	16.42	47.53	74.00	150	165	-26.47

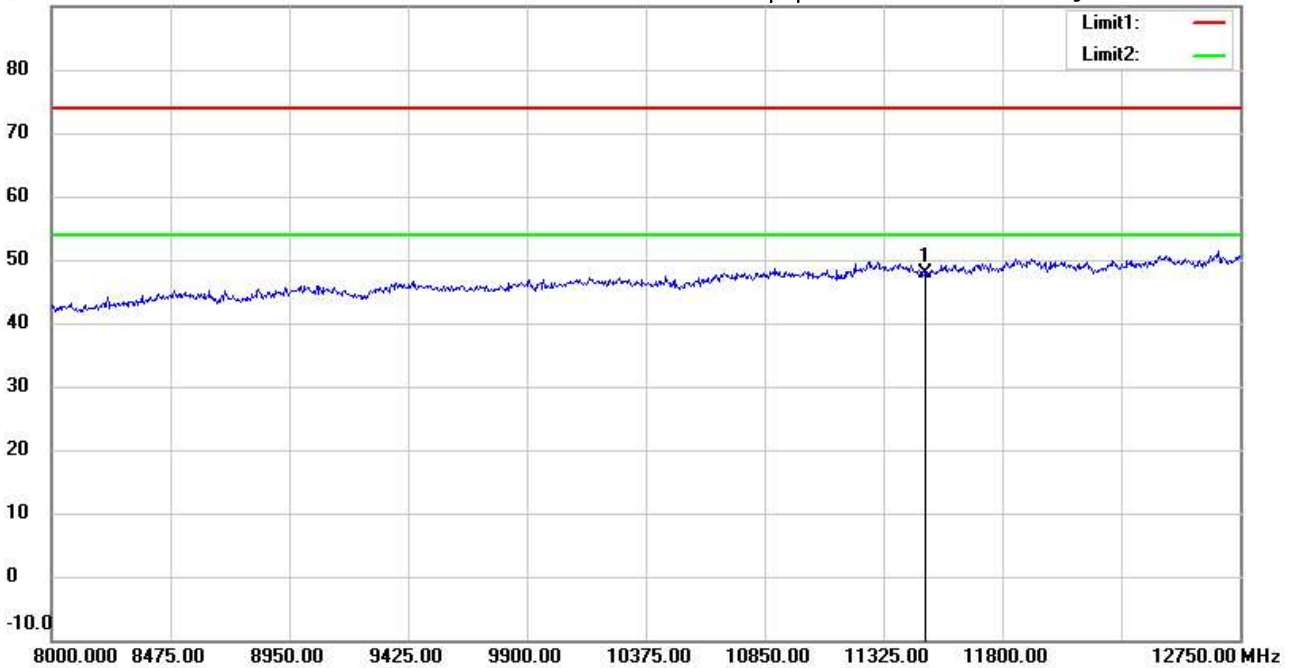
Polarization: *Vertical*

Test Mode : TX 802.11n20 CH149

Mk.	Frequency (MHz)	Reading (dBuV)	Detector	Corr. factor (dB/m)	Result (dBuV/m)	Limit (dBuV/m)	Ant.Pos (cm)	Tab.Pos (deg.)	Margin (dB)	Comment
*	11490.000	31.42	peak	16.42	47.84	74.00	150	55	-26.16

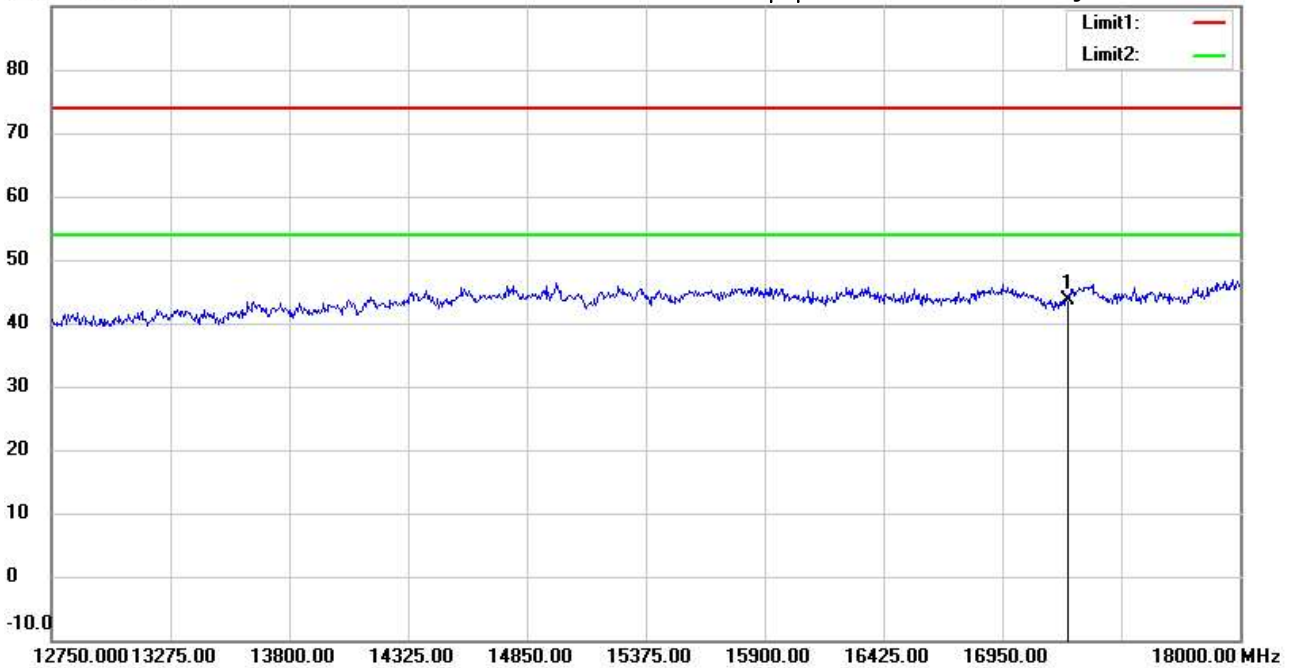
Polarization: *Horizontal*

Test Mode : TX 802.11n20 CH149

Mk.	Frequency (MHz)	Reading (dBuV)	Detector	Corr. factor (dB/m)	Result (dBuV/m)	Limit (dBuV/m)	Ant.Pos (cm)	Tab.Pos (deg.)	Margin (dB)	Comment
*	17235.000	19.92	peak	23.74	43.66	74.00	150	84	-30.34

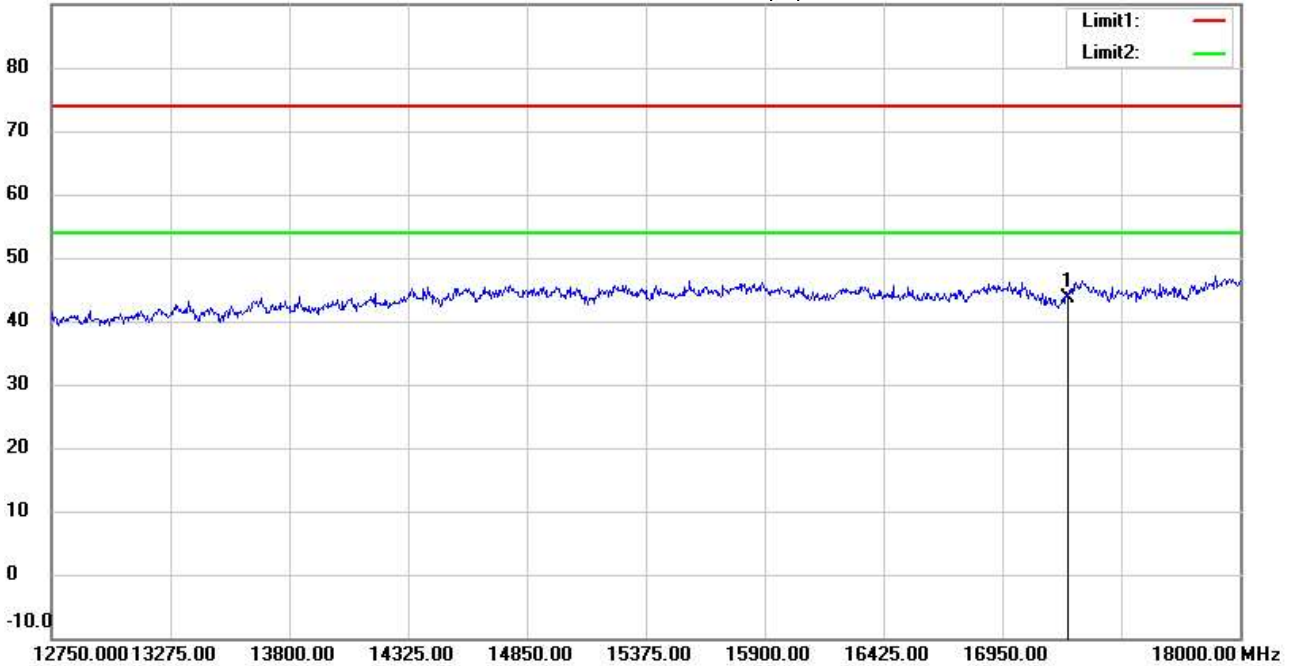
Polarization: **Vertical**

Test Mode : TX 802.11n20 CH149

Mk.	Frequency (MHz)	Reading (dBuV)	Detector	Corr. factor (dB/m)	Result (dBuV/m)	Limit (dBuV/m)	Ant.Pos (cm)	Tab.Pos (deg.)	Margin (dB)	Comment
*	17235.000	19.80	peak	23.74	43.54	74.00	150	223	-30.46
