Radiated Emission Measurement

Condition : FCC_part 15E RE_Above 1GHz_PK

EUT : W6M22311-23090

Test Mode : TX 802.11n40 CH38

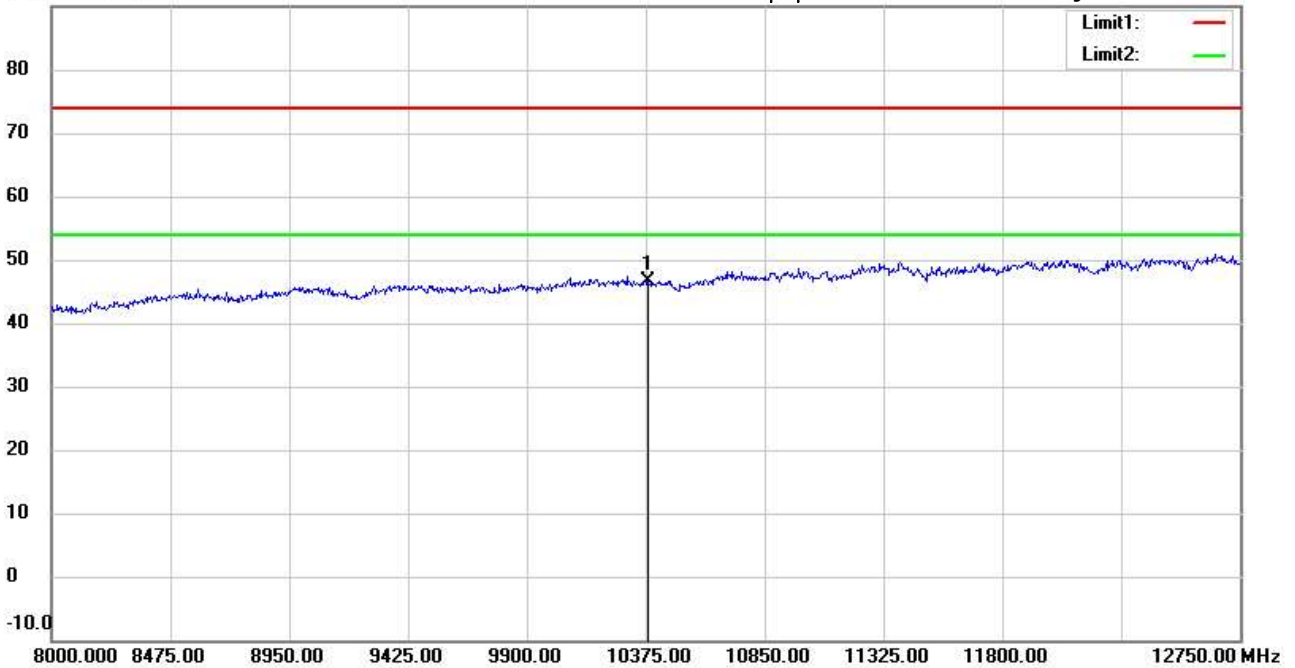
Data :#3

Condition : FCC_part 15E RE_Above 1GHz_PK

Polarization: **Horizontal**

Test Mode : TX 802.11n40 CH38

Mk.	Frequency (MHz)	Reading (dBuV)	Detector	Corr. factor (dB/m)	Result (dBuV/m)	Limit (dBuV/m)	Ant.Pos (cm)	Tab.Pos (deg.)	Margin (dB)	Comment
*	10380.000	32.40	peak	14.15	46.55	74.00	150	328	-27.45

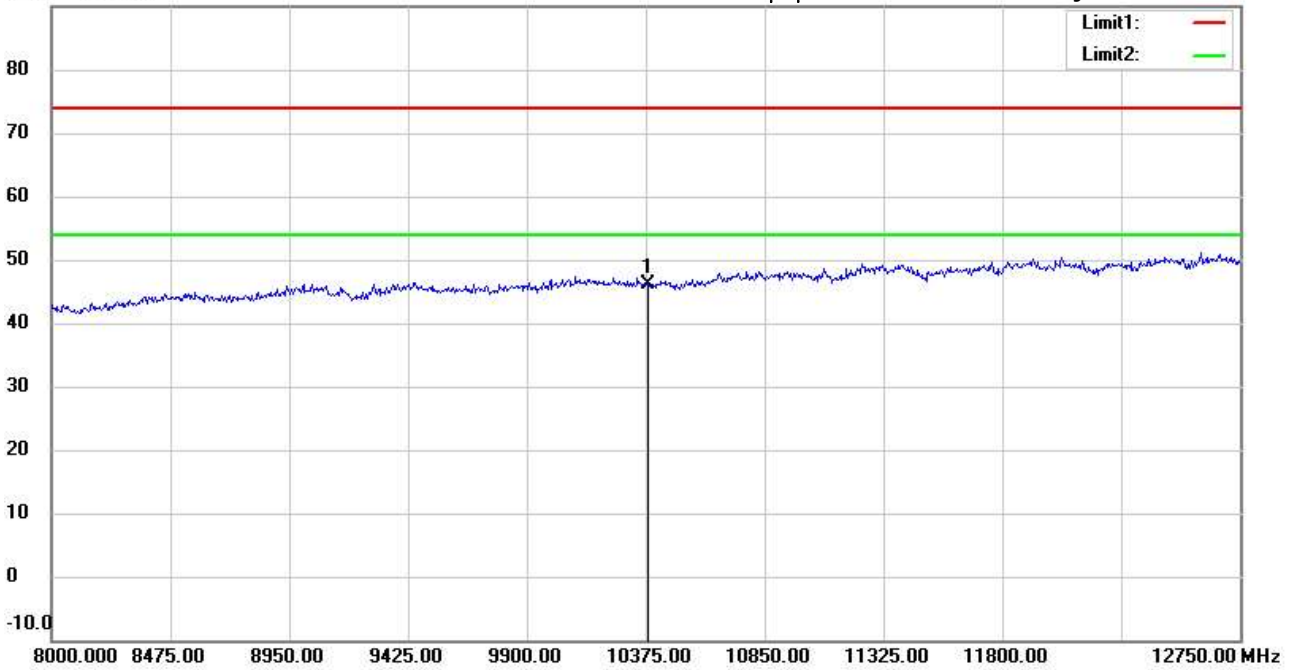
Data :#9

Condition : FCC_part 15E RE_Above 1GHz_PK

Polarization: **Vertical**

Test Mode : TX 802.11n40 CH38

Mk.	Frequency (MHz)	Reading (dBuV)	Detector	Corr. factor (dB/m)	Result (dBuV/m)	Limit (dBuV/m)	Ant.Pos (cm)	Tab.Pos (deg.)	Margin (dB)	Comment
*	10380.000	32.02	peak	14.15	46.17	74.00	150	199	-27.83

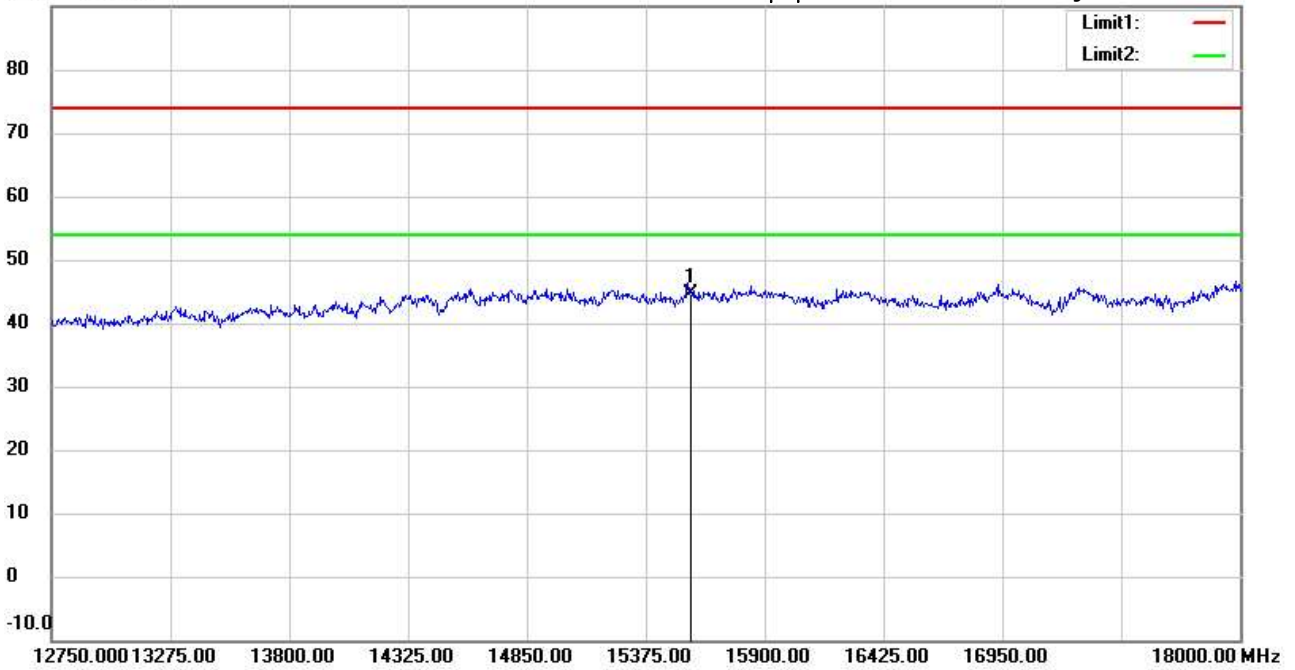
Data :#4

Condition : FCC_part 15E RE_Above 1GHz_PK

Polarization: *Horizontal*

Test Mode : TX 802.11n40 CH38

Mk.	Frequency (MHz)	Reading (dBuV)	Detector	Corr. factor (dB/m)	Result (dBuV/m)	Limit (dBuV/m)	Ant.Pos (cm)	Tab.Pos (deg.)	Margin (dB)	Comment
*	15570.000	21.04	peak	23.52	44.56	74.00	150	304	-29.44

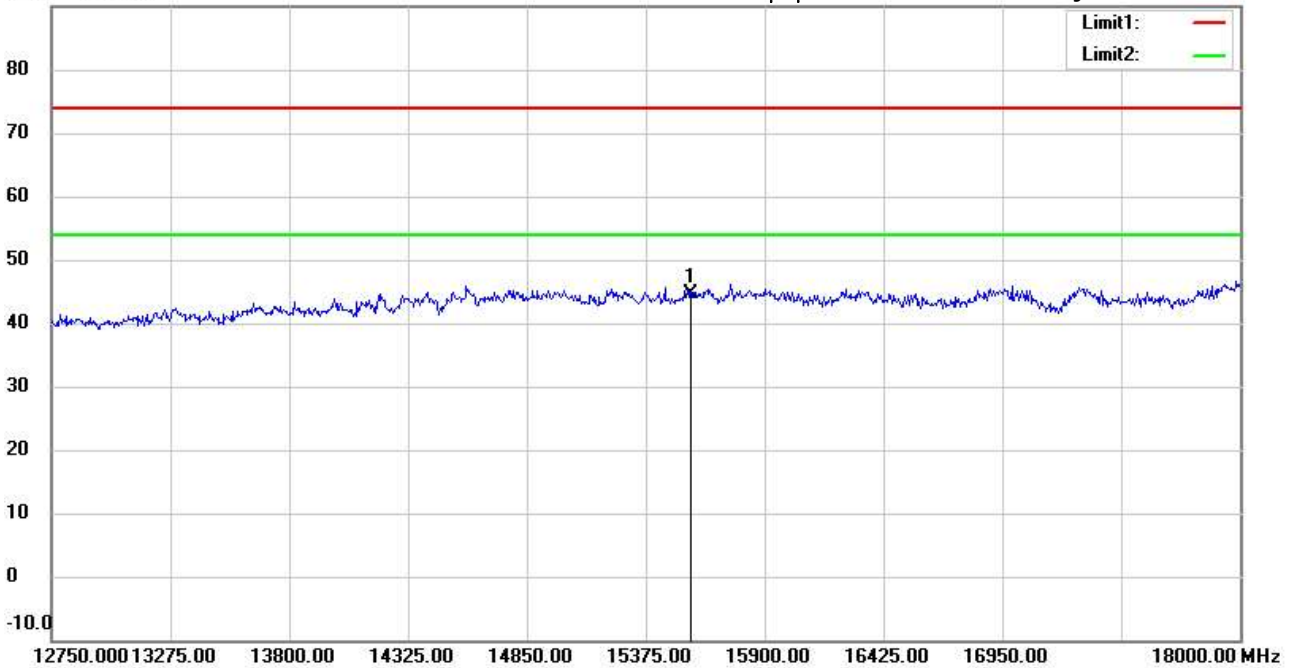
Data :#10

Condition : FCC_part 15E RE_Above 1GHz_PK

Polarization: **Vertical**

Test Mode : TX 802.11n40 CH38

Mk.	Frequency (MHz)	Reading (dBuV)	Detector	Corr. factor (dB/m)	Result (dBuV/m)	Limit (dBuV/m)	Ant.Pos (cm)	Tab.Pos (deg.)	Margin (dB)	Comment
*	15570.000	21.08	peak	23.52	44.60	74.00	150	237	-29.40

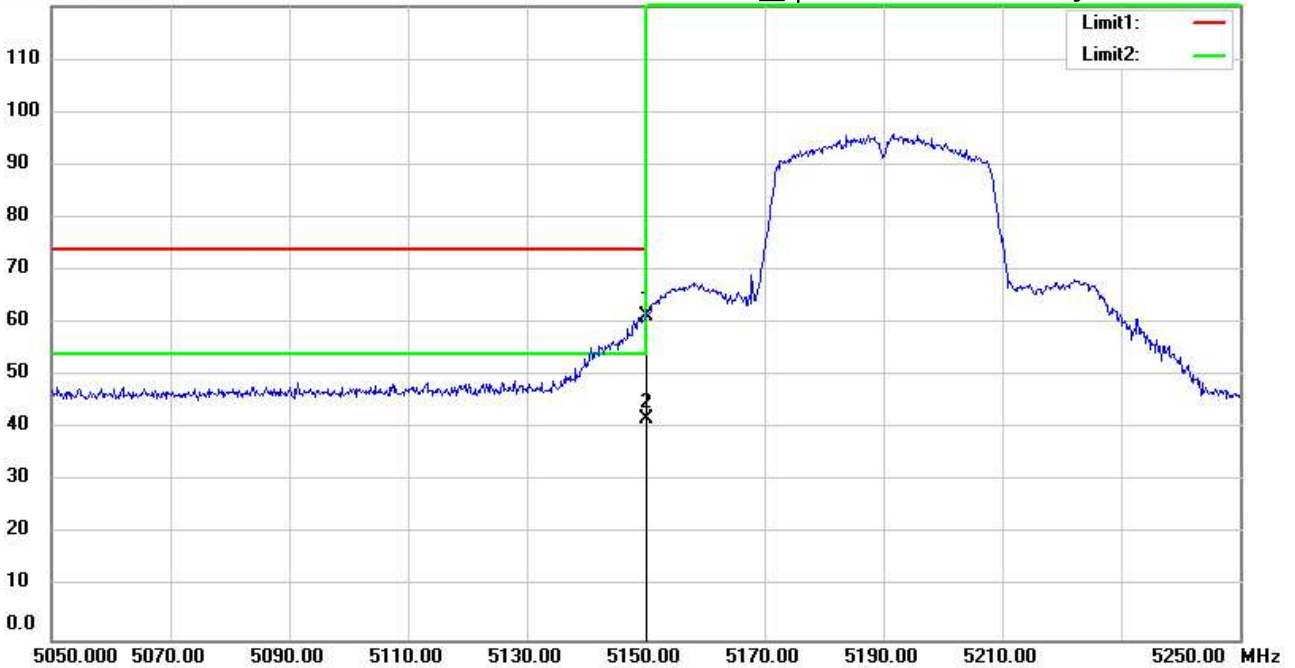
Data :#1

Condition : FCC 15.407 PK (Bandedge)(B1_5150_5250)

Polarization: *Horizontal*

Test Mode : TX 802.11n40 CH38

Mk.	Frequency (MHz)	Reading (dBuV)	Detector	Corr. factor (dB/m)	Result (dBuV/m)	Limit (dBuV/m)	Ant.Pos (cm)	Tab.Pos (deg.)	Margin (dB)	Comment
	5150.000	56.01	peak	5.31	61.32	74.00	150	318	-12.68	
*	5150.000	36.45	AVG	5.31	41.76	54.00	150	318	-12.24

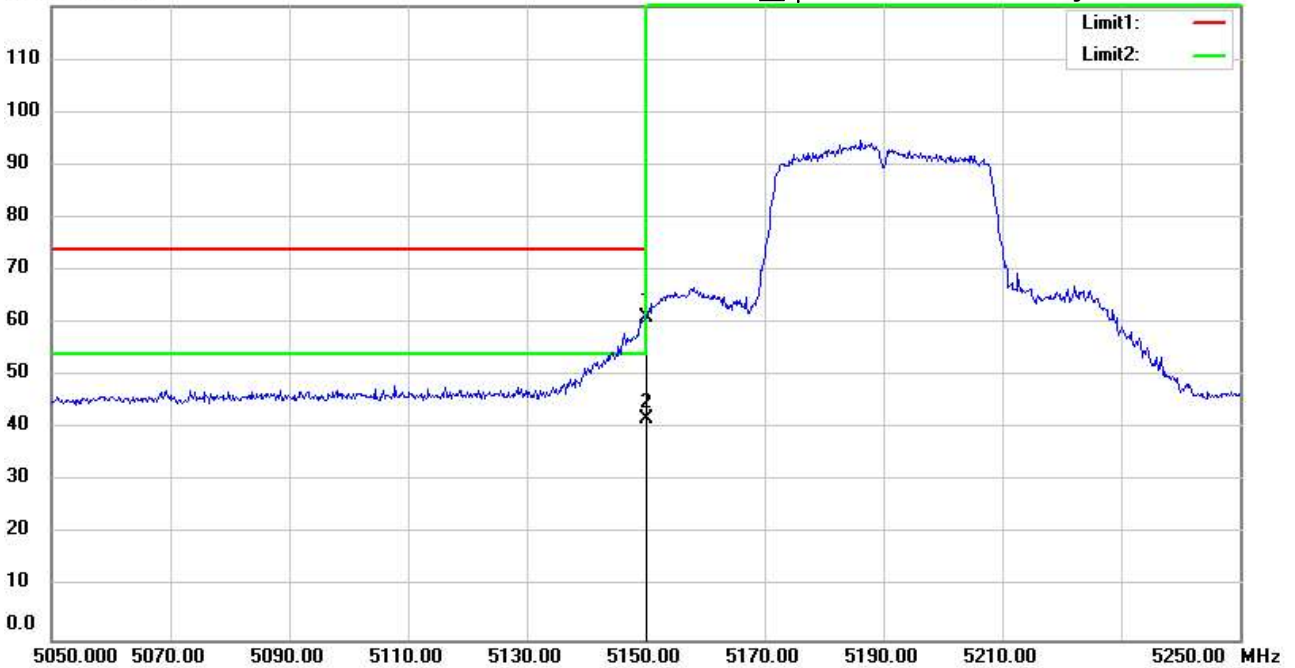
Data :#2

Condition : FCC 15.407 PK (Bandedge)(B1_5150_5250)

Polarization: *Vertical*

Test Mode : TX 802.11n40 CH38

Mk.	Frequency (MHz)	Reading (dBuV)	Detector	Corr. factor (dB/m)	Result (dBuV/m)	Limit (dBuV/m)	Ant.Pos (cm)	Tab.Pos (deg.)	Margin (dB)	Comment
	5150.000	55.79	peak	5.31	61.10	74.00	150	81	-12.90	
*	5150.000	36.40	AVG	5.31	41.71	54.00	150	81	-12.29

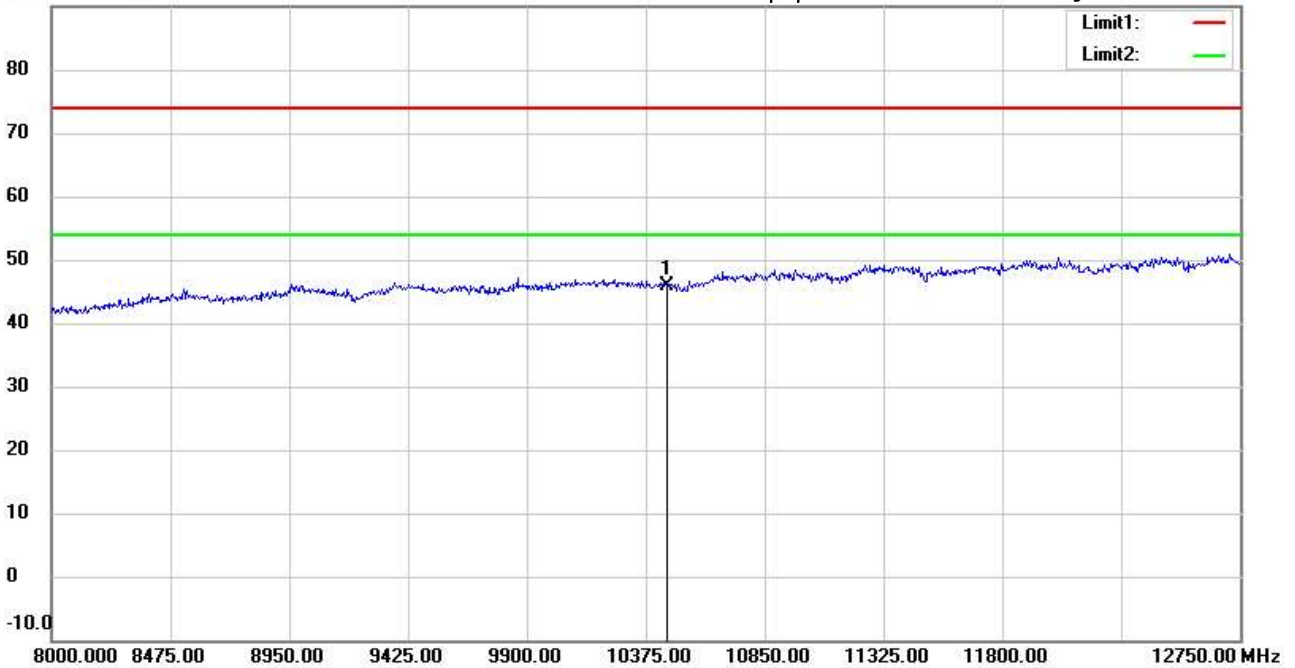
Data :#3

Condition : FCC_part 15E RE_Above 1GHz_PK

Polarization: *Horizontal*

Test Mode : TX 802.11n40 CH46

Mk.	Frequency (MHz)	Reading (dBuV)	Detector	Corr. factor (dB/m)	Result (dBuV/m)	Limit (dBuV/m)	Ant.Pos (cm)	Tab.Pos (deg.)	Margin (dB)	Comment
*	10460.000	31.79	peak	14.10	45.89	74.00	150	166	-28.11

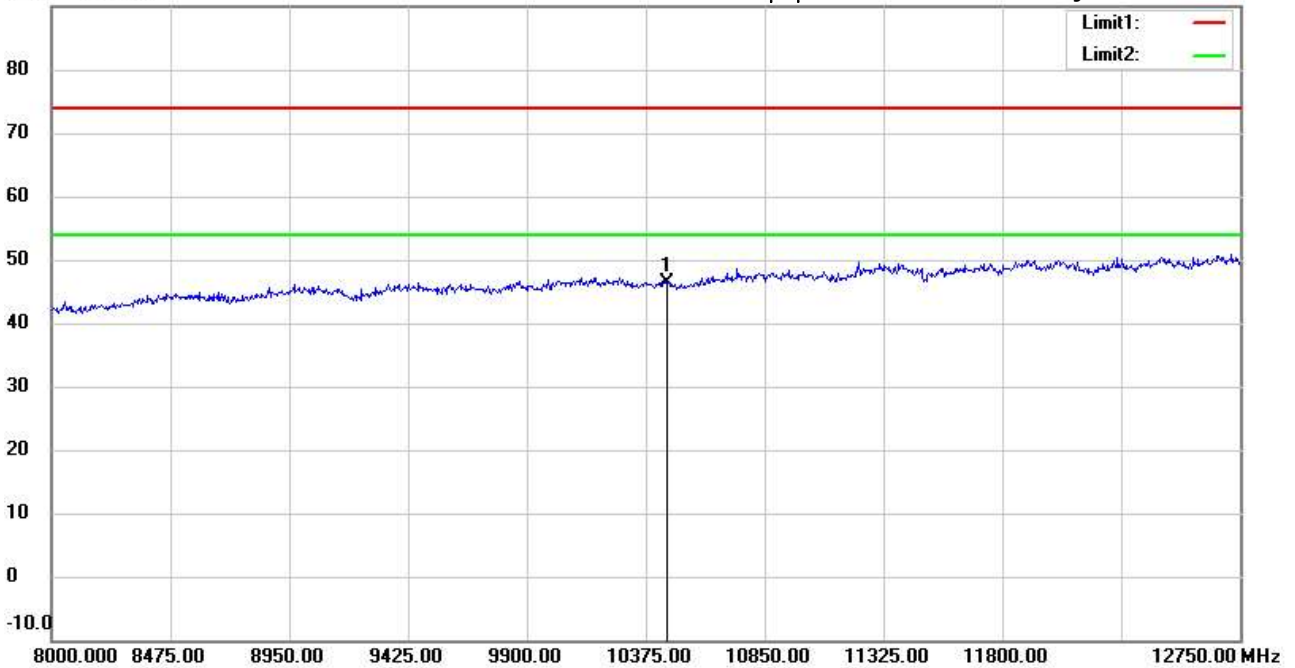
Data :#9

Condition : FCC_part 15E RE_Above 1GHz_PK

Polarization: *Vertical*

Test Mode : TX 802.11n40 CH46

Mk.	Frequency (MHz)	Reading (dBuV)	Detector	Corr. factor (dB/m)	Result (dBuV/m)	Limit (dBuV/m)	Ant.Pos (cm)	Tab.Pos (deg.)	Margin (dB)	Comment
*	10460.000	32.18	peak	14.10	46.28	74.00	150	48	-27.72

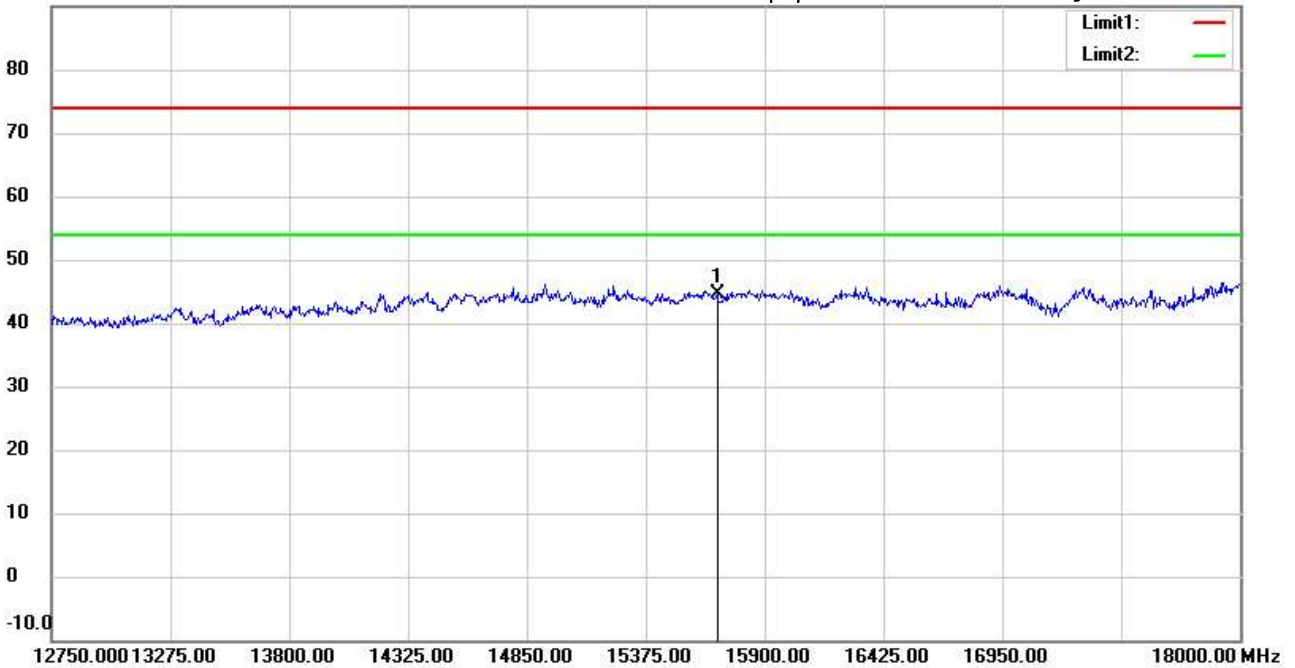
Data :#4

Condition : FCC_part 15E RE_Above 1GHz_PK

Polarization: *Horizontal*

Test Mode : TX 802.11n40 CH46

Mk.	Frequency (MHz)	Reading (dBuV)	Detector	Corr. factor (dB/m)	Result (dBuV/m)	Limit (dBuV/m)	Ant.Pos (cm)	Tab.Pos (deg.)	Margin (dB)	Comment
*	15690.000	21.72	peak	22.91	44.63	74.00	150	203	-29.37

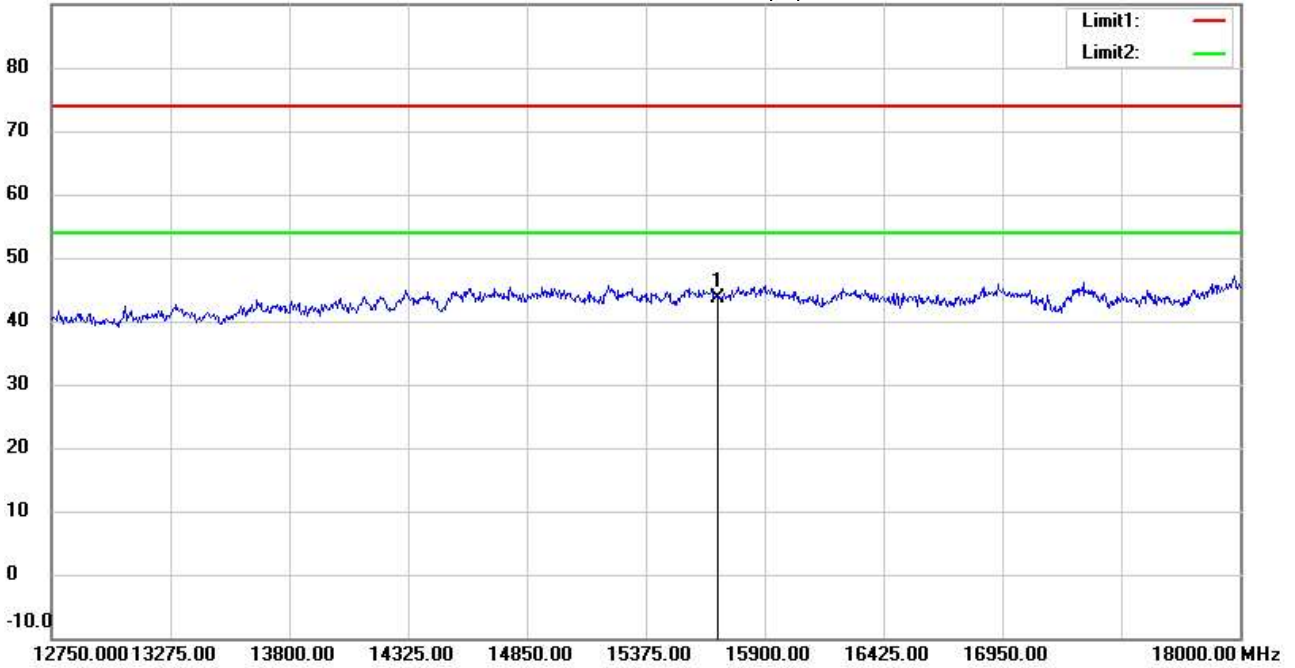
Data :#10

Condition : FCC_part 15E RE_Above 1GHz_PK

Polarization: *Vertical*

Test Mode : TX 802.11n40 CH46

Mk.	Frequency (MHz)	Reading (dBuV)	Detector	Corr. factor (dB/m)	Result (dBuV/m)	Limit (dBuV/m)	Ant.Pos (cm)	Tab.Pos (deg.)	Margin (dB)	Comment
*	15690.000	20.71	peak	22.91	43.62	74.00	150	25	-30.38
