Radiated Emission Measurement

Condition : FCC_part 15E RE_Above 1GHz_PK

EUT : W6M22311-23090

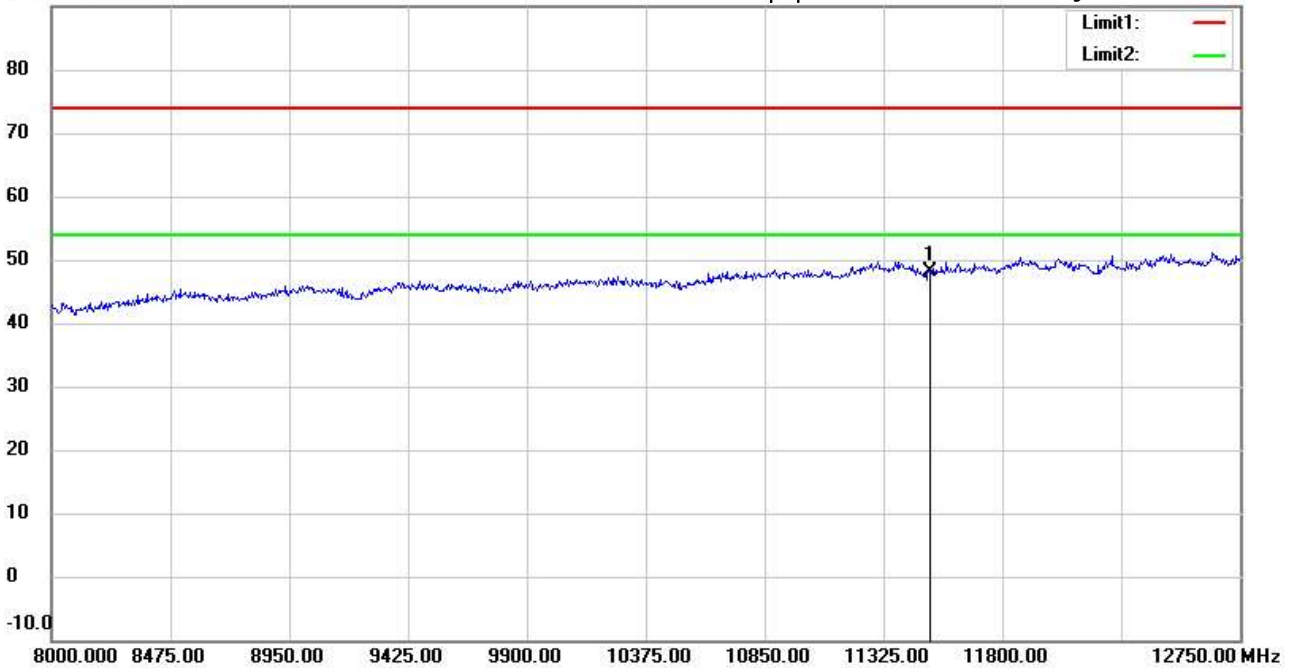
Polarization: *Horizontal*

Test Mode : TX 802.11n40 CH151

Mk.	Frequency (MHz)	Reading (dBuV)	Detector	Corr. factor (dB/m)	Result (dBuV/m)	Limit (dBuV/m)	Ant.Pos (cm)	Tab.Pos (deg.)	Margin (dB)	Comment
*	11510.000	31.69	peak	16.46	48.15	74.00	150	338	-25.85

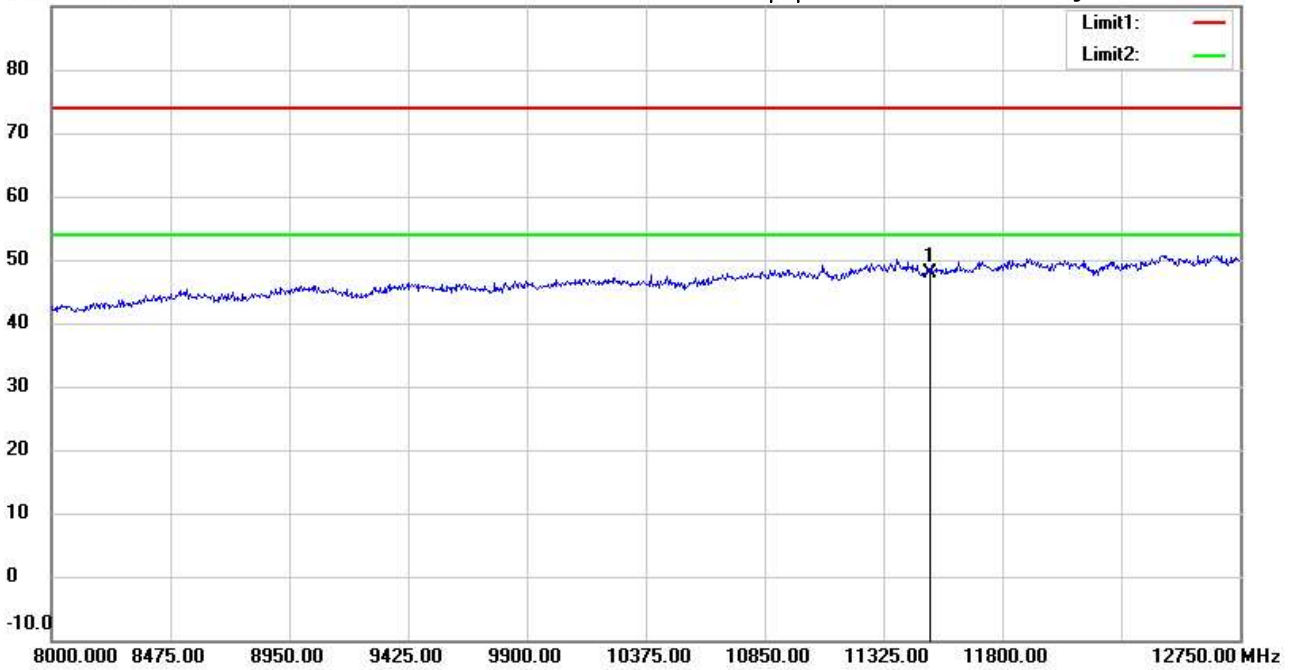
Polarization: *Vertical*

Test Mode : TX 802.11n40 CH151

Mk.	Frequency (MHz)	Reading (dBuV)	Detector	Corr. factor (dB/m)	Result (dBuV/m)	Limit (dBuV/m)	Ant.Pos (cm)	Tab.Pos (deg.)	Margin (dB)	Comment
*	11510.000	31.40	peak	16.46	47.86	74.00	150	336	-26.14

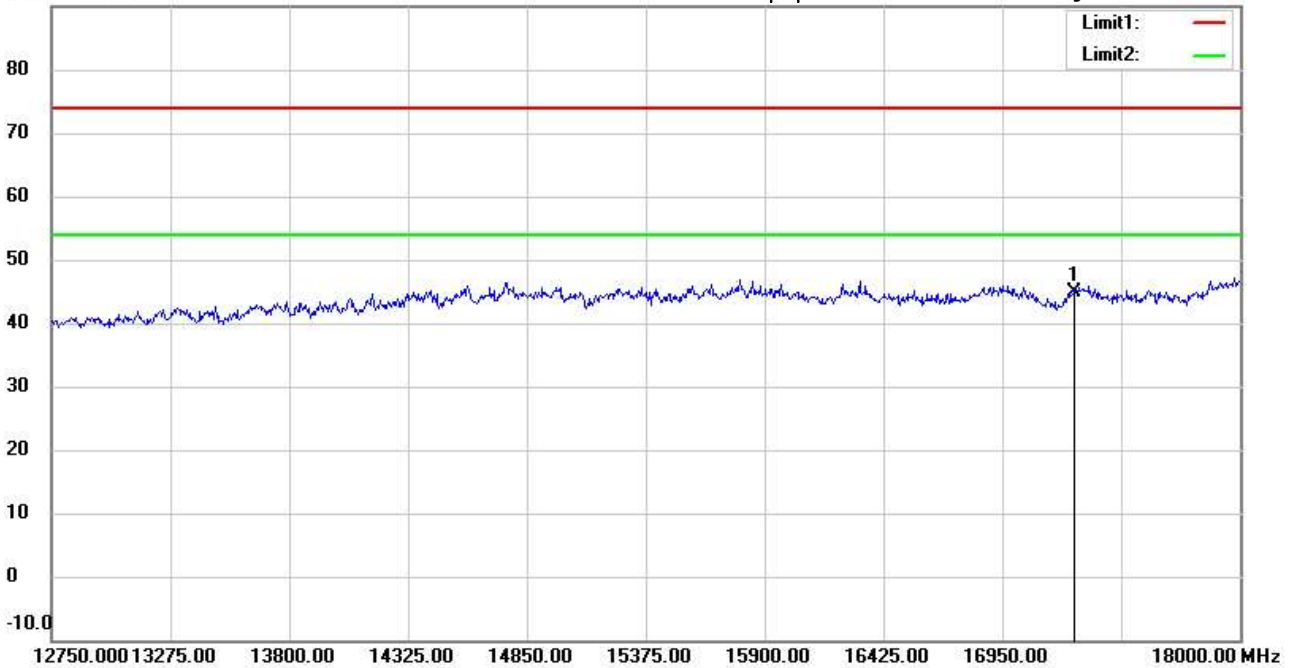
Polarization: **Horizontal**

Test Mode : TX 802.11n40 CH151

Mk.	Frequency (MHz)	Reading (dBuV)	Detector	Corr. factor (dB/m)	Result (dBuV/m)	Limit (dBuV/m)	Ant.Pos (cm)	Tab.Pos (deg.)	Margin (dB)	Comment
*	17265.000	20.91	peak	23.96	44.87	74.00	150	197	-29.13

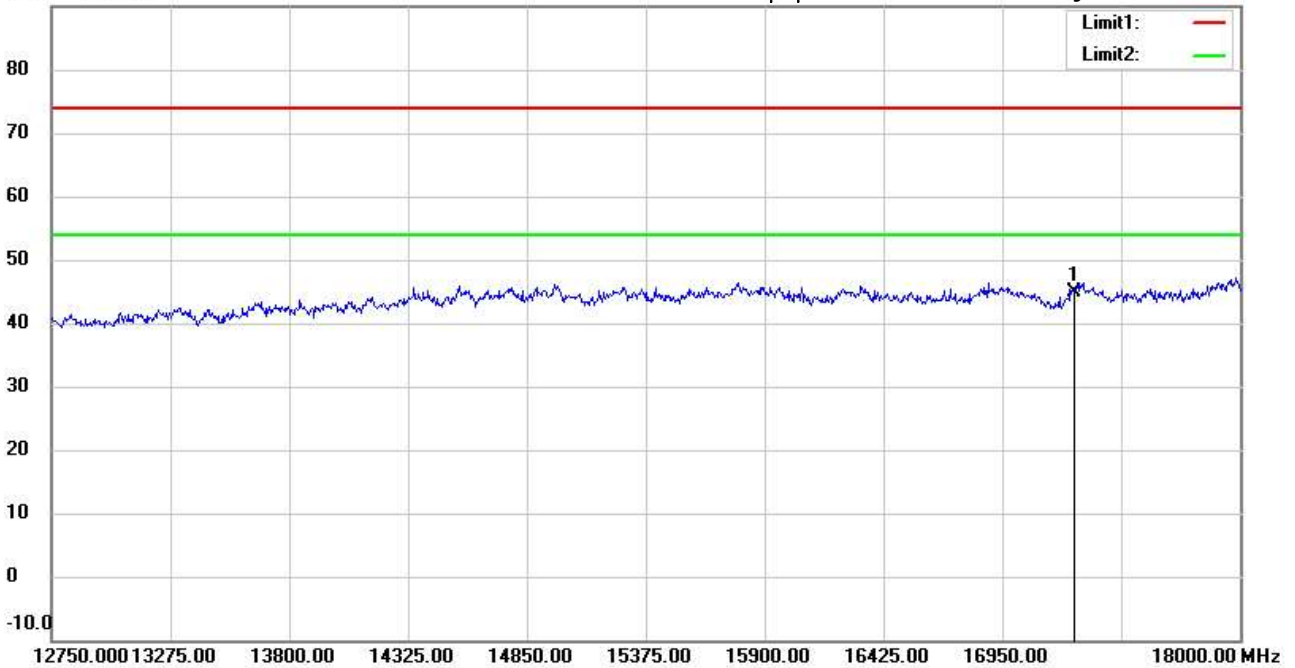
Polarization: **Vertical**

Test Mode : TX 802.11n40 CH151

Mk.	Frequency (MHz)	Reading (dBuV)	Detector	Corr. factor (dB/m)	Result (dBuV/m)	Limit (dBuV/m)	Ant.Pos (cm)	Tab.Pos (deg.)	Margin (dB)	Comment
*	17265.000	20.86	peak	23.96	44.82	74.00	150	27	-29.18

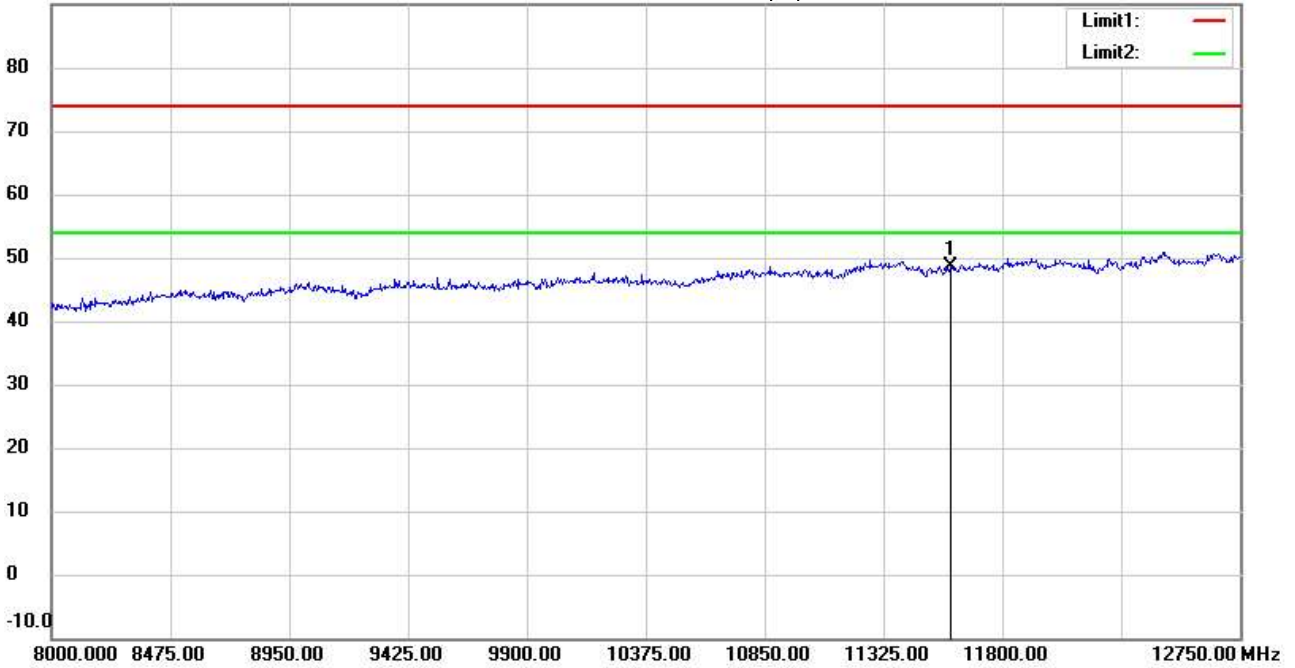
Polarization: *Horizontal*

Test Mode : TX 802.11n40 CH159

Mk.	Frequency (MHz)	Reading (dBuV)	Detector	Corr. factor (dB/m)	Result (dBuV/m)	Limit (dBuV/m)	Ant.Pos (cm)	Tab.Pos (deg.)	Margin (dB)	Comment
*	11590.000	32.01	peak	16.65	48.66	74.00	150	275	-25.34

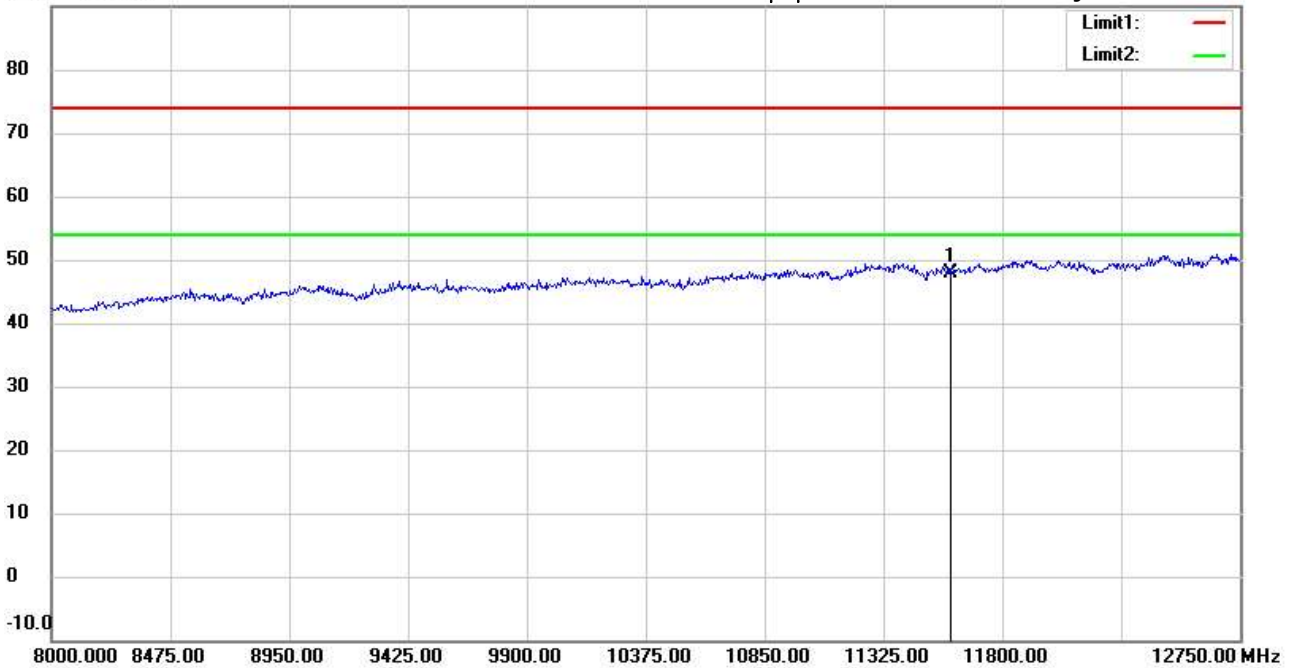
Polarization: *Vertical*

Test Mode : TX 802.11n40 CH159

Mk.	Frequency (MHz)	Reading (dBuV)	Detector	Corr. factor (dB/m)	Result (dBuV/m)	Limit (dBuV/m)	Ant.Pos (cm)	Tab.Pos (deg.)	Margin (dB)	Comment
*	11590.000	31.18	peak	16.65	47.83	74.00	150	3	-26.17

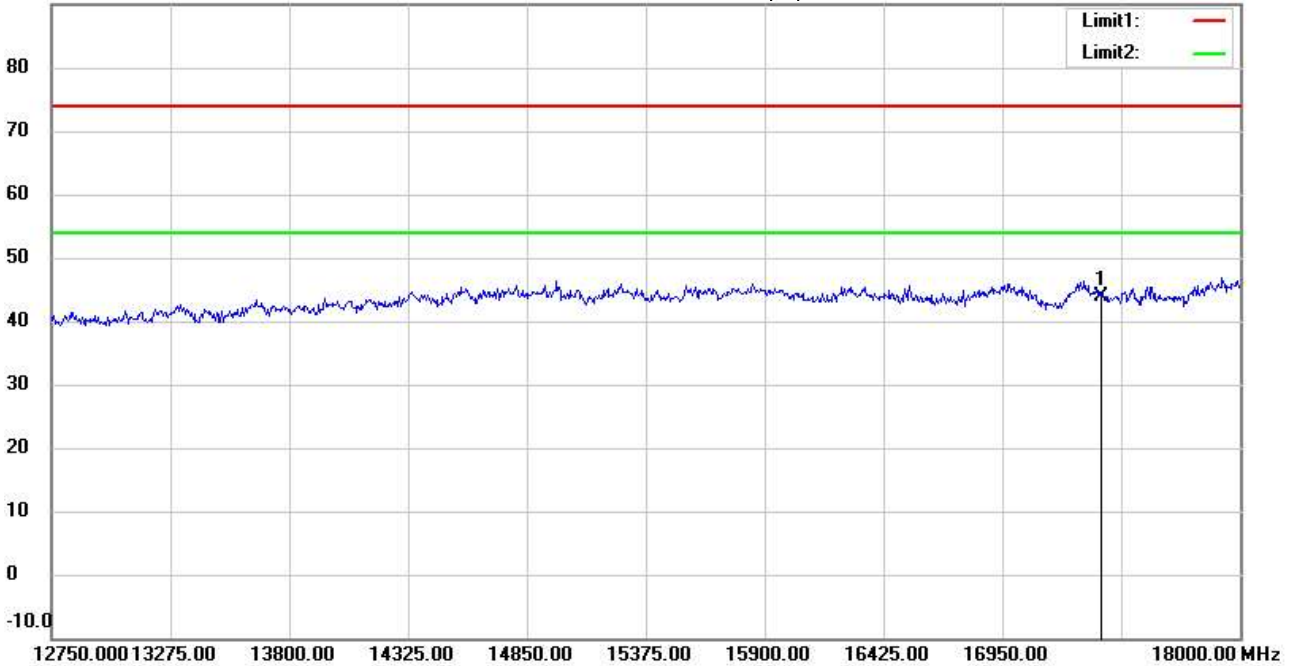
Polarization: *Horizontal*

Test Mode : TX 802.11n40 CH159

Mk.	Frequency (MHz)	Reading (dBuV)	Detector	Corr. factor (dB/m)	Result (dBuV/m)	Limit (dBuV/m)	Ant.Pos (cm)	Tab.Pos (deg.)	Margin (dB)	Comment
*	17385.000	19.92	peak	23.84	43.76	74.00	150	351	-30.24

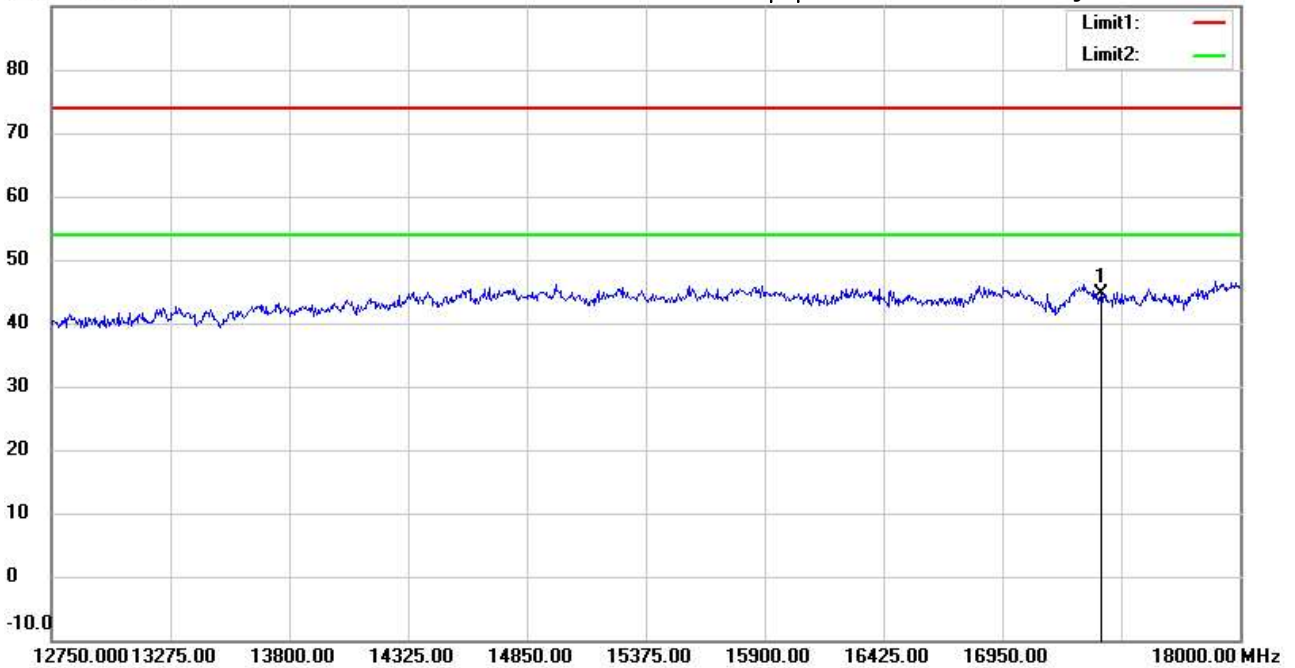
Polarization: **Vertical**

Test Mode : TX 802.11n40 CH159

Mk.	Frequency (MHz)	Reading (dBuV)	Detector	Corr. factor (dB/m)	Result (dBuV/m)	Limit (dBuV/m)	Ant.Pos (cm)	Tab.Pos (deg.)	Margin (dB)	Comment
*	17385.000	20.79	peak	23.84	44.63	74.00	150	357	-29.37

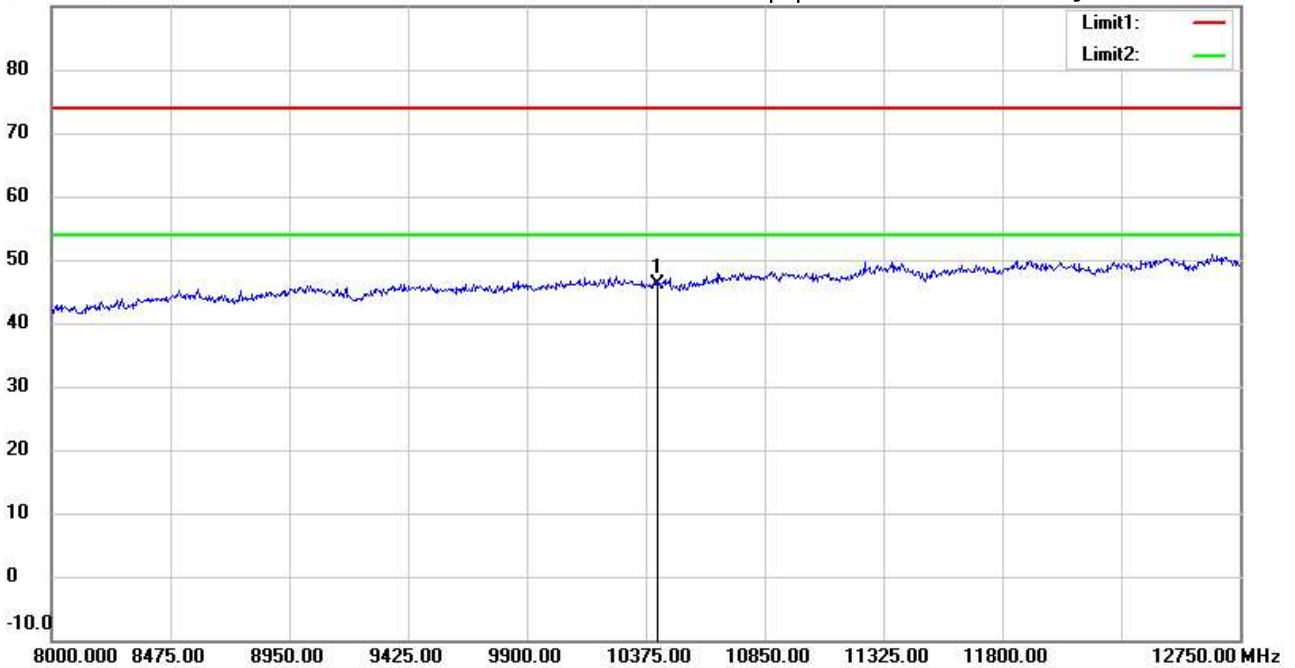
Polarization: *Horizontal*

Test Mode : TX 802.11ac80 CH42

Mk.	Frequency (MHz)	Reading (dBuV)	Detector	Corr. factor (dB/m)	Result (dBuV/m)	Limit (dBuV/m)	Ant.Pos (cm)	Tab.Pos (deg.)	Margin (dB)	Comment
*	10420.000	31.91	peak	14.13	46.04	74.00	150	10	-27.96

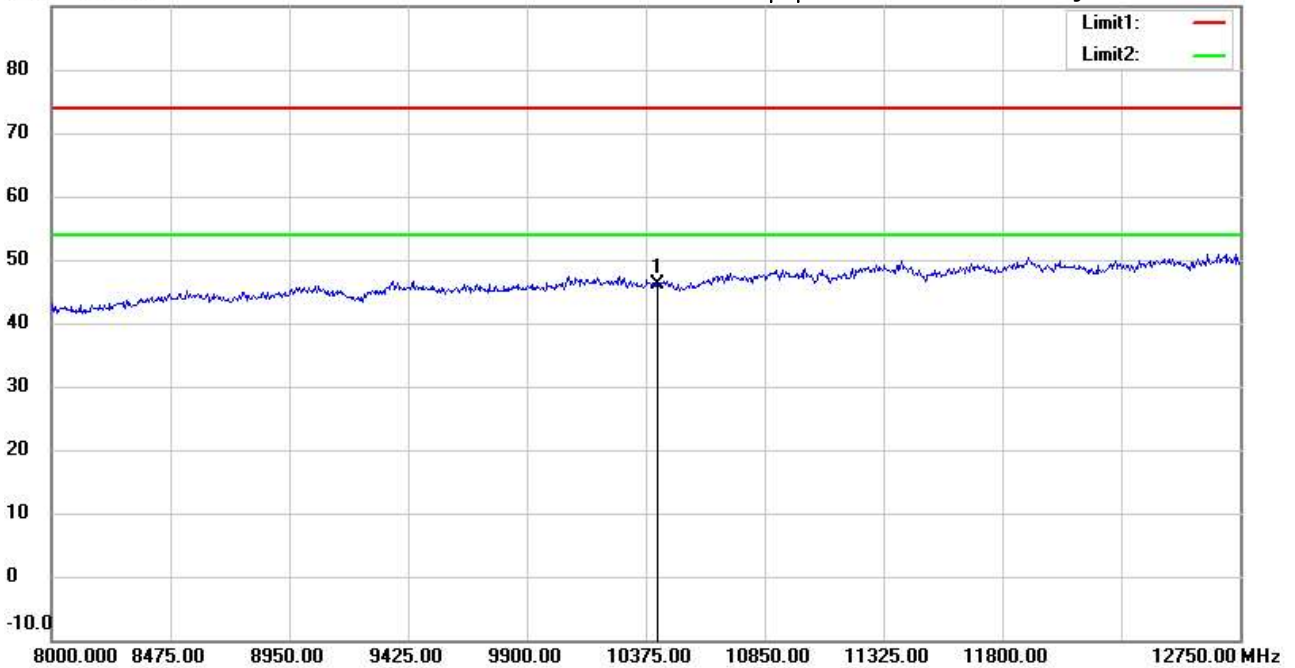
Polarization: **Vertical**

Test Mode : TX 802.11ac80 CH42

Mk.	Frequency (MHz)	Reading (dBuV)	Detector	Corr. factor (dB/m)	Result (dBuV/m)	Limit (dBuV/m)	Ant.Pos (cm)	Tab.Pos (deg.)	Margin (dB)	Comment
*	10420.000	32.12	peak	14.13	46.25	74.00	150	129	-27.75
