Radiated Emission Measurement

Condition : FCC_part 15E RE_Above 1GHz_PK

EUT : W6M22311-23090

Test Mode : TX 802.11ac80 CH42

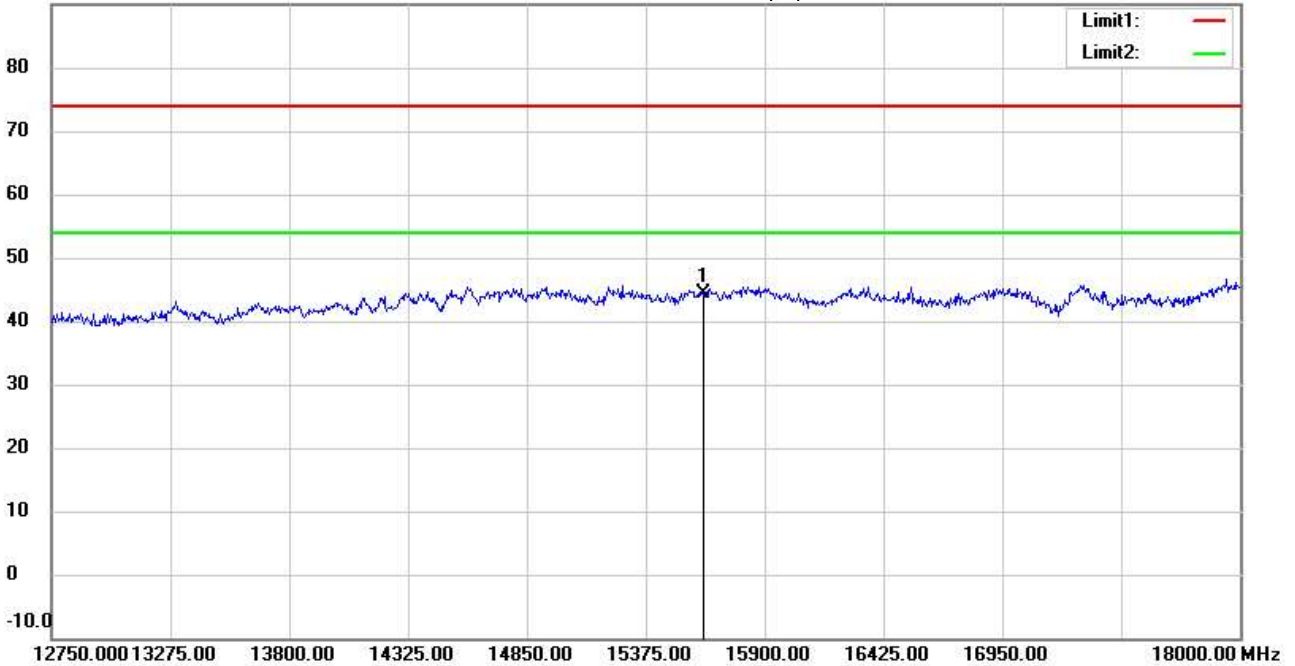
Data :#4

Polarization: *Horizontal*

Mk.	Frequency (MHz)	Reading (dBuV)	Detector	Corr. factor (dB/m)	Result (dBuV/m)	Limit (dBuV/m)	Ant.Pos (cm)	Tab.Pos (deg.)	Margin (dB)	Comment
*	15630.000	21.01	peak	23.39	44.40	74.00	150	270	-29.60

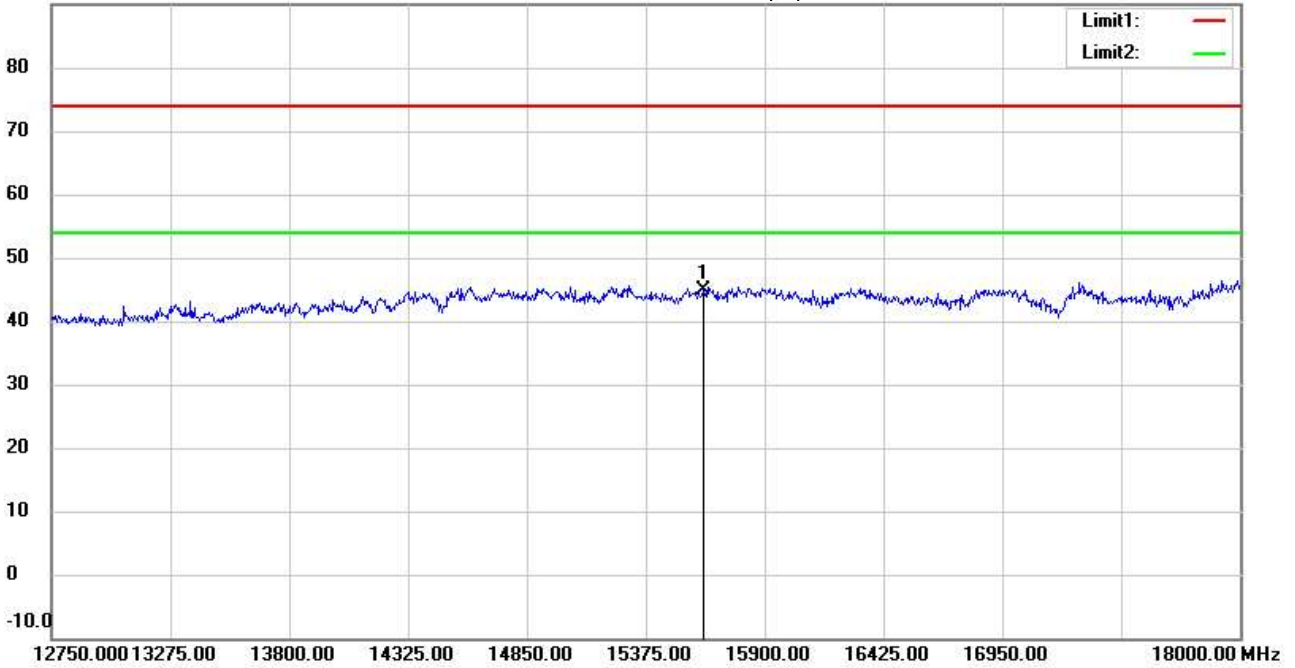
Data :#10

Condition : FCC_part 15E RE_Above 1GHz_PK

Polarization: *Vertical*

Test Mode : TX 802.11ac80 CH42

Mk.	Frequency (MHz)	Reading (dBuV)	Detector	Corr. factor (dB/m)	Result (dBuV/m)	Limit (dBuV/m)	Ant.Pos (cm)	Tab.Pos (deg.)	Margin (dB)	Comment
*	15630.000	21.60	peak	23.39	44.99	74.00	150	336	-29.01

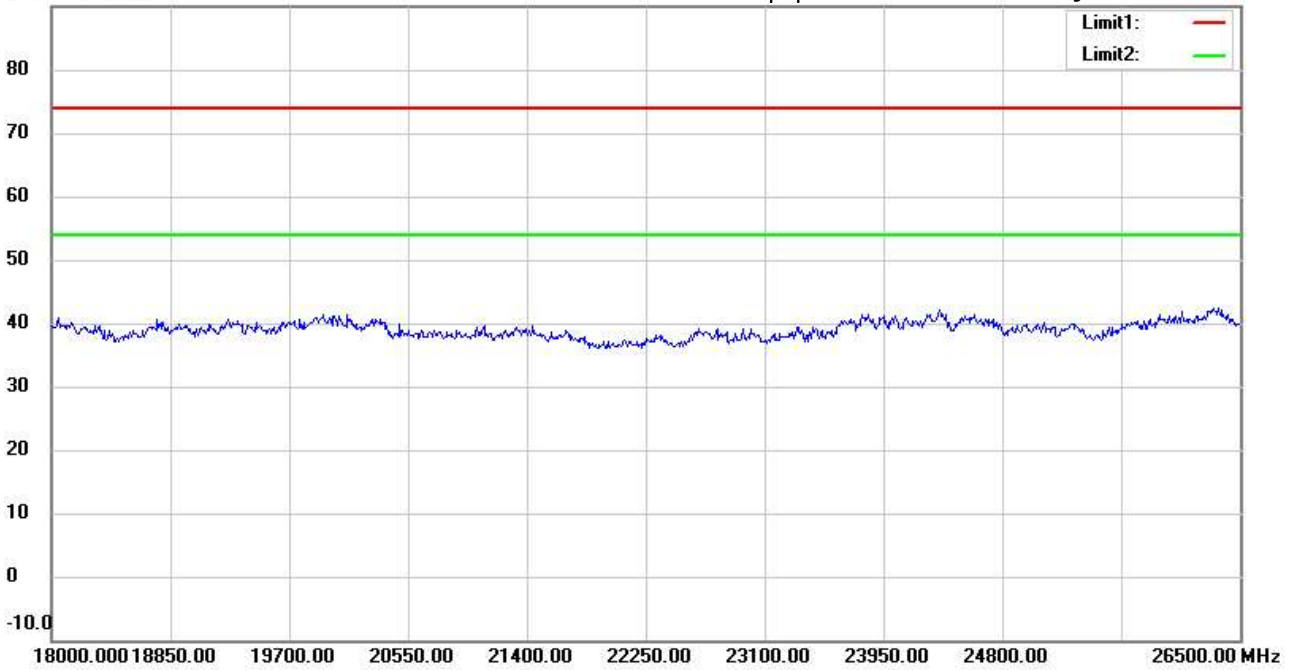
Data :#5

Condition : FCC_part 15E RE_Above 1GHz_PK

Polarization: *Horizontal*

Test Mode : TX 802.11ac80 CH42

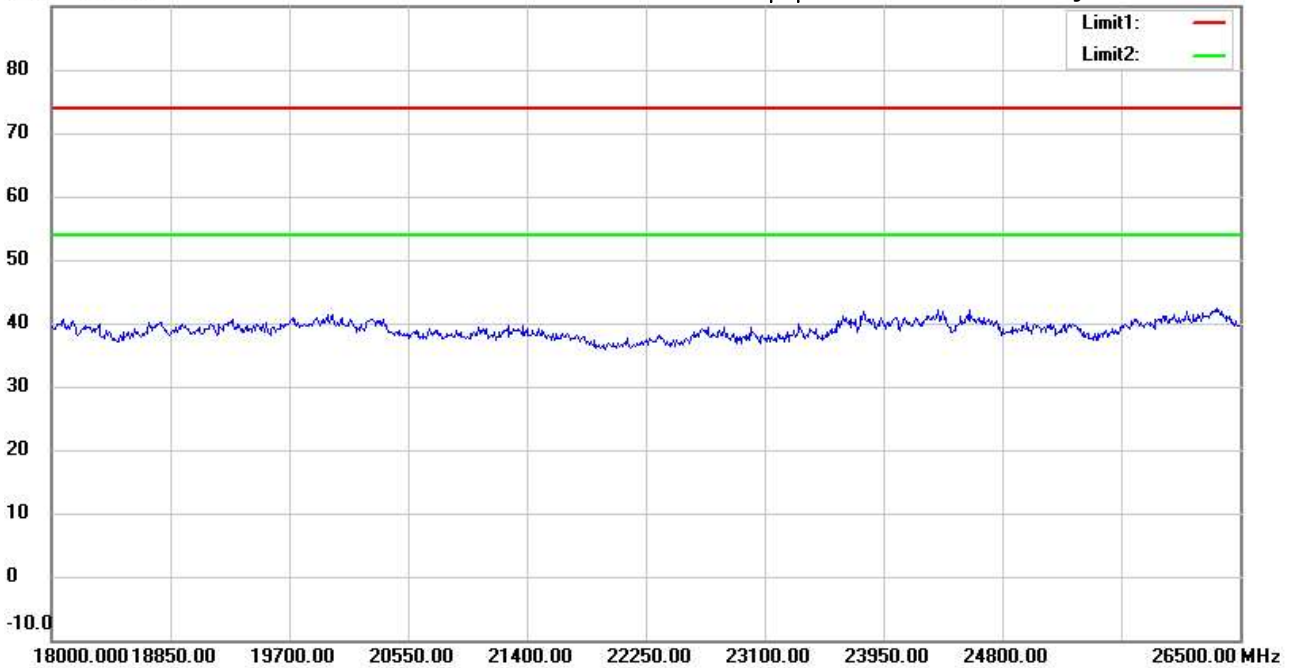
Data :#11

Condition : FCC_part 15E RE_Above 1GHz_PK

Polarization: *Vertical*

Test Mode : TX 802.11ac80 CH42

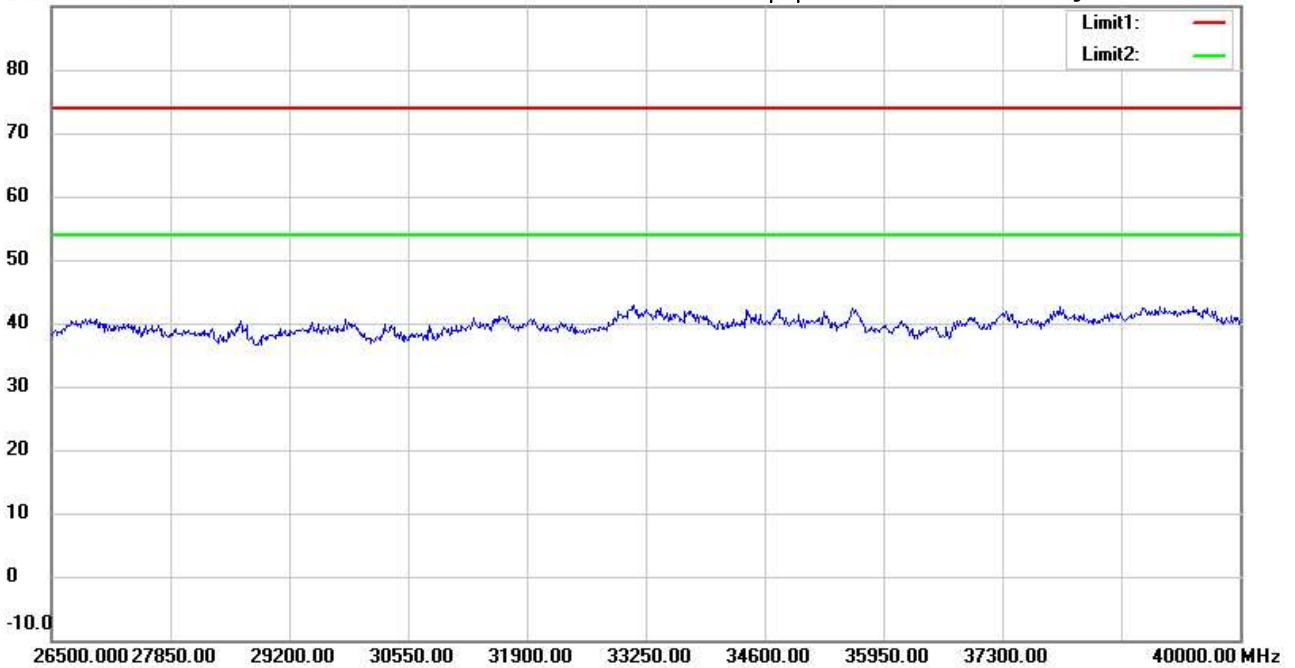
Data :#6

Condition : FCC_part 15E RE_Above 1GHz_PK

Polarization: *Horizontal*

Test Mode : TX 802.11ac80 CH42

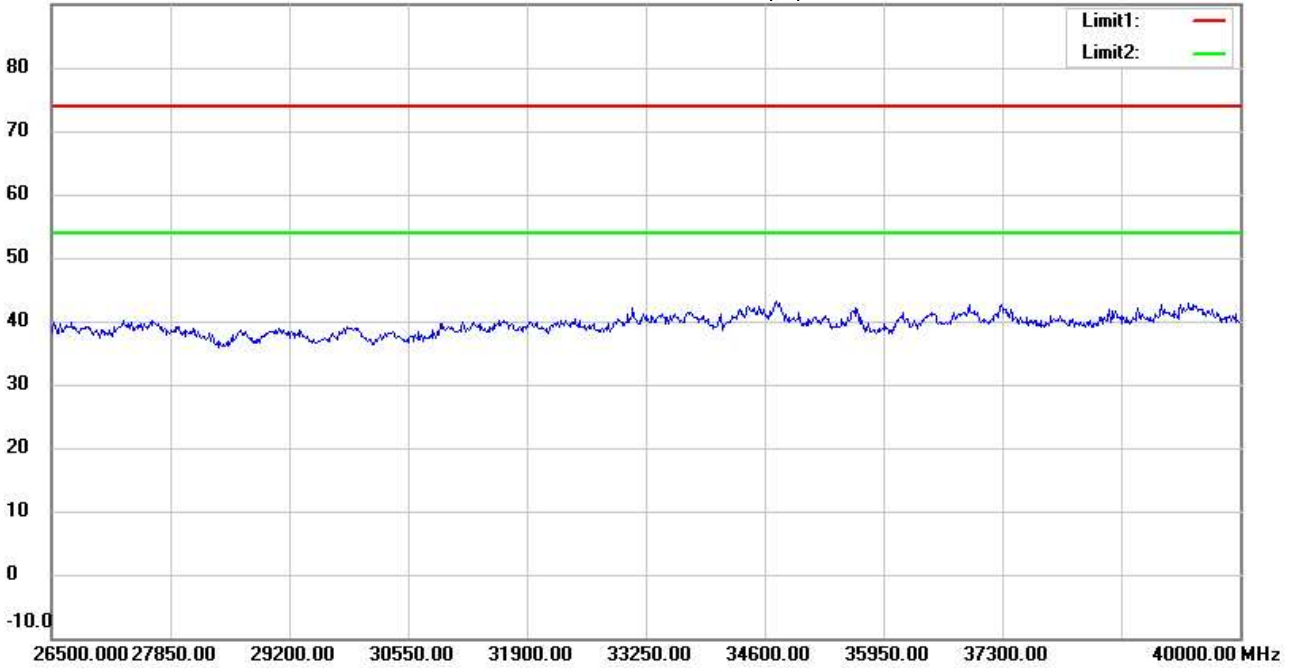
Data :#12

Condition : FCC_part 15E RE_Above 1GHz_PK

Polarization: *Vertical*

Test Mode : TX 802.11ac80 CH42

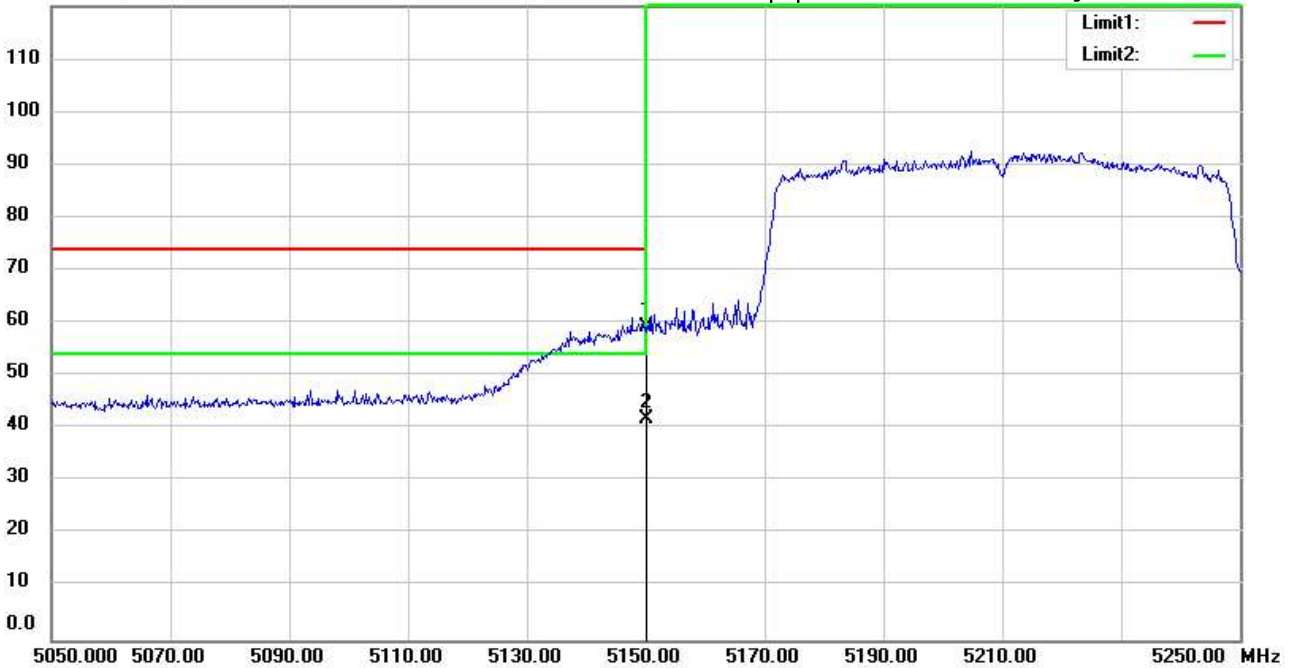
Data :#1

Condition : FCC 15.407 PK (Bandedge)(B1_5150_5250)

Polarization: *Horizontal*

Test Mode : TX 802.11ac80 CH42

Mk.	Frequency (MHz)	Reading (dBuV)	Detector	Corr. factor (dB/m)	Result (dBuV/m)	Limit (dBuV/m)	Ant.Pos (cm)	Tab.Pos (deg.)	Margin (dB)	Comment
	5150.000	53.83	peak	5.31	59.14	74.00	150	320	-14.86	
*	5150.000	36.68	AVG	5.31	41.99	54.00	150	320	-12.01

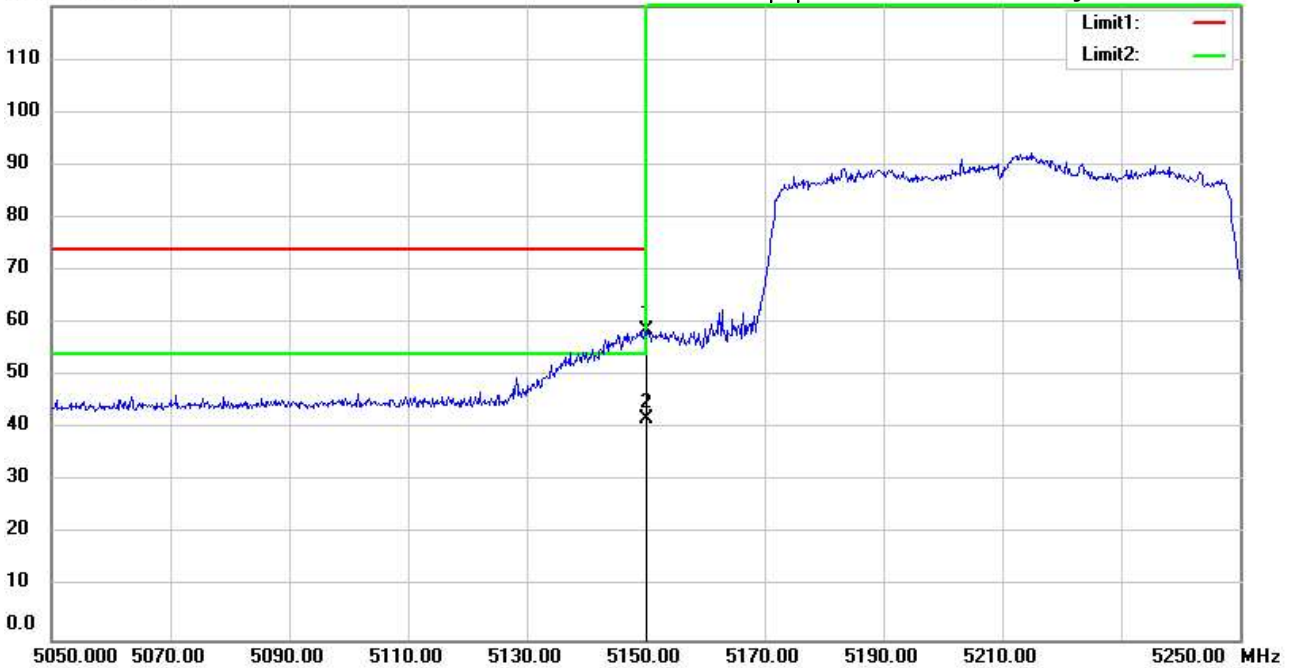
Data :#2

Condition : FCC 15.407 PK (Bandedge)(B1_5150_5250)

Polarization: *Vertical*

Test Mode : TX 802.11ac80 CH42

Mk.	Frequency (MHz)	Reading (dBuV)	Detector	Corr. factor (dB/m)	Result (dBuV/m)	Limit (dBuV/m)	Ant.Pos (cm)	Tab.Pos (deg.)	Margin (dB)	Comment
	5150.000	53.22	peak	5.31	58.53	74.00	150	88	-15.47	
*	5150.000	36.45	AVG	5.31	41.76	54.00	150	88	-12.24

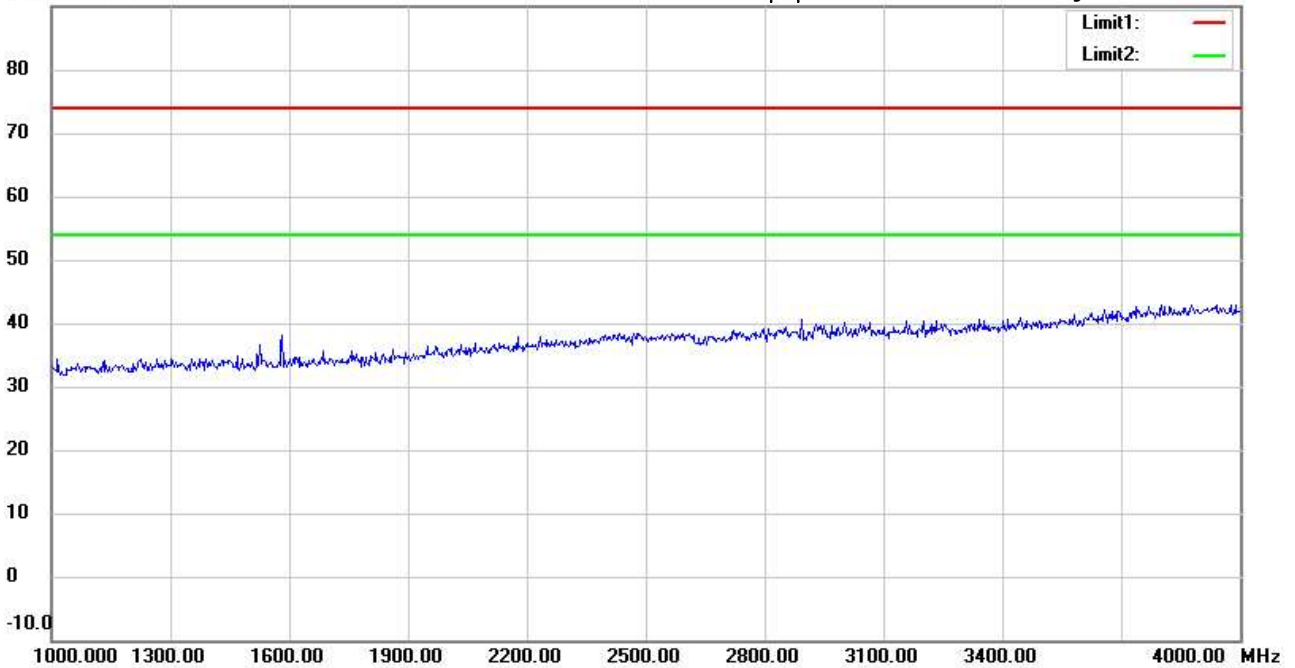
Data :#1

Condition : FCC_part 15E RE_Above 1GHz_PK

Polarization: *Horizontal*

Test Mode : TX 802.11ac80 CH155

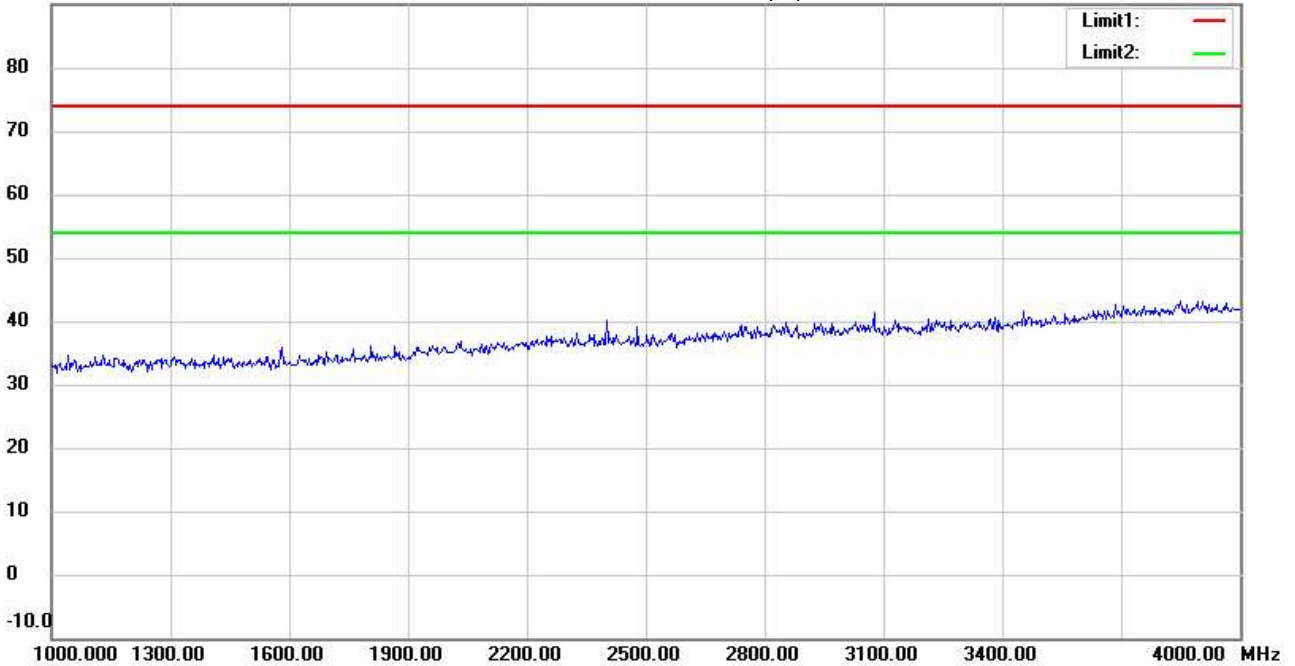
Data :#7

Condition : FCC_part 15E RE_Above 1GHz_PK

Polarization: *Vertical*

Test Mode : TX 802.11ac80 CH155

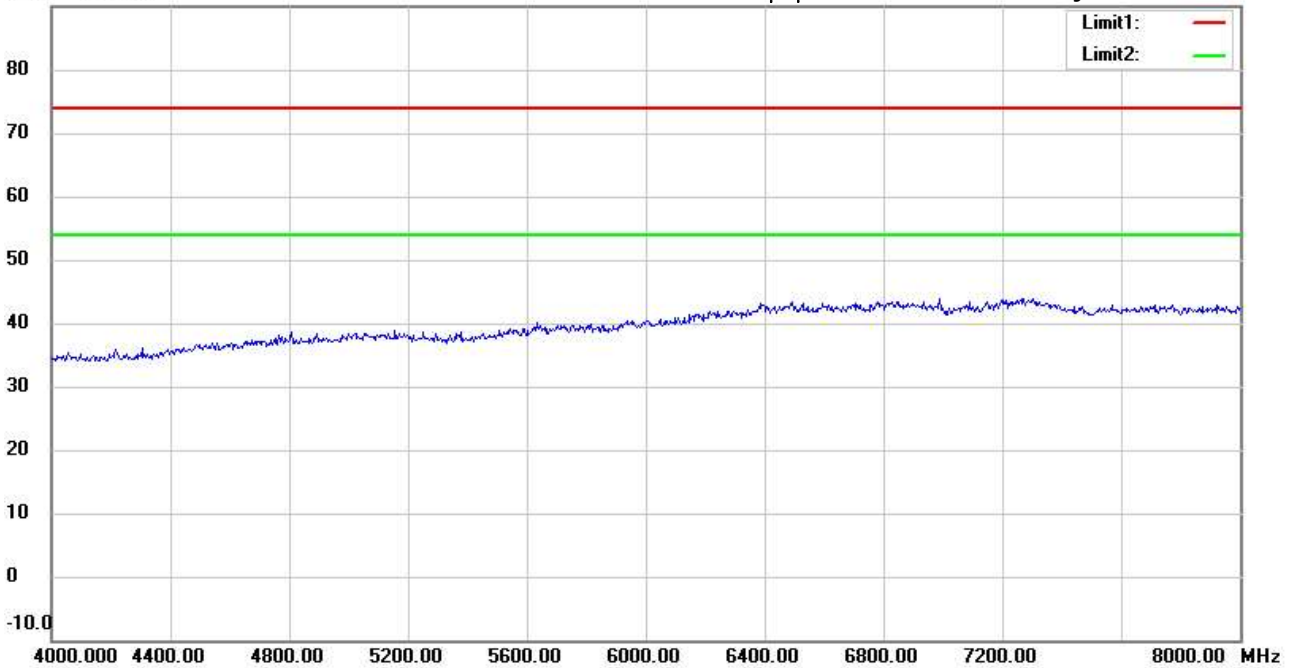
Data :#2

Condition : FCC_part 15E RE_Above 1GHz_PK

Polarization: *Horizontal*

Test Mode : TX 802.11ac80 CH155

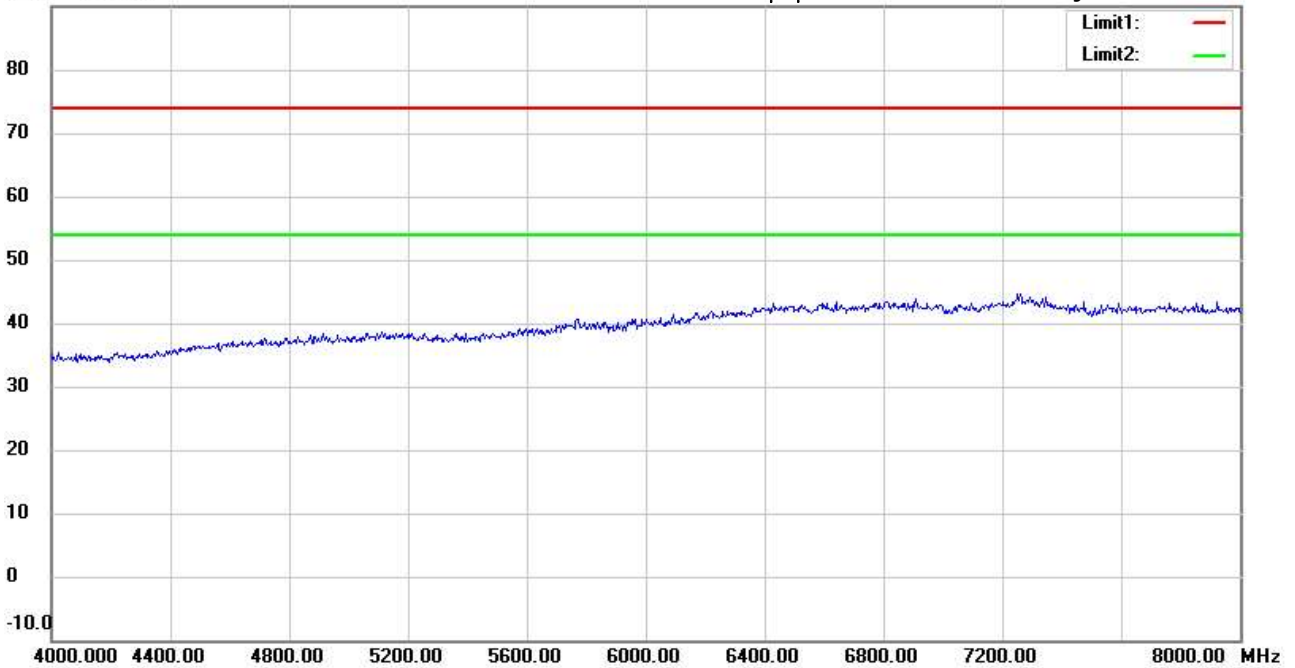
Data :#8

Condition : FCC_part 15E RE_Above 1GHz_PK

Polarization: **Vertical**

Test Mode : TX 802.11ac80 CH155

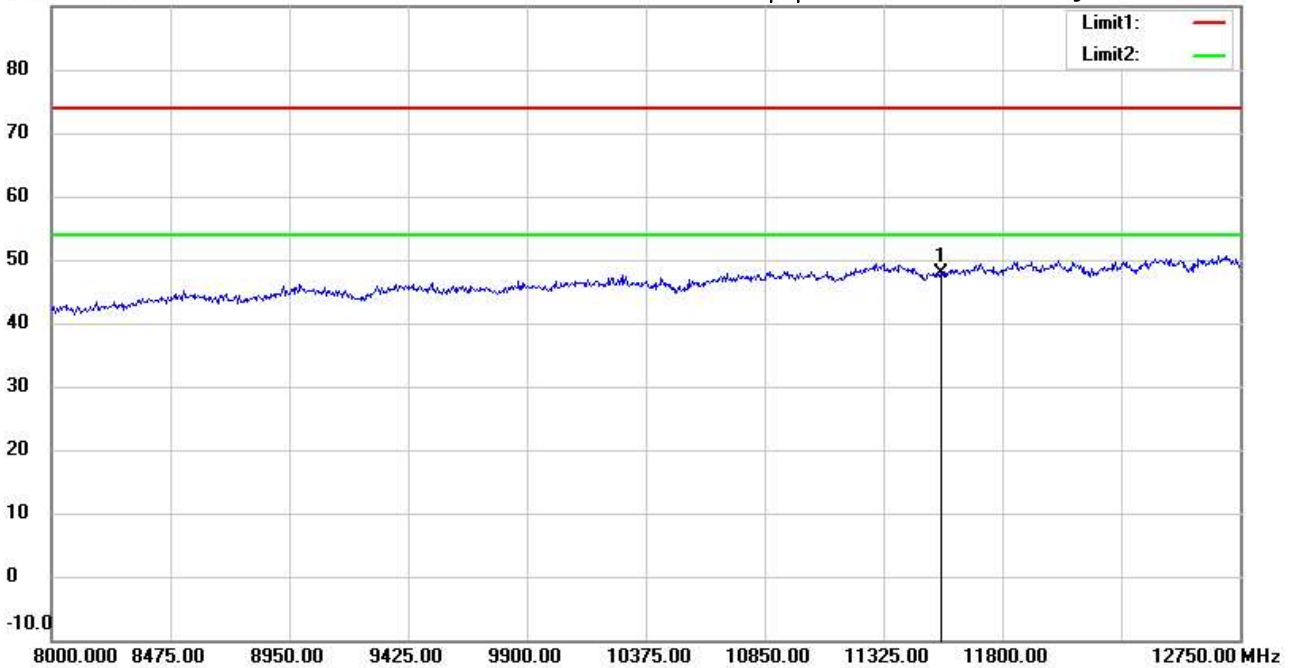
Data :#3

Condition : FCC_part 15E RE_Above 1GHz_PK

Polarization: *Horizontal*

Test Mode : TX 802.11ac80 CH155

Mk.	Frequency (MHz)	Reading (dBuV)	Detector	Corr. factor (dB/m)	Result (dBuV/m)	Limit (dBuV/m)	Ant.Pos (cm)	Tab.Pos (deg.)	Margin (dB)	Comment
*	11550.000	31.26	peak	16.55	47.81	74.00	150	14	-26.19

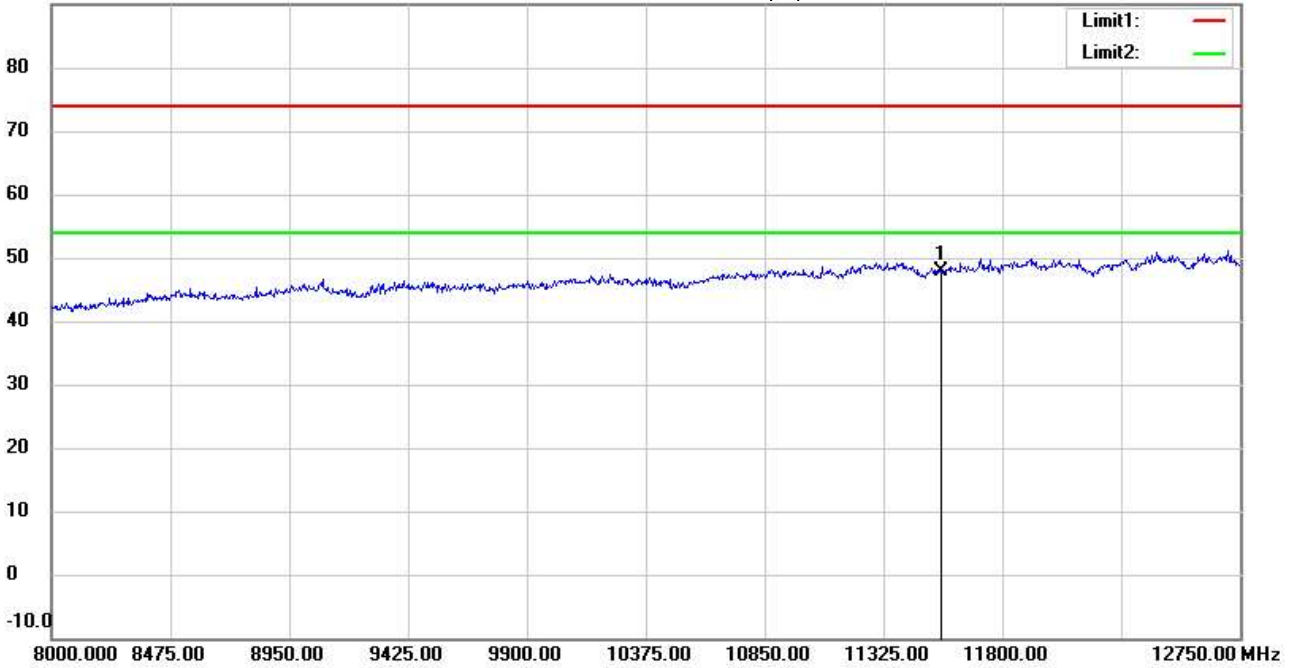
Data :#9

Condition : FCC_part 15E RE_Above 1GHz_PK

Polarization: *Vertical*

Test Mode : TX 802.11ac80 CH155

Mk.	Frequency (MHz)	Reading (dBuV)	Detector	Corr. factor (dB/m)	Result (dBuV/m)	Limit (dBuV/m)	Ant.Pos (cm)	Tab.Pos (deg.)	Margin (dB)	Comment
*	11550.000	31.39	peak	16.55	47.94	74.00	150	27	-26.06

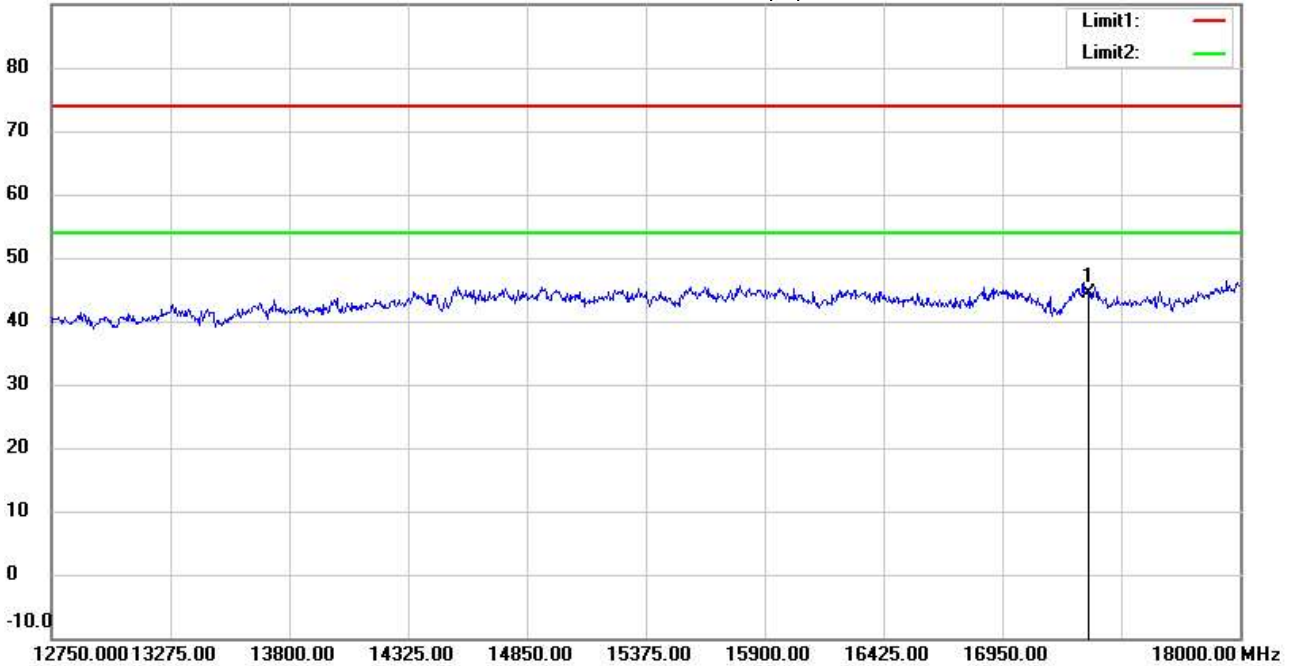
Data :#4

Condition : FCC_part 15E RE_Above 1GHz_PK

Polarization: *Horizontal*

Test Mode : TX 802.11ac80 CH155

Mk.	Frequency (MHz)	Reading (dBuV)	Detector	Corr. factor (dB/m)	Result (dBuV/m)	Limit (dBuV/m)	Ant.Pos (cm)	Tab.Pos (deg.)	Margin (dB)	Comment
*	17325.000	20.20	peak	24.11	44.31	74.00	150	120	-29.69

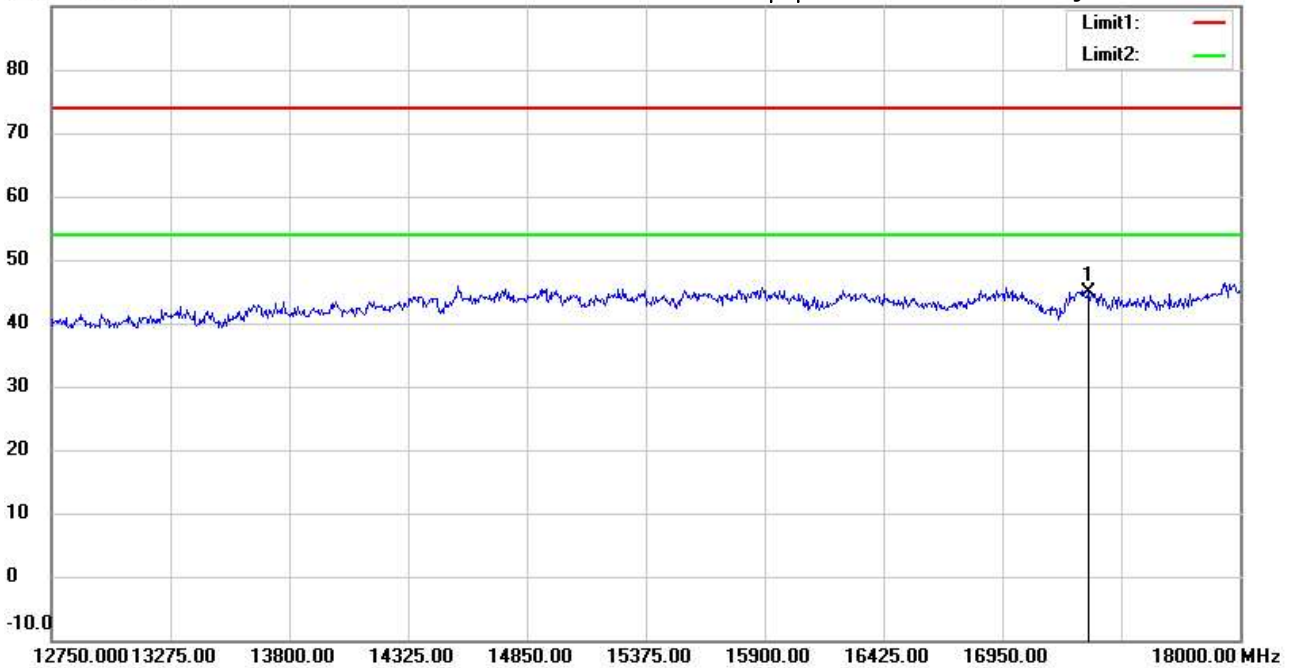
Data :#10

Condition : FCC_part 15E RE_Above 1GHz_PK

Polarization: *Vertical*

Test Mode : TX 802.11ac80 CH155

Mk.	Frequency (MHz)	Reading (dBuV)	Detector	Corr. factor (dB/m)	Result (dBuV/m)	Limit (dBuV/m)	Ant.Pos (cm)	Tab.Pos (deg.)	Margin (dB)	Comment
*	17325.000	20.78	peak	24.11	44.89	74.00	150	16	-29.11

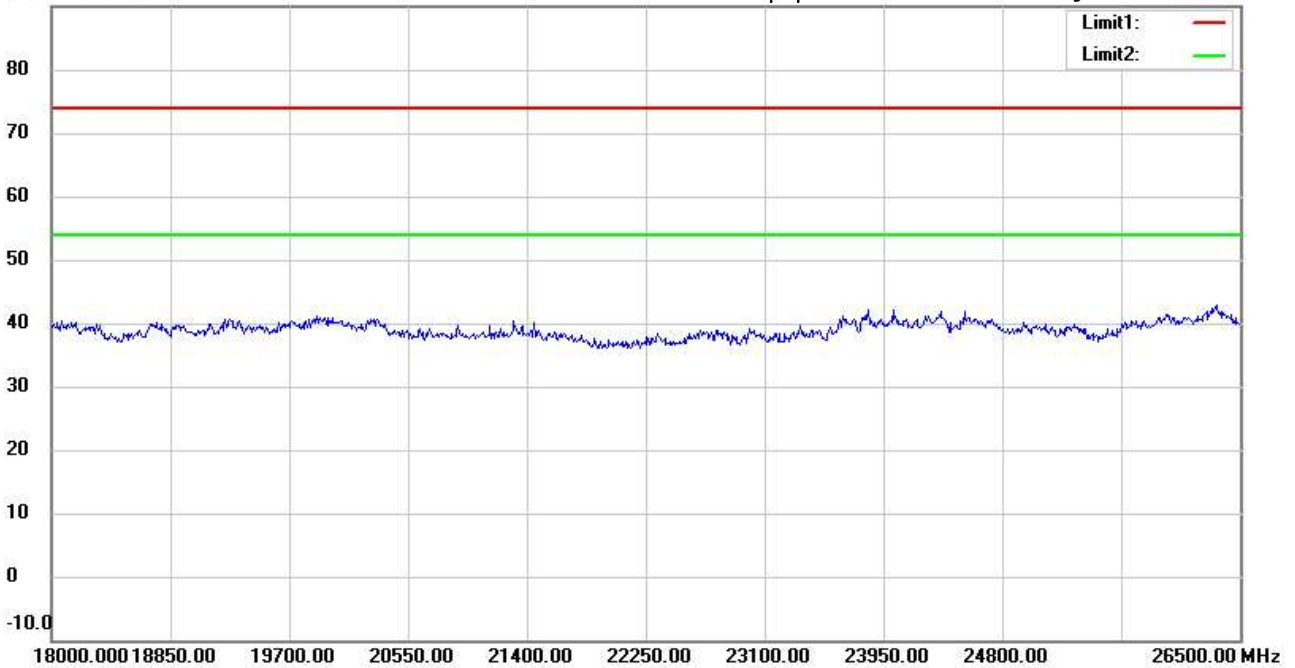
Data :#5

Condition : FCC_part 15E RE_Above 1GHz_PK

Polarization: *Horizontal*

Test Mode : TX 802.11ac80 CH155

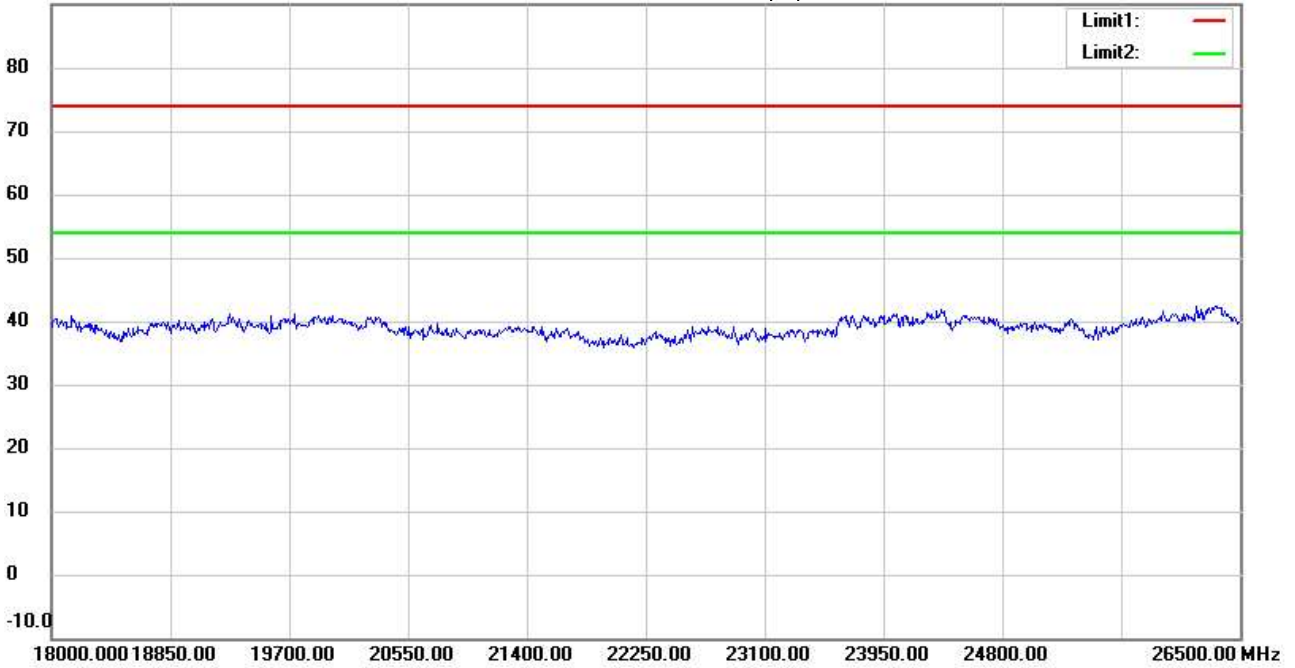
Data :#11

Condition : FCC_part 15E RE_Above 1GHz_PK

Polarization: **Vertical**

Test Mode : TX 802.11ac80 CH155

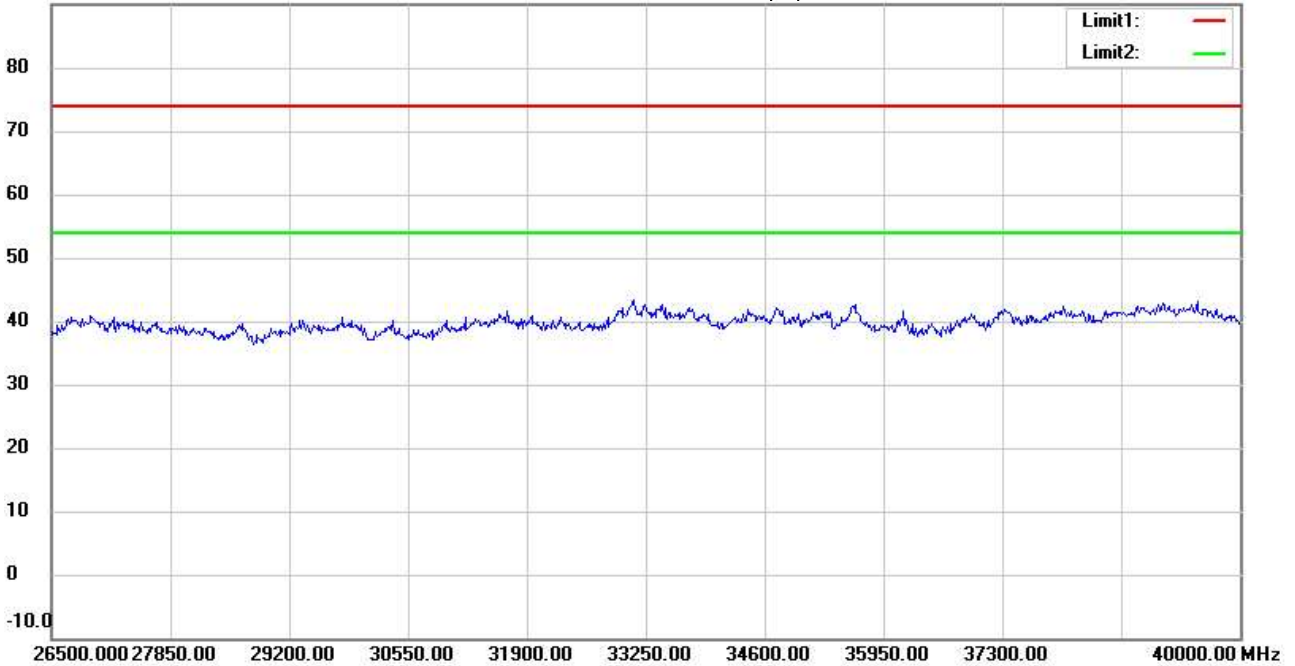
Data :#6

Condition : FCC_part 15E RE_Above 1GHz_PK

Polarization: *Horizontal*

Test Mode : TX 802.11ac80 CH155

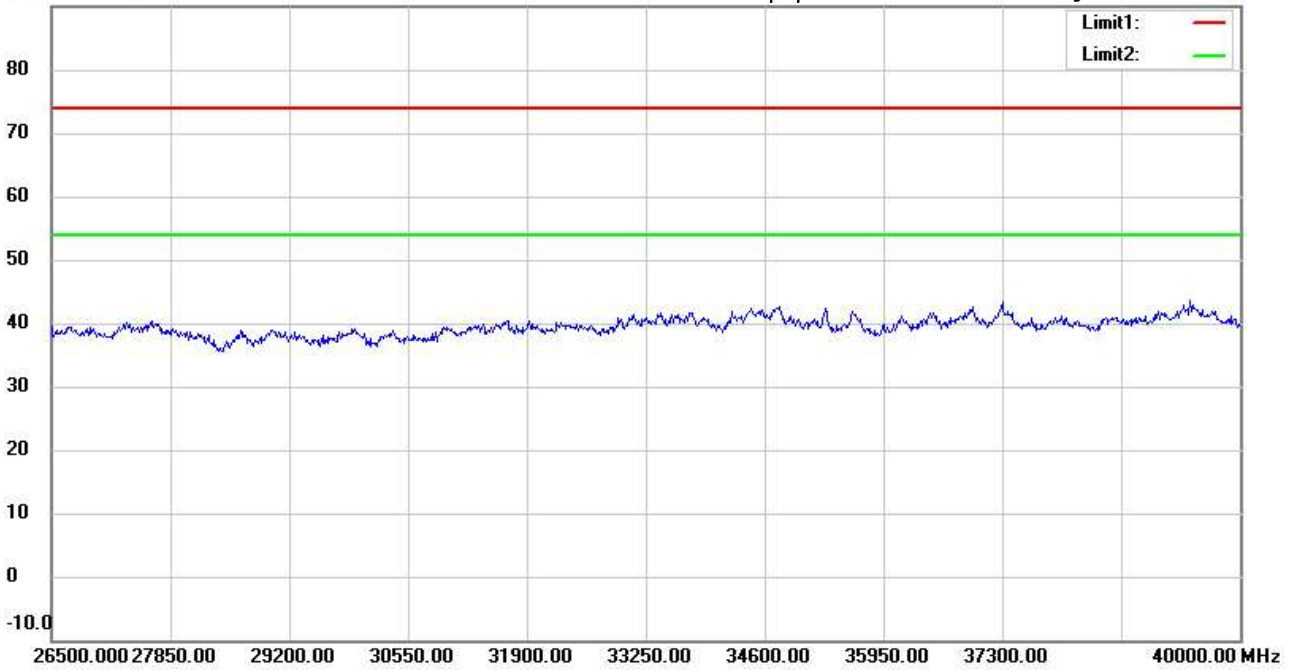
Data :#12

Condition : FCC_part 15E RE_Above 1GHz_PK

Polarization: **Vertical**

Test Mode : TX 802.11ac80 CH155
