Photo Report on RF-310

Report Reference: MDE_DEDRONE_2202_FCC_Photo_Setups

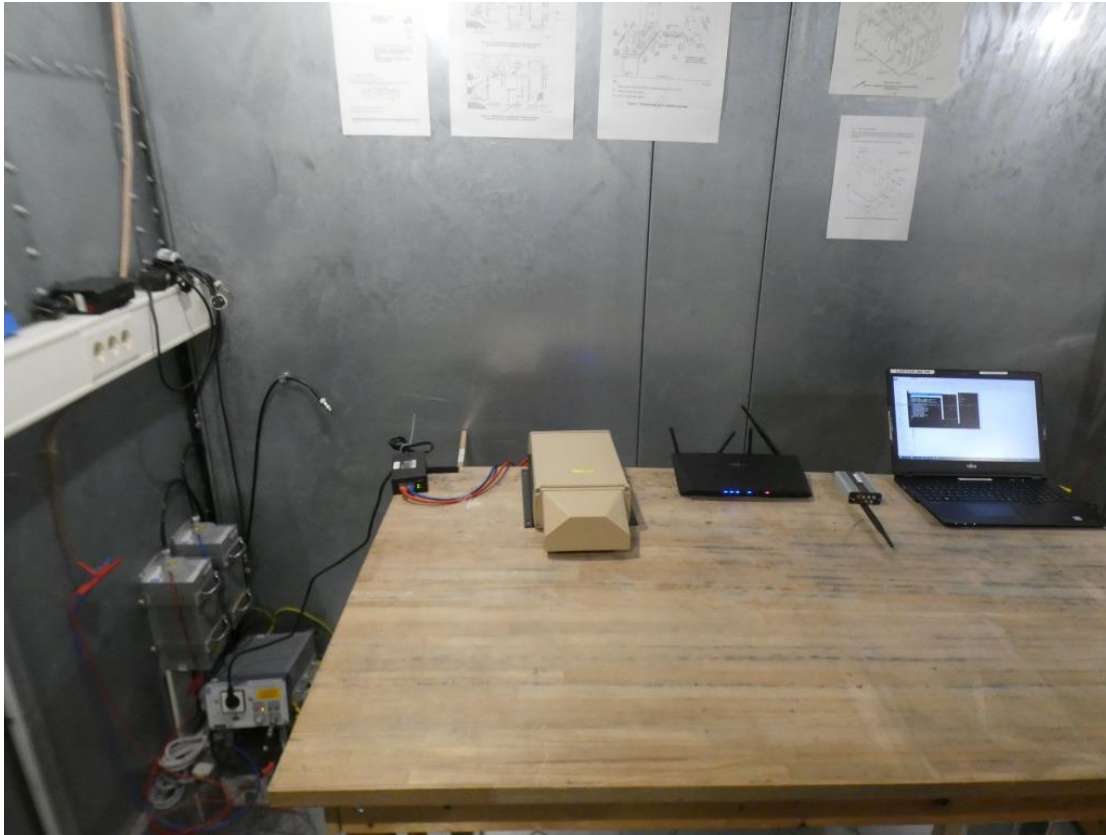
Photo 1: Test setup for conducted measurements (Test Setup: computer peripheral setup, AC mains connection: connected via auxiliary equipment, unintentional radiator §15.107, ANSI C63.4)

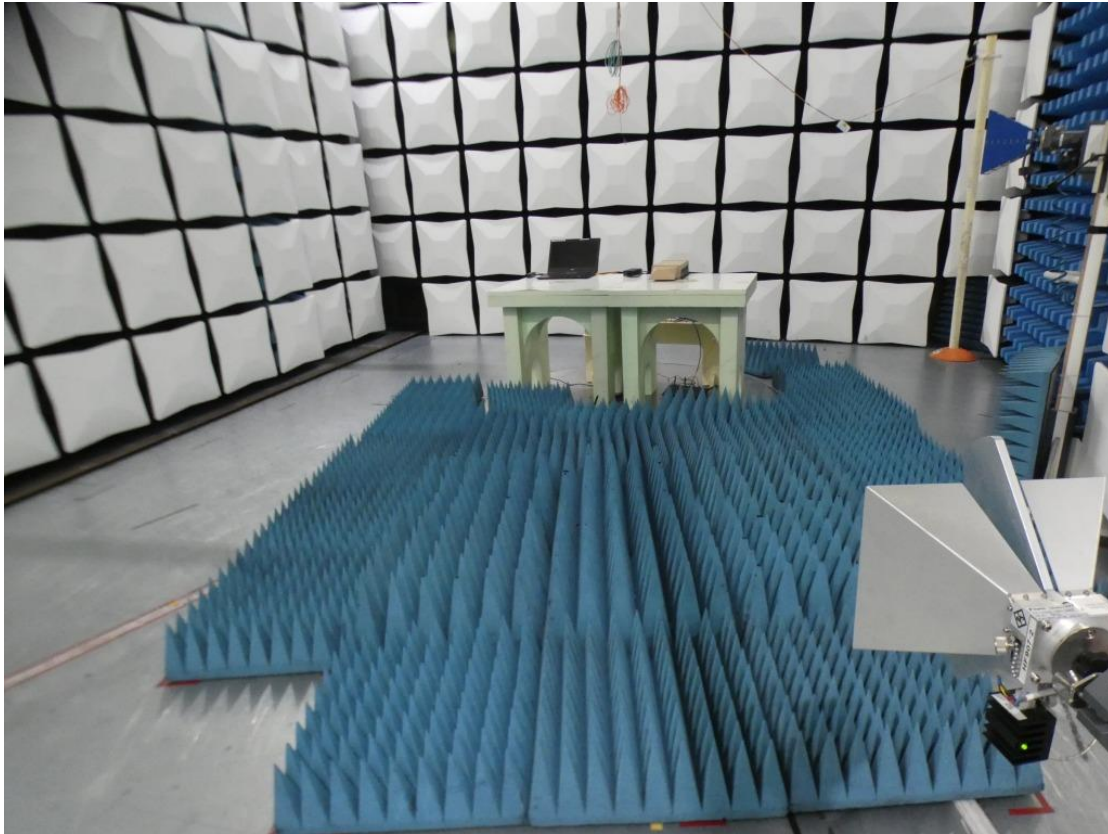
Photo 3: Test setup for radiated measurements (computer peripheral setup, 1 GHz – 18 GHz; unintentional radiator §15.109, ANSI C63.4)

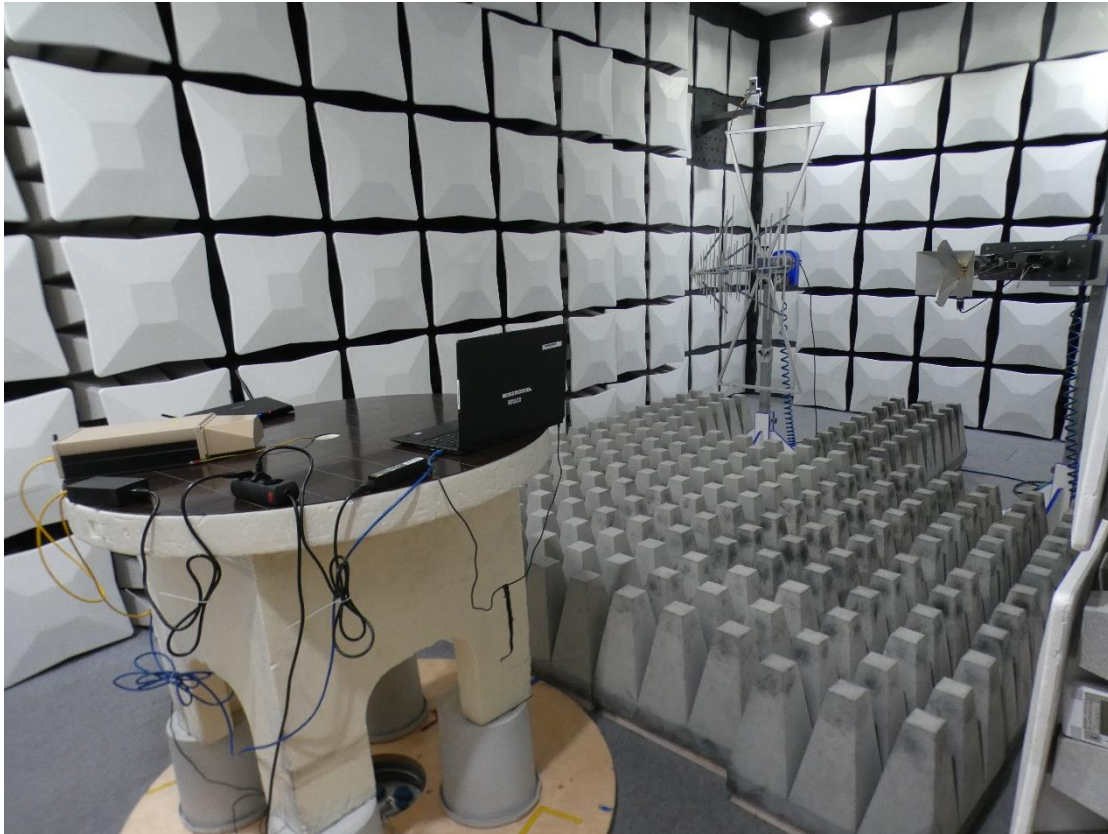
Photo 4: Test setup for radiated measurements (computer peripheral setup, 18 - 26 GHz; unintentional radiator §15.109, ANSI C63.4)
