Photo Report on Test Setups

FCC ID 2AOUZ17101031
IC:23650-17101031

Report Reference: MDE_CONTI_1740_FCC_Photo_Setups

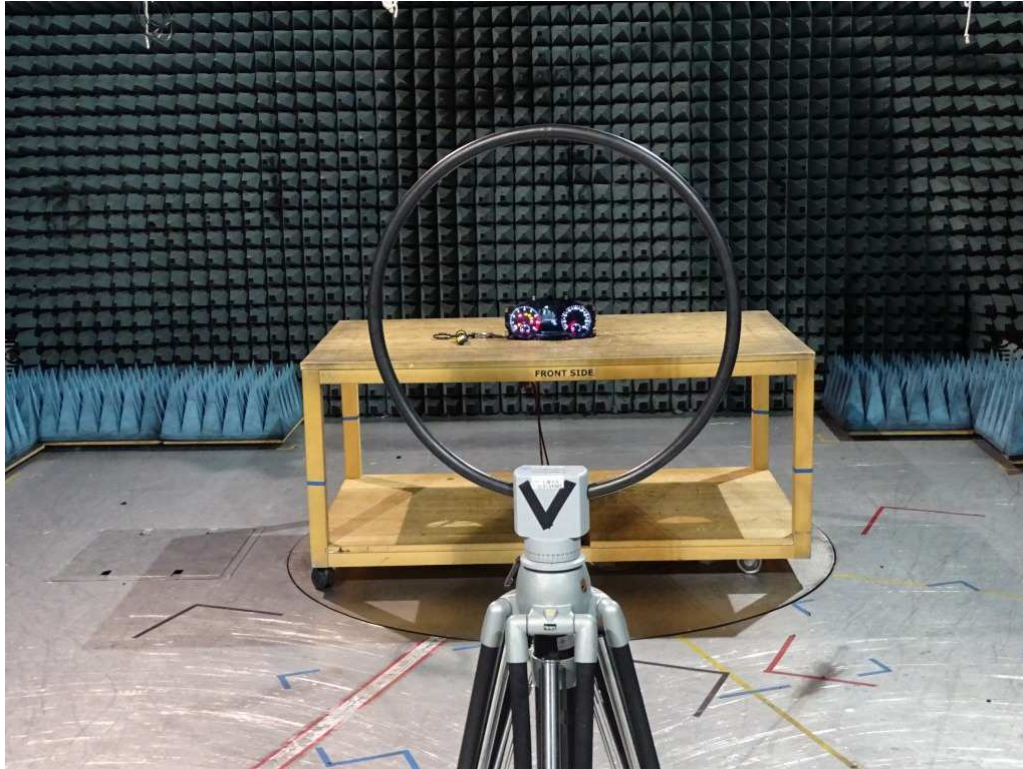
Photo 1: Test setup for radiated measurements (Enclosure, below 30 MHz, intentional radiator §15.209, ANSI C63.10)

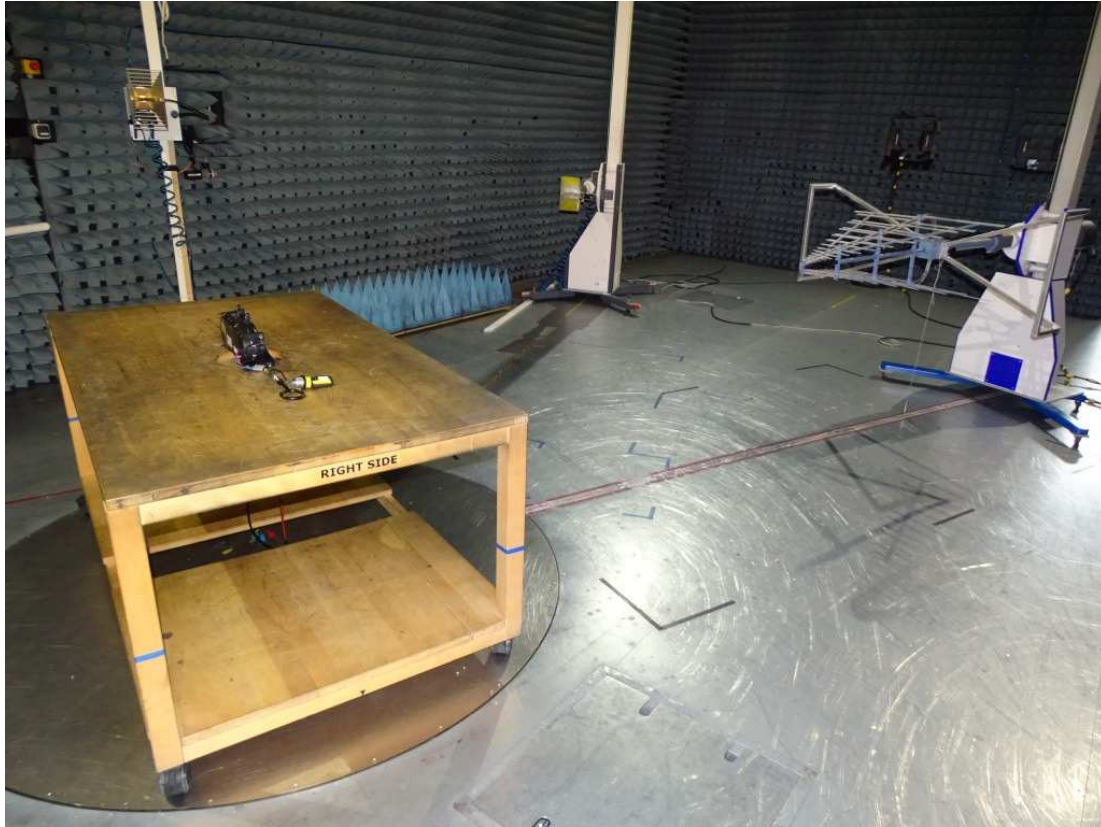
Photo 2: Test setup for radiated measurements (Enclosure, semi-anechoic chamber, 30 MHz to 1 GHz, intentional radiator §15.209, ANSI C63.10)
