## Appendix F: Band edge measurements

## Appendix G: Conducted Spurious Emission Test Result

## Appendix H: Duty Cycle

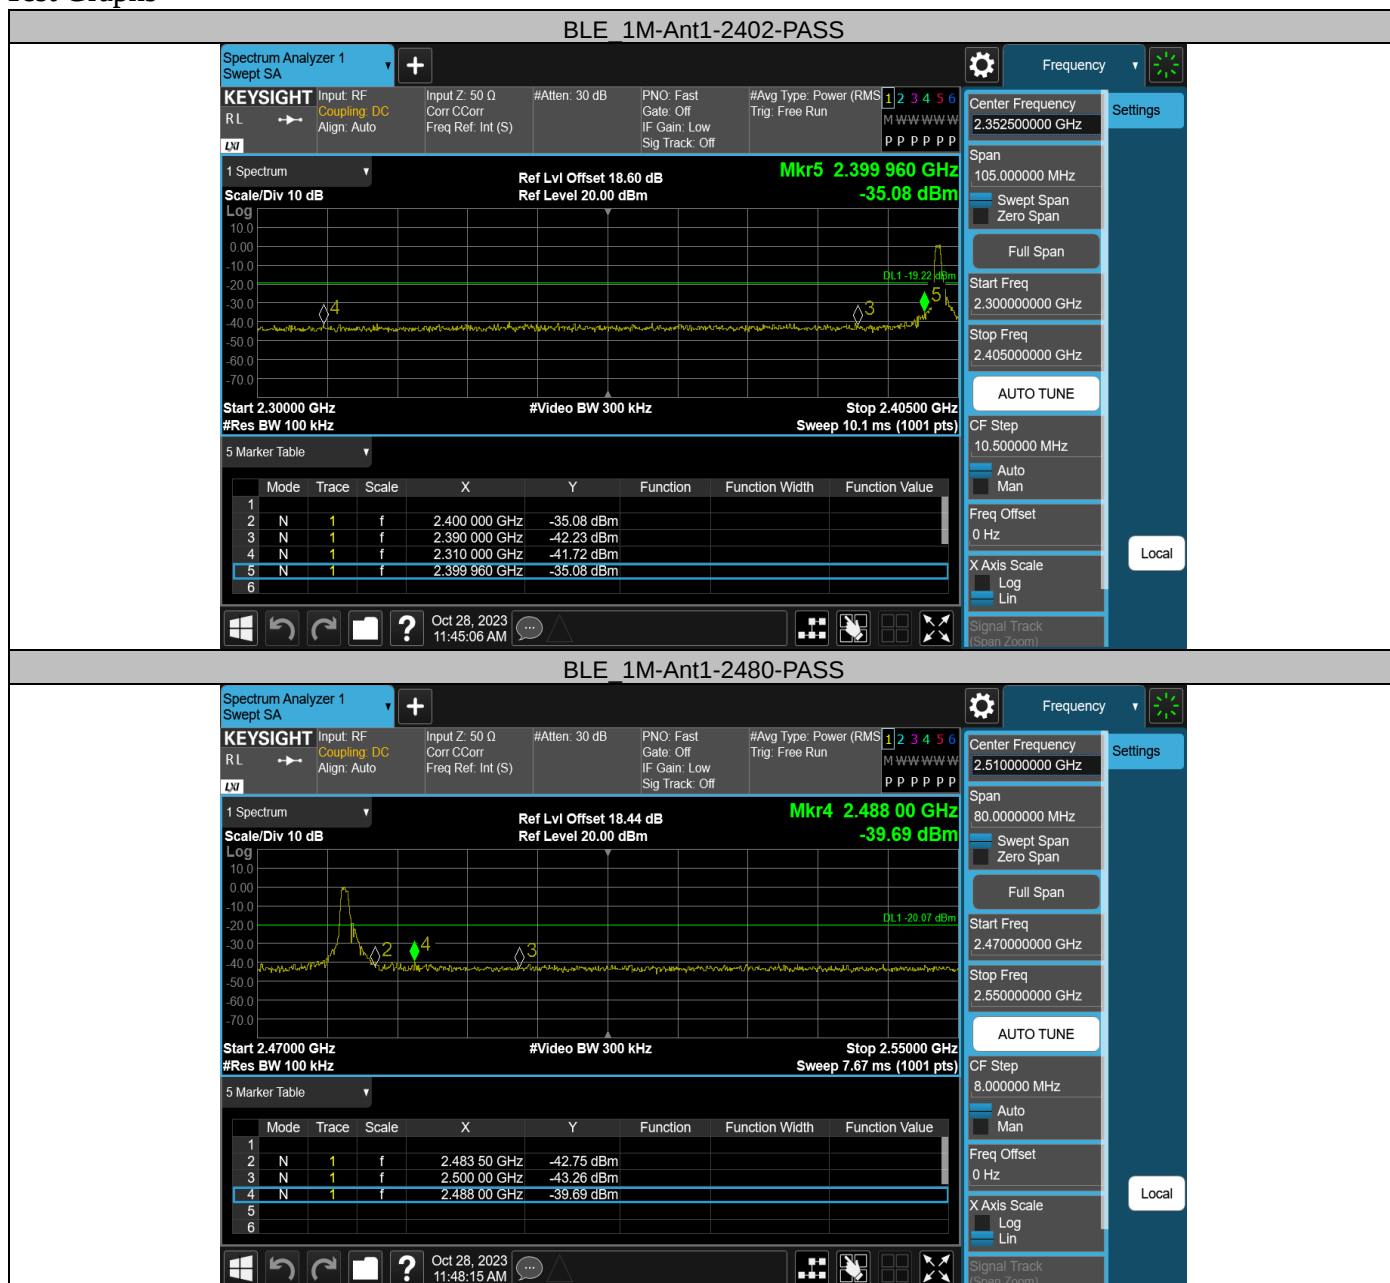
## Test Graphs

| TestMode | Antenna | ChName | Frequency[MHz] | RefLevel[dBm] | Result[dBm] | Limit[dBm] | Verdict |
| BLE_1M | Ant1 | Low | 2402 | 0.78 | -35.08 | $\leq -19.22$ | PASS |
| BLE_1M | Ant1 | High | 2480 | -0.07 | -39.69 | $\leq -20.07$ | PASS |
| BLE_2M | Ant1 | Low | 2402 | 0.55 | -31.27 | $\leq -19.45$ | PASS |
| BLE_2M | Ant1 | High | 2480 | -0.29 | -37.97 | $\leq -20.29$ | PASS |
