10.7 APPENDIX : CONDUCTED SPURIOUS EMISSION

APPENDIX A: PHOTOGRAPHS OF TEST SETUP

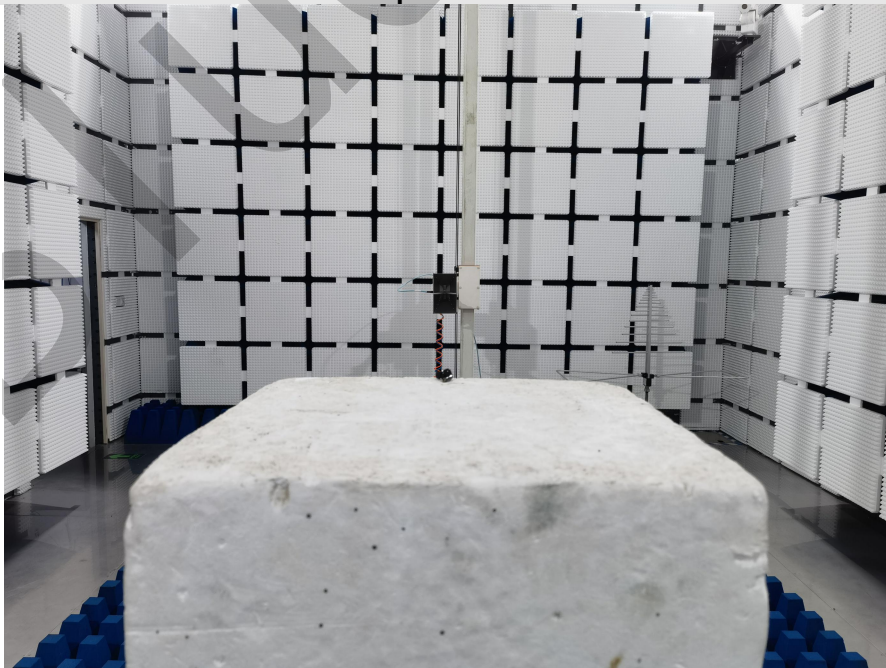
Radiated Spurious Emissions
