# Radiated Emission Measurement

Condition : FCC\_part 15 RE-Class C\_Above 1GHz\_PK

EUT : W6M21903-18922

Test Mode : TX 802.11g CH1

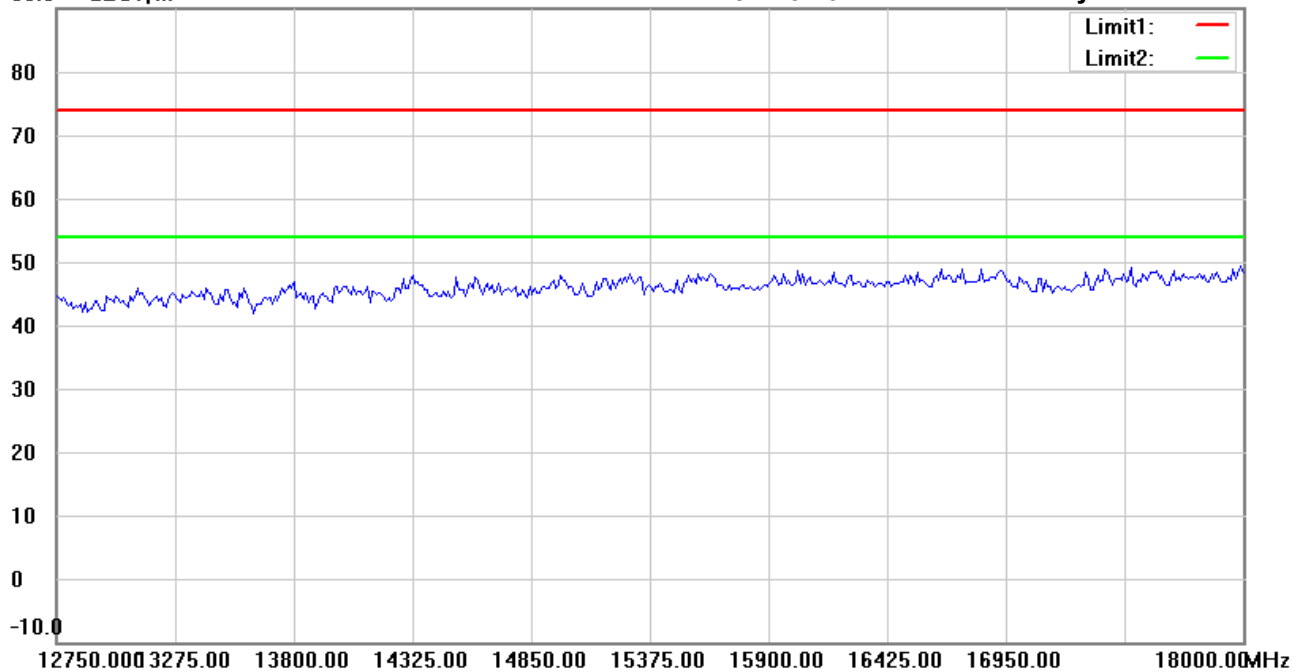
Site : Chamber

Condition : FCC\_part 15 RE-Class C\_Above 1GHz\_PK

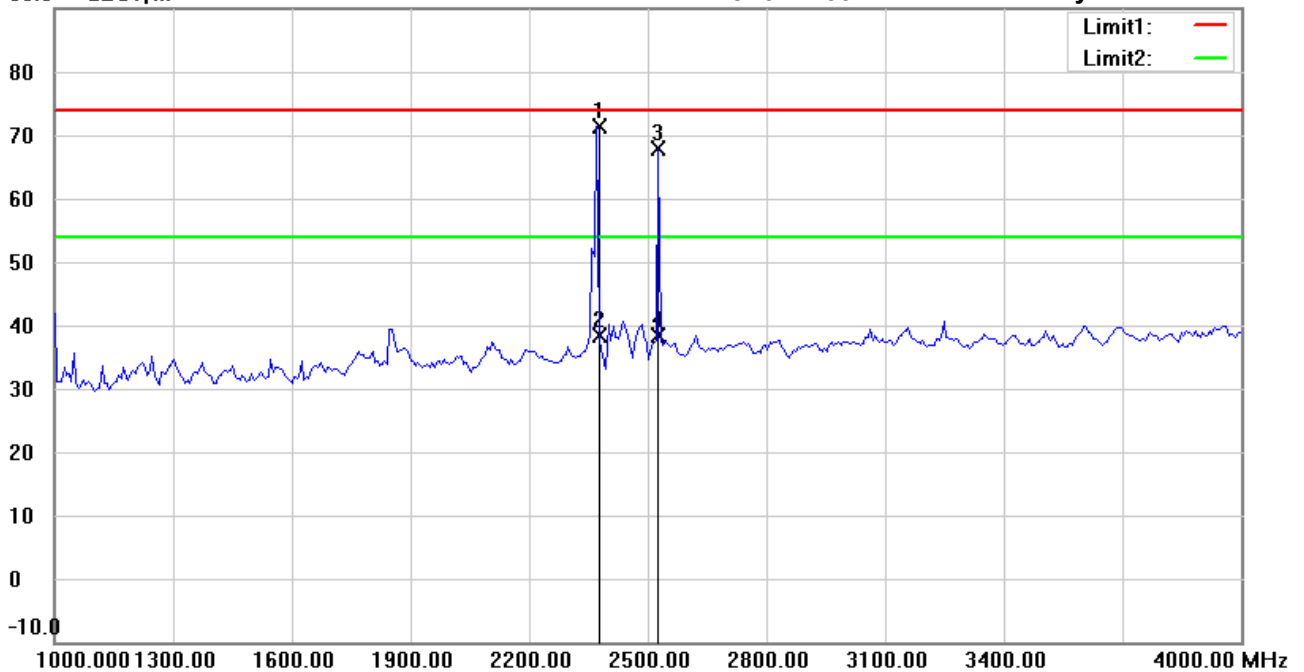
Site : Chamber

Condition : FCC\_part 15 RE-Class C\_Above 1GHz\_PK

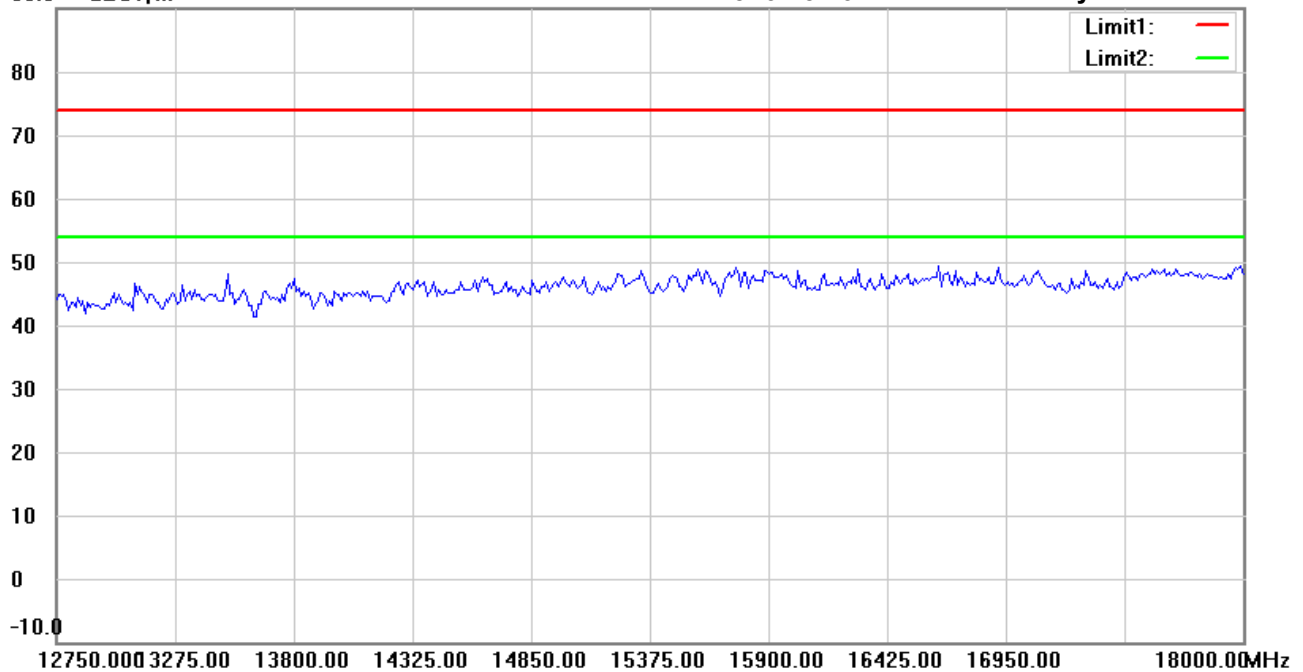
Site : Chamber

Condition : FCC\_part 15 RE-Class C\_Above 1GHz\_PK

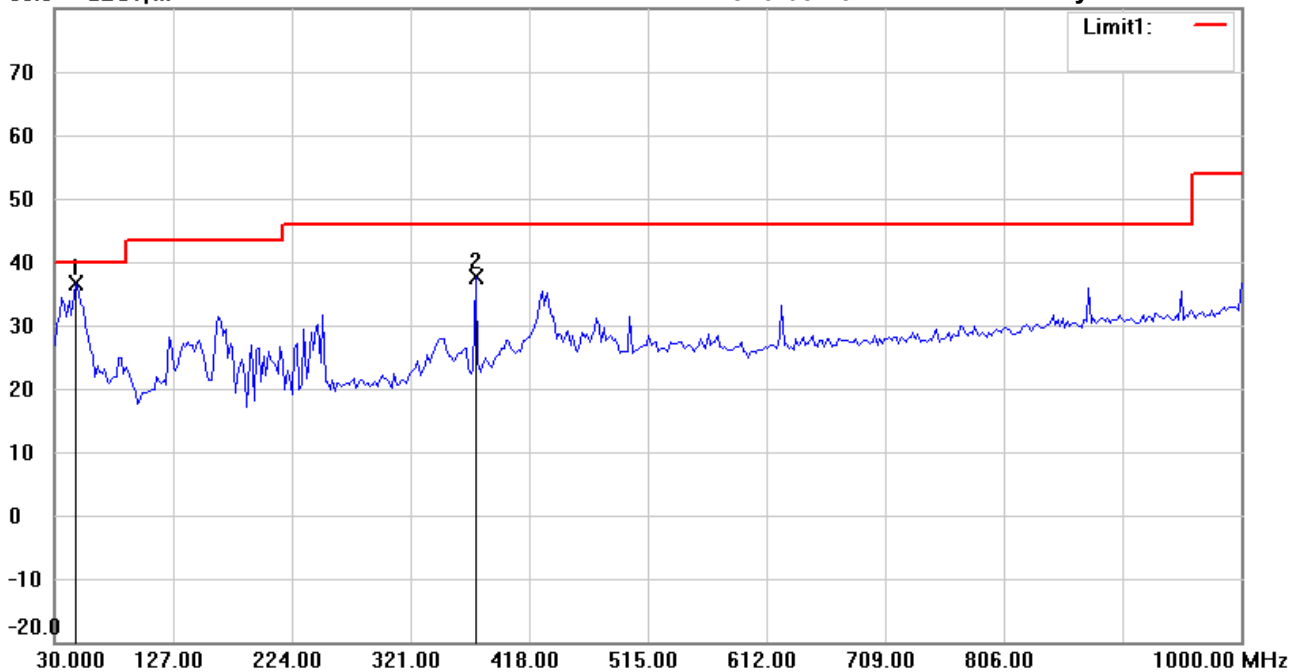
Site : Chamber

Condition : FCC\_part 15 RE-Class C\_30-1000MHz
