# Worldwide Testing Services(Taiwan) Co., Ltd.

Registration number: W6M21903-18922-C-54  
FCC ID: 2AUISION8ION8E

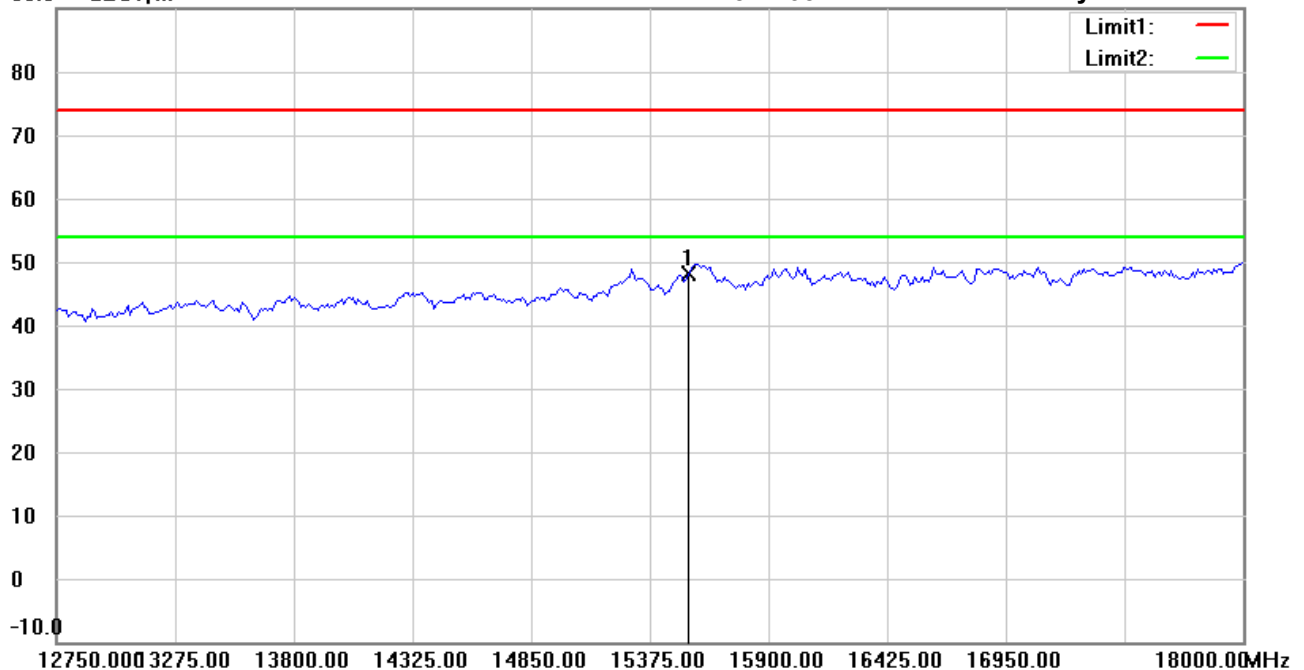
Site : Chamber

Condition : FCC\_part 15E RE\_Above 1GHz\_PK

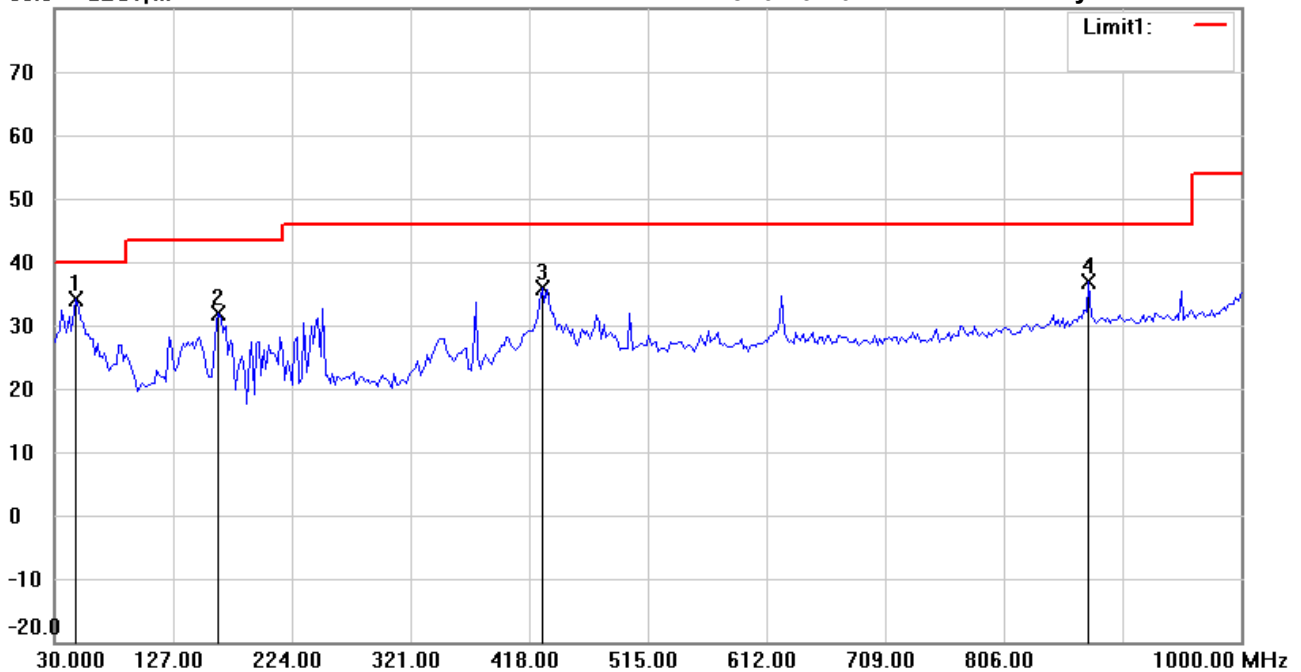
Site : Chamber

Condition : FCC\_part 15 RE-Class E\_30-1000MHz

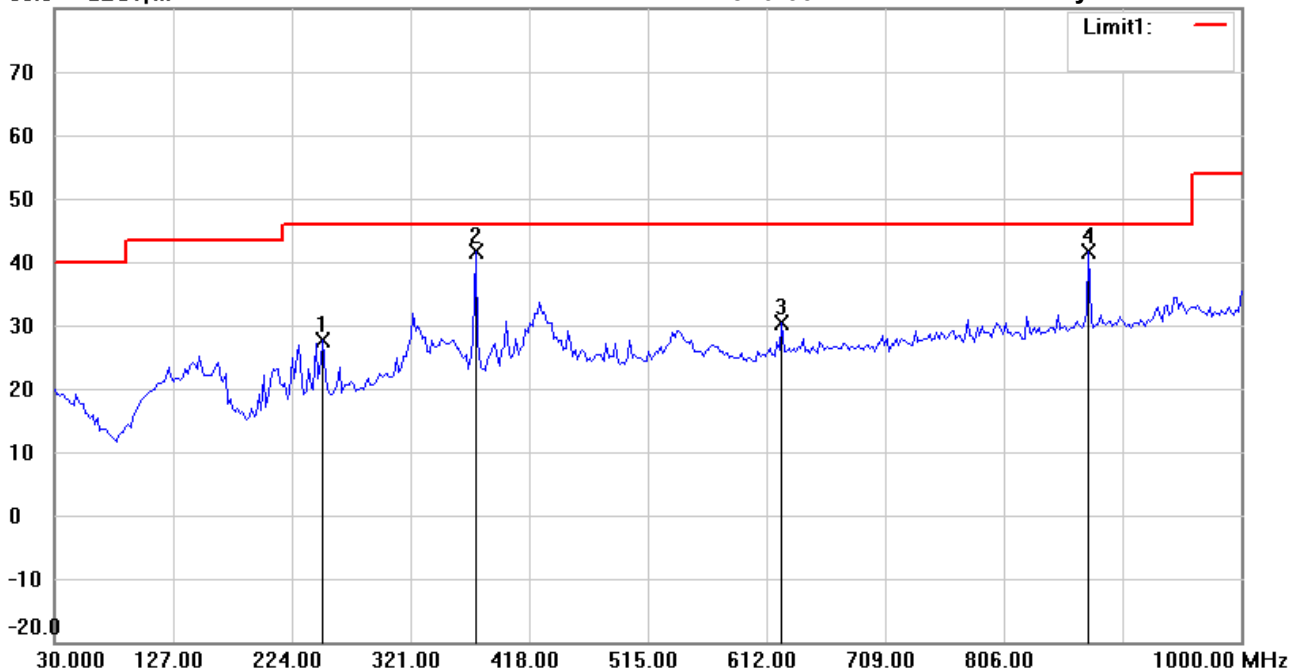
Site : Chamber

Condition : FCC\_part 15 RE-Class E\_30-1000MHz
