21.8 APPENDIX H: CONDUCTED SPURIOUS EMISSION
Test Result

APPENDIX A: PHOTOGRAPHS OF TEST SETUP

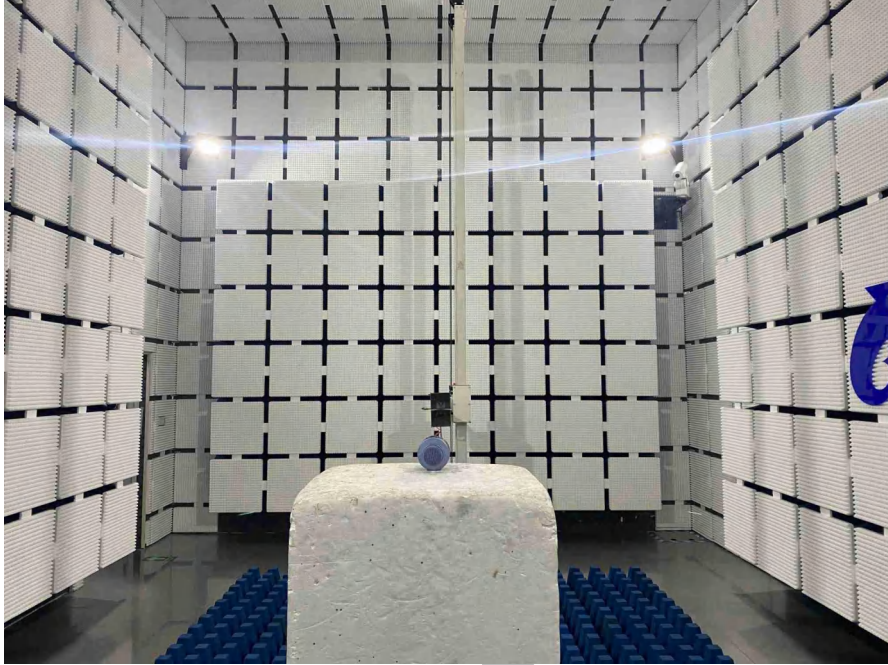
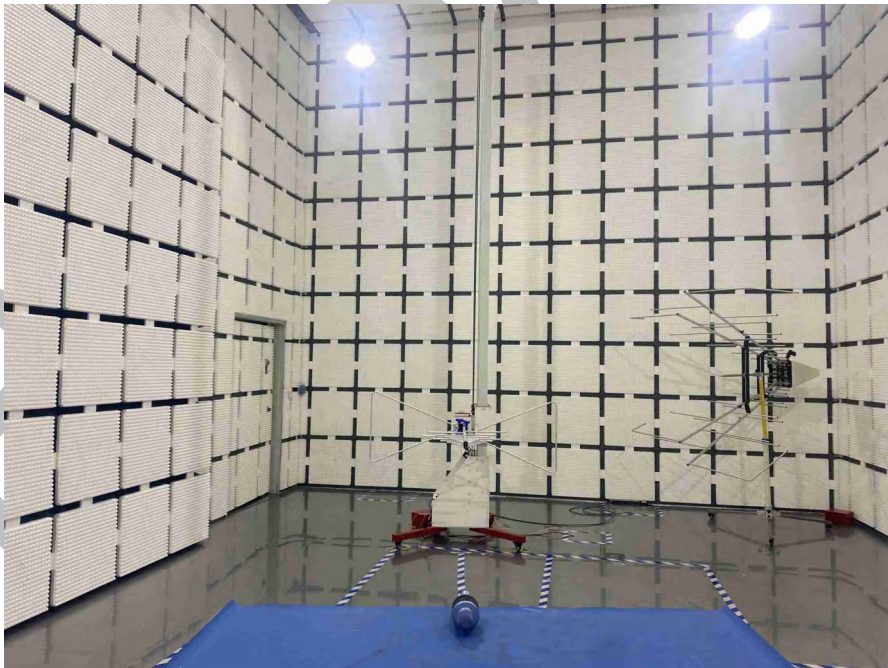
Radiated Spurious Emissions

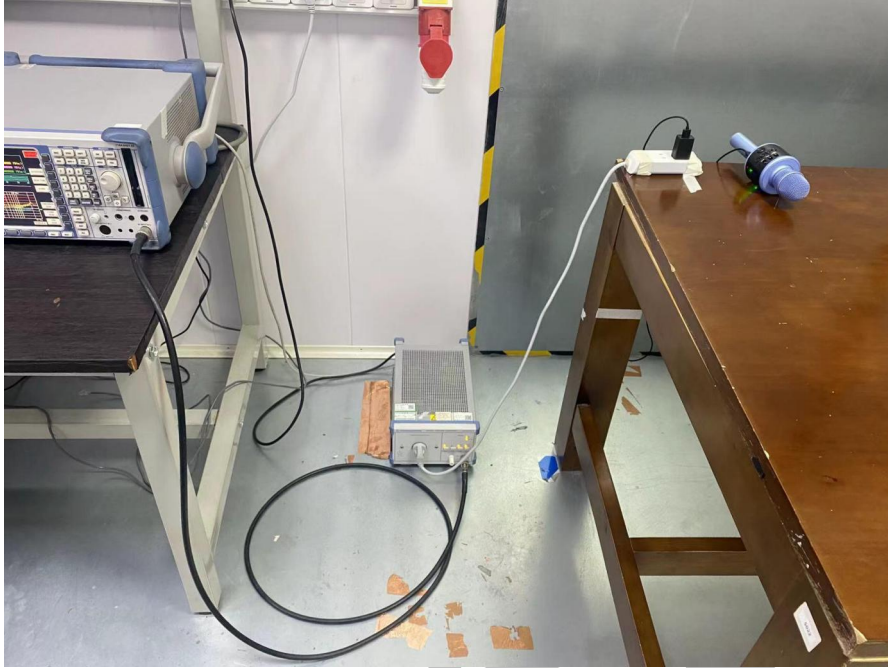
Conducted Emissions at AC Power Line (150kHz-30MHz)
