APPENDIX 3: Photographs of test setup

Radiated Emission

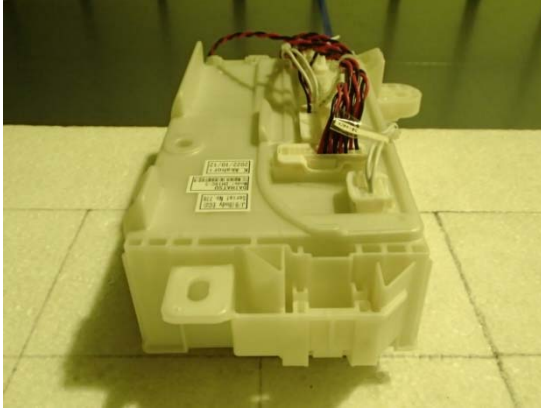
Worst Case Position

ECU
Below 30 MHz
X-axis
Above 30 MHz
Horizontal: X-axis / Vertical: X-axis
X-axis

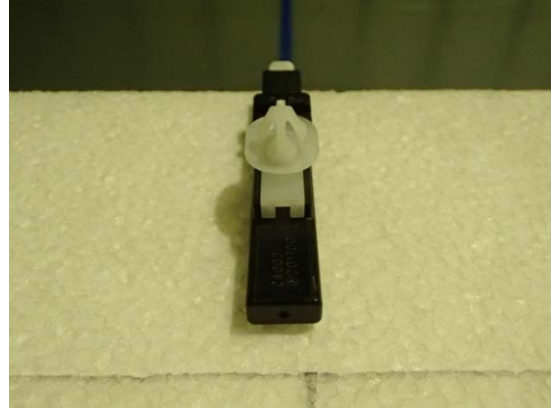
LF Antenna
Below 30 MHz
X-axis
Above 30 MHz
Horizontal: X-axis / Vertical: X-axis
X-axis

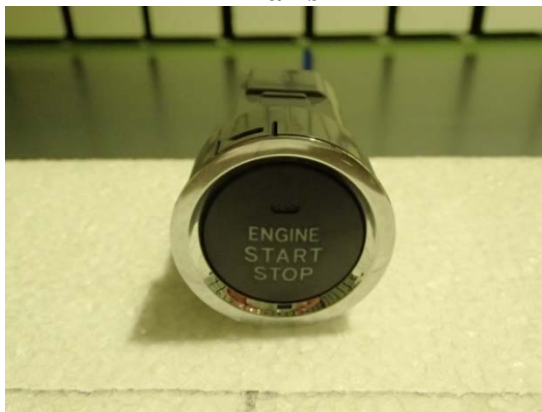
Worst Case Position

Immobilizer Antenna

Below 30 MHz

X-axis

Above 30 MHz

Horizontal: X-axis / Vertical: X-axis

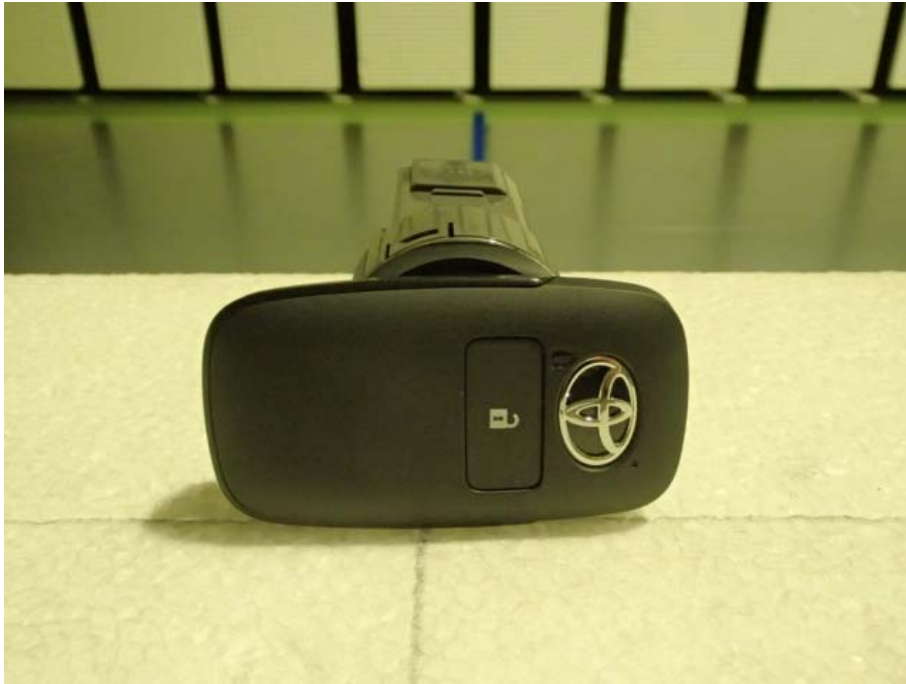
With key

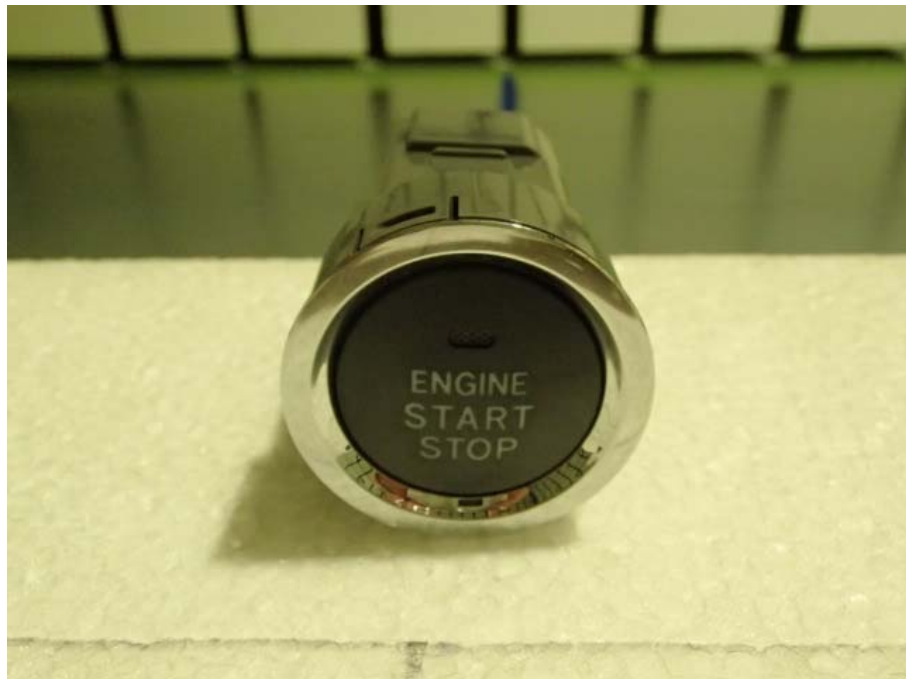
Without key (Worst)
