APPENDIX 3: Photographs of test setup

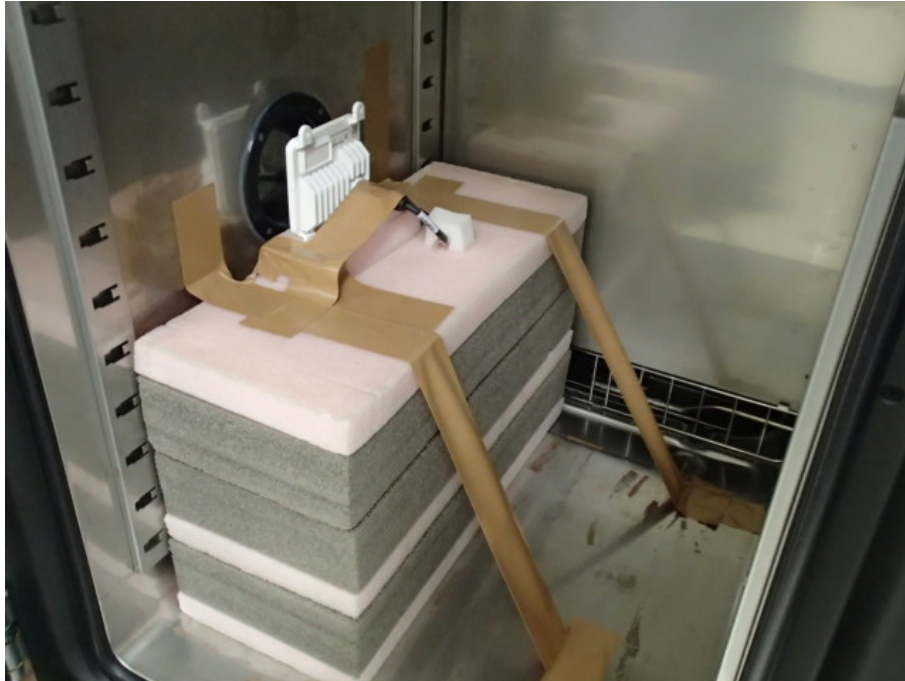
Photo 1

Frequency Stability
