## 15. Antenna Requirement

## 16. EUT Photographs

## 17. EUT Test Setup Photographs

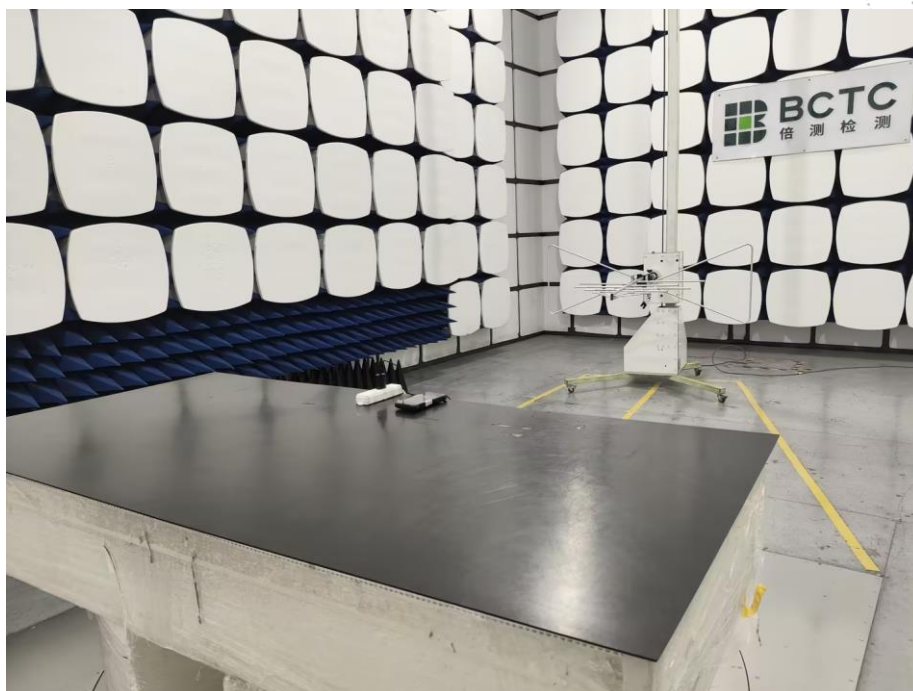
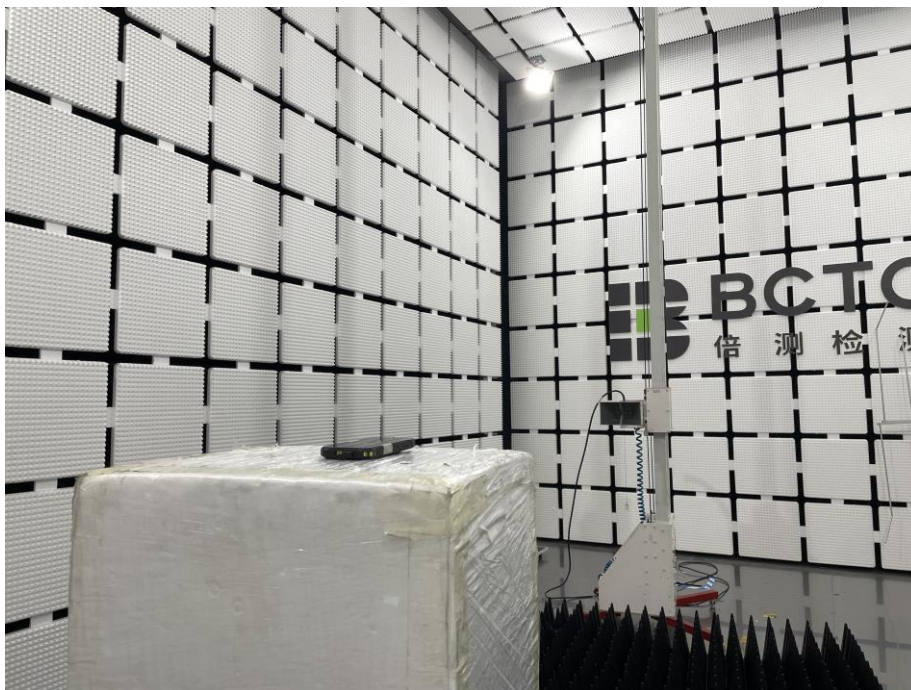
### Radiated Measurement Photos
