APPENDIX E: NUMBER OF HOPPING CHANNELS

APPENDIX F: BAND EDGE MEASUREMENTS

APPENDIX G: CONDUCTED SPURIOUS EMISSION

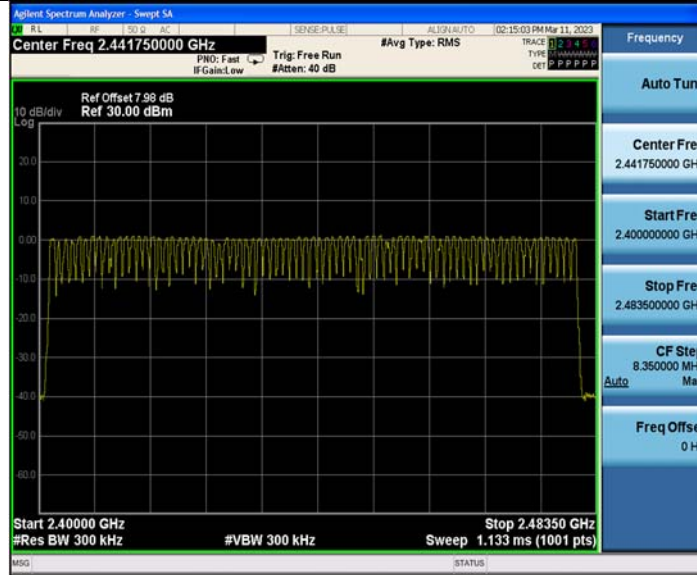
DH5_Ant1_Hop

Test Mode	Antenna	Frequency [MHz]	Result [Num]	Limit [Num]	Verdict
DH5	Ant1	Hop	79	≥15	PASS
2DH5	Ant1	Hop	79	≥15	PASS
3DH5	Ant1	Hop	79	≥15	PASS
