## Appendix G: Conducted Spurious Emission Test Result

13. EUT PHOTO

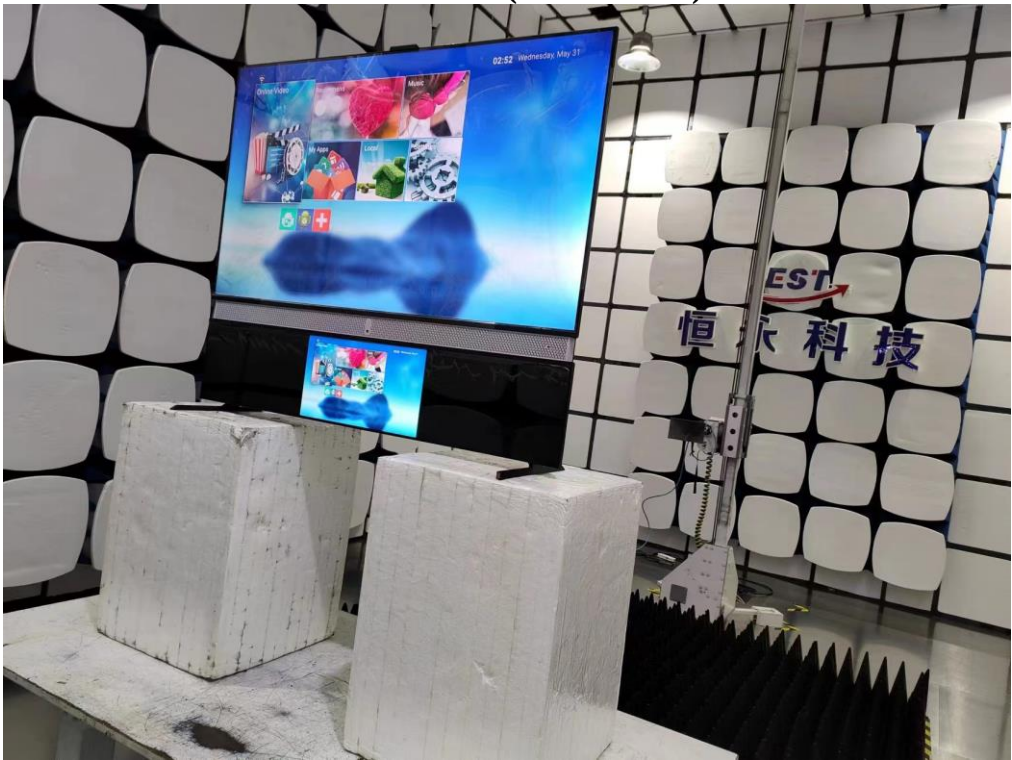
**Radiated Test (Above 1GHz)**
