## Appendix F: Reference level measurement

## Appendix G: Band edge measurements

## Appendix H: Conducted Spurious Emission Test Result

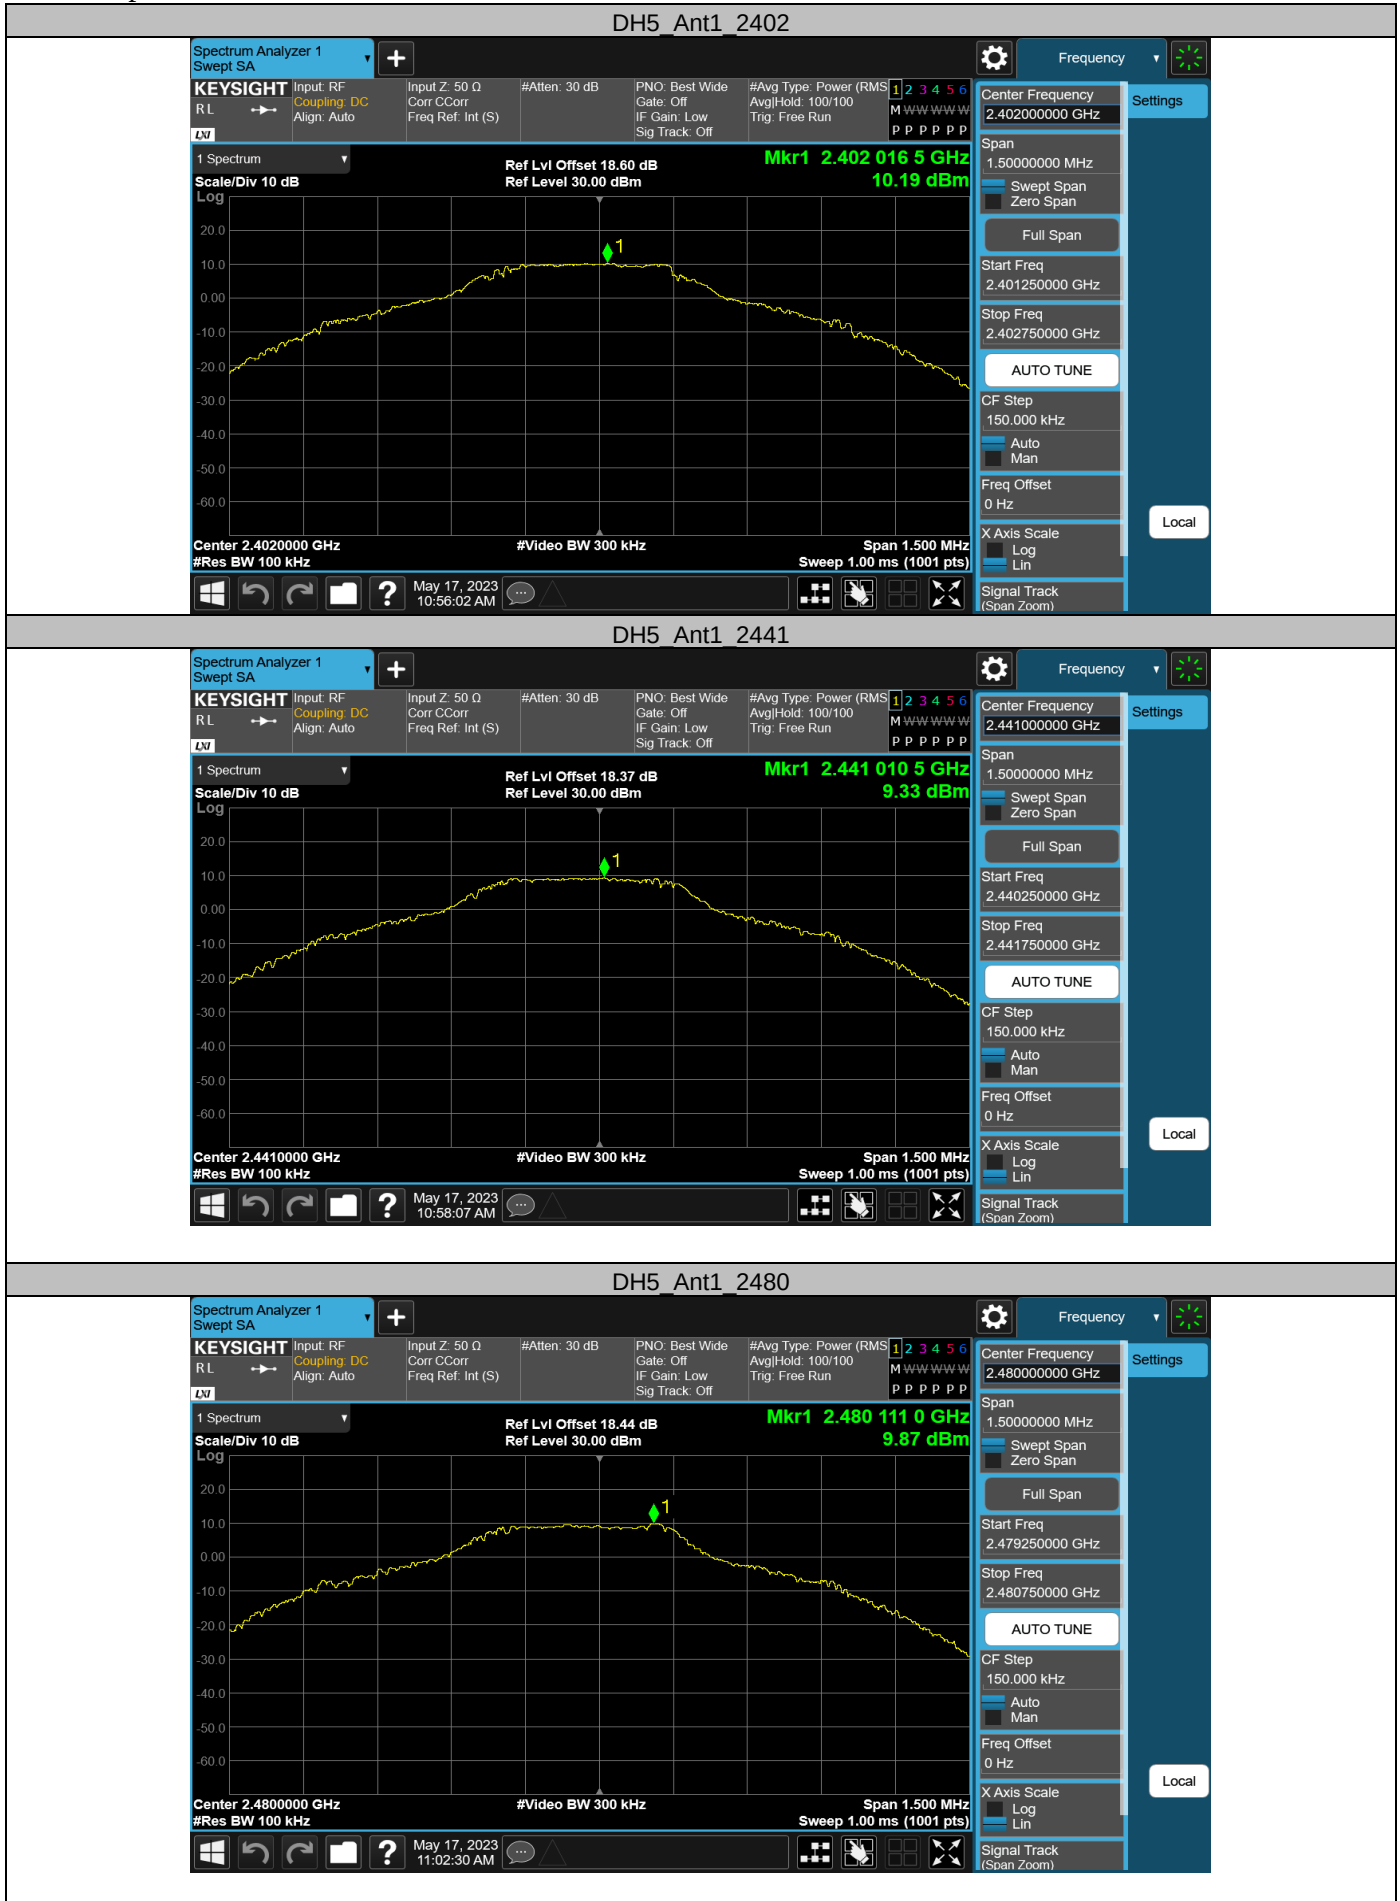
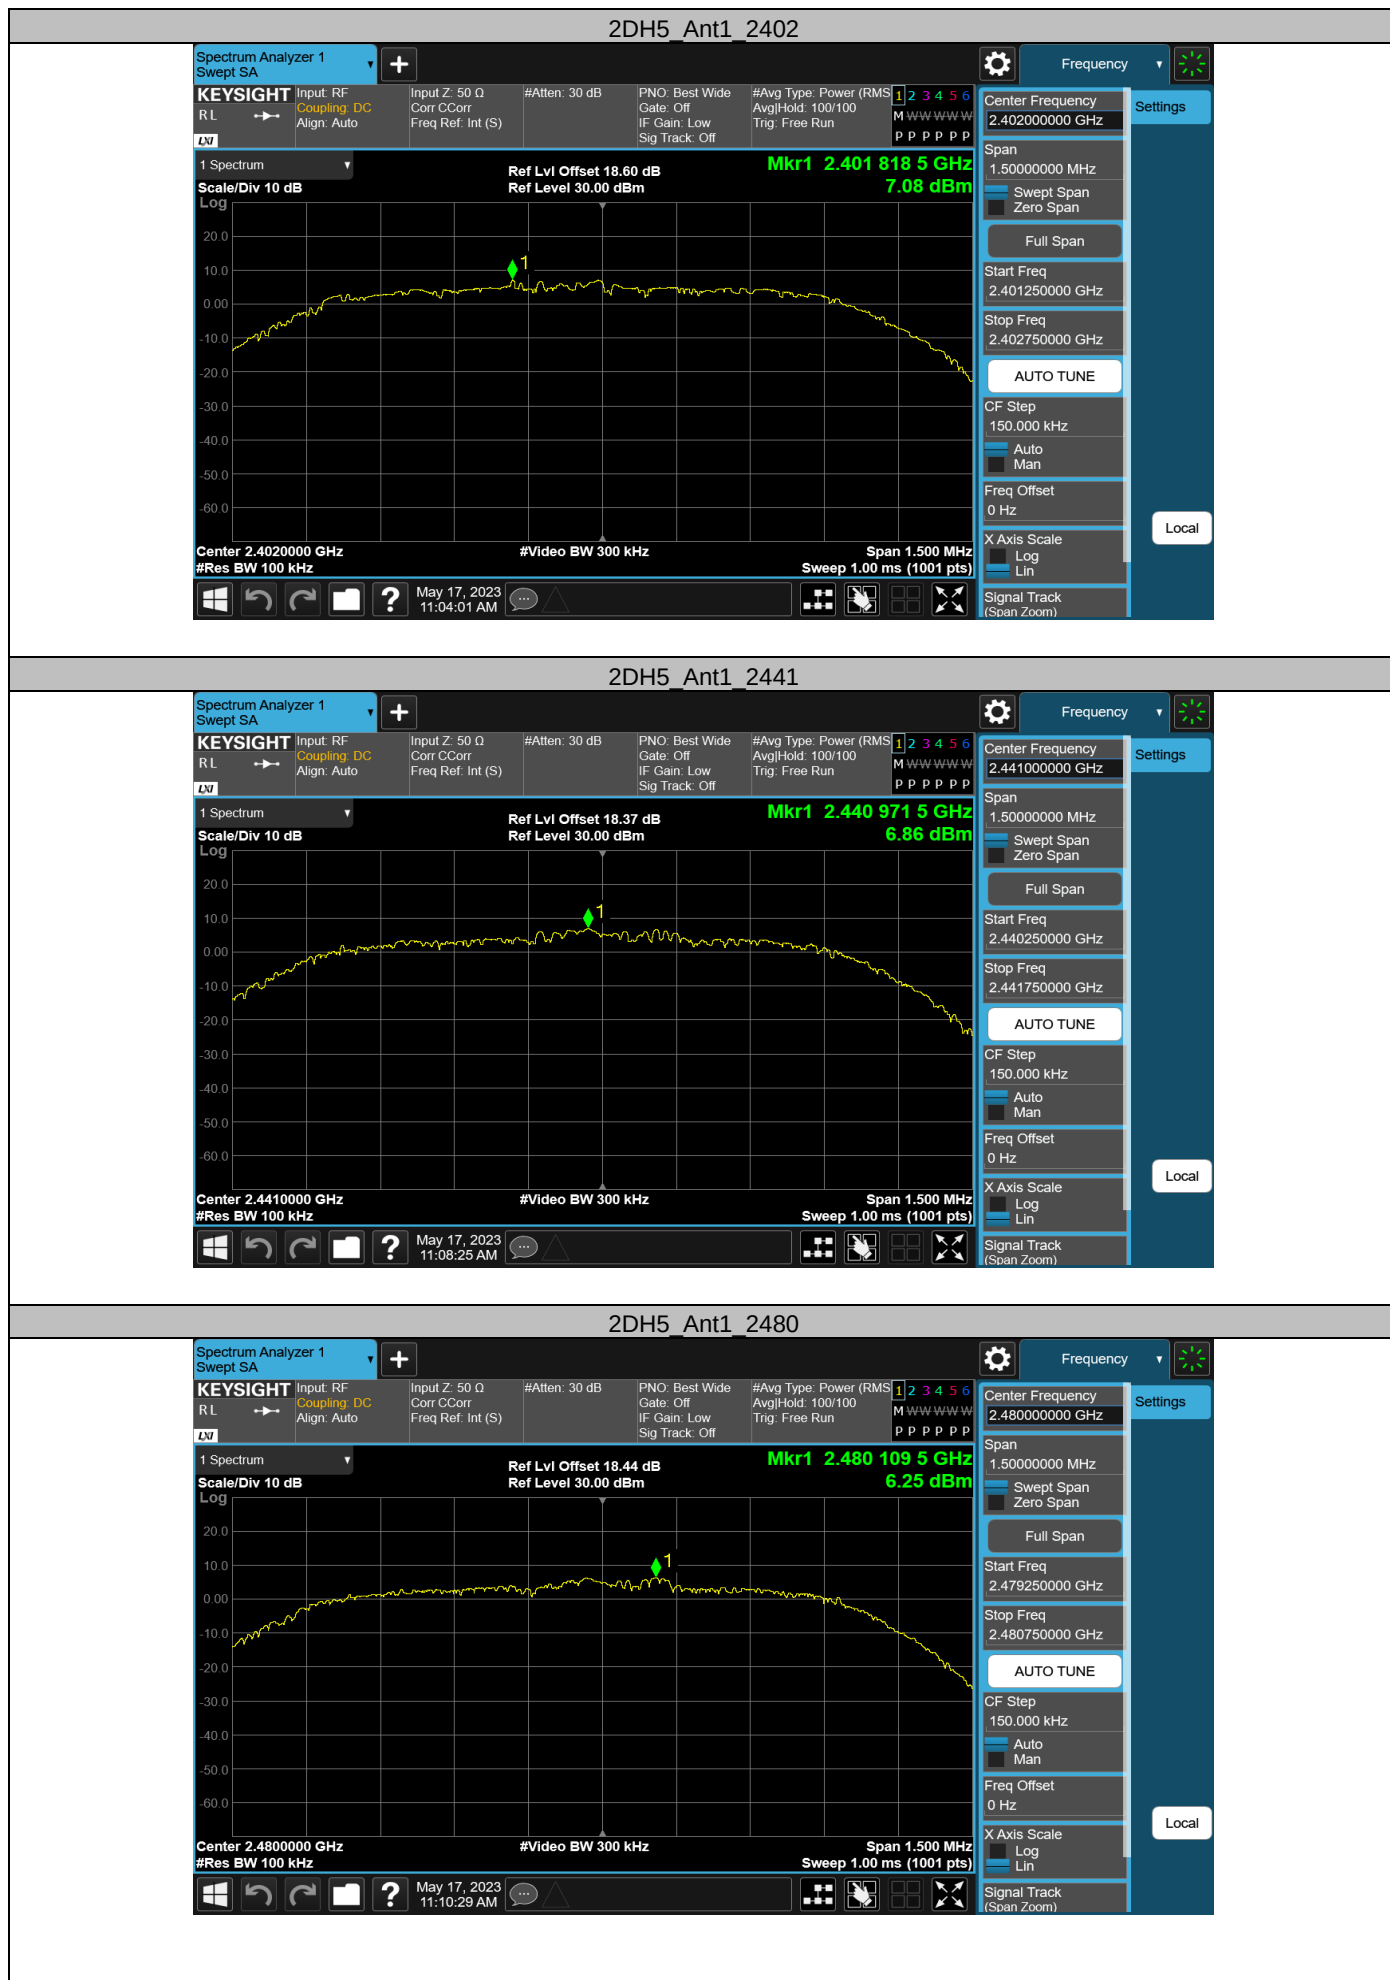
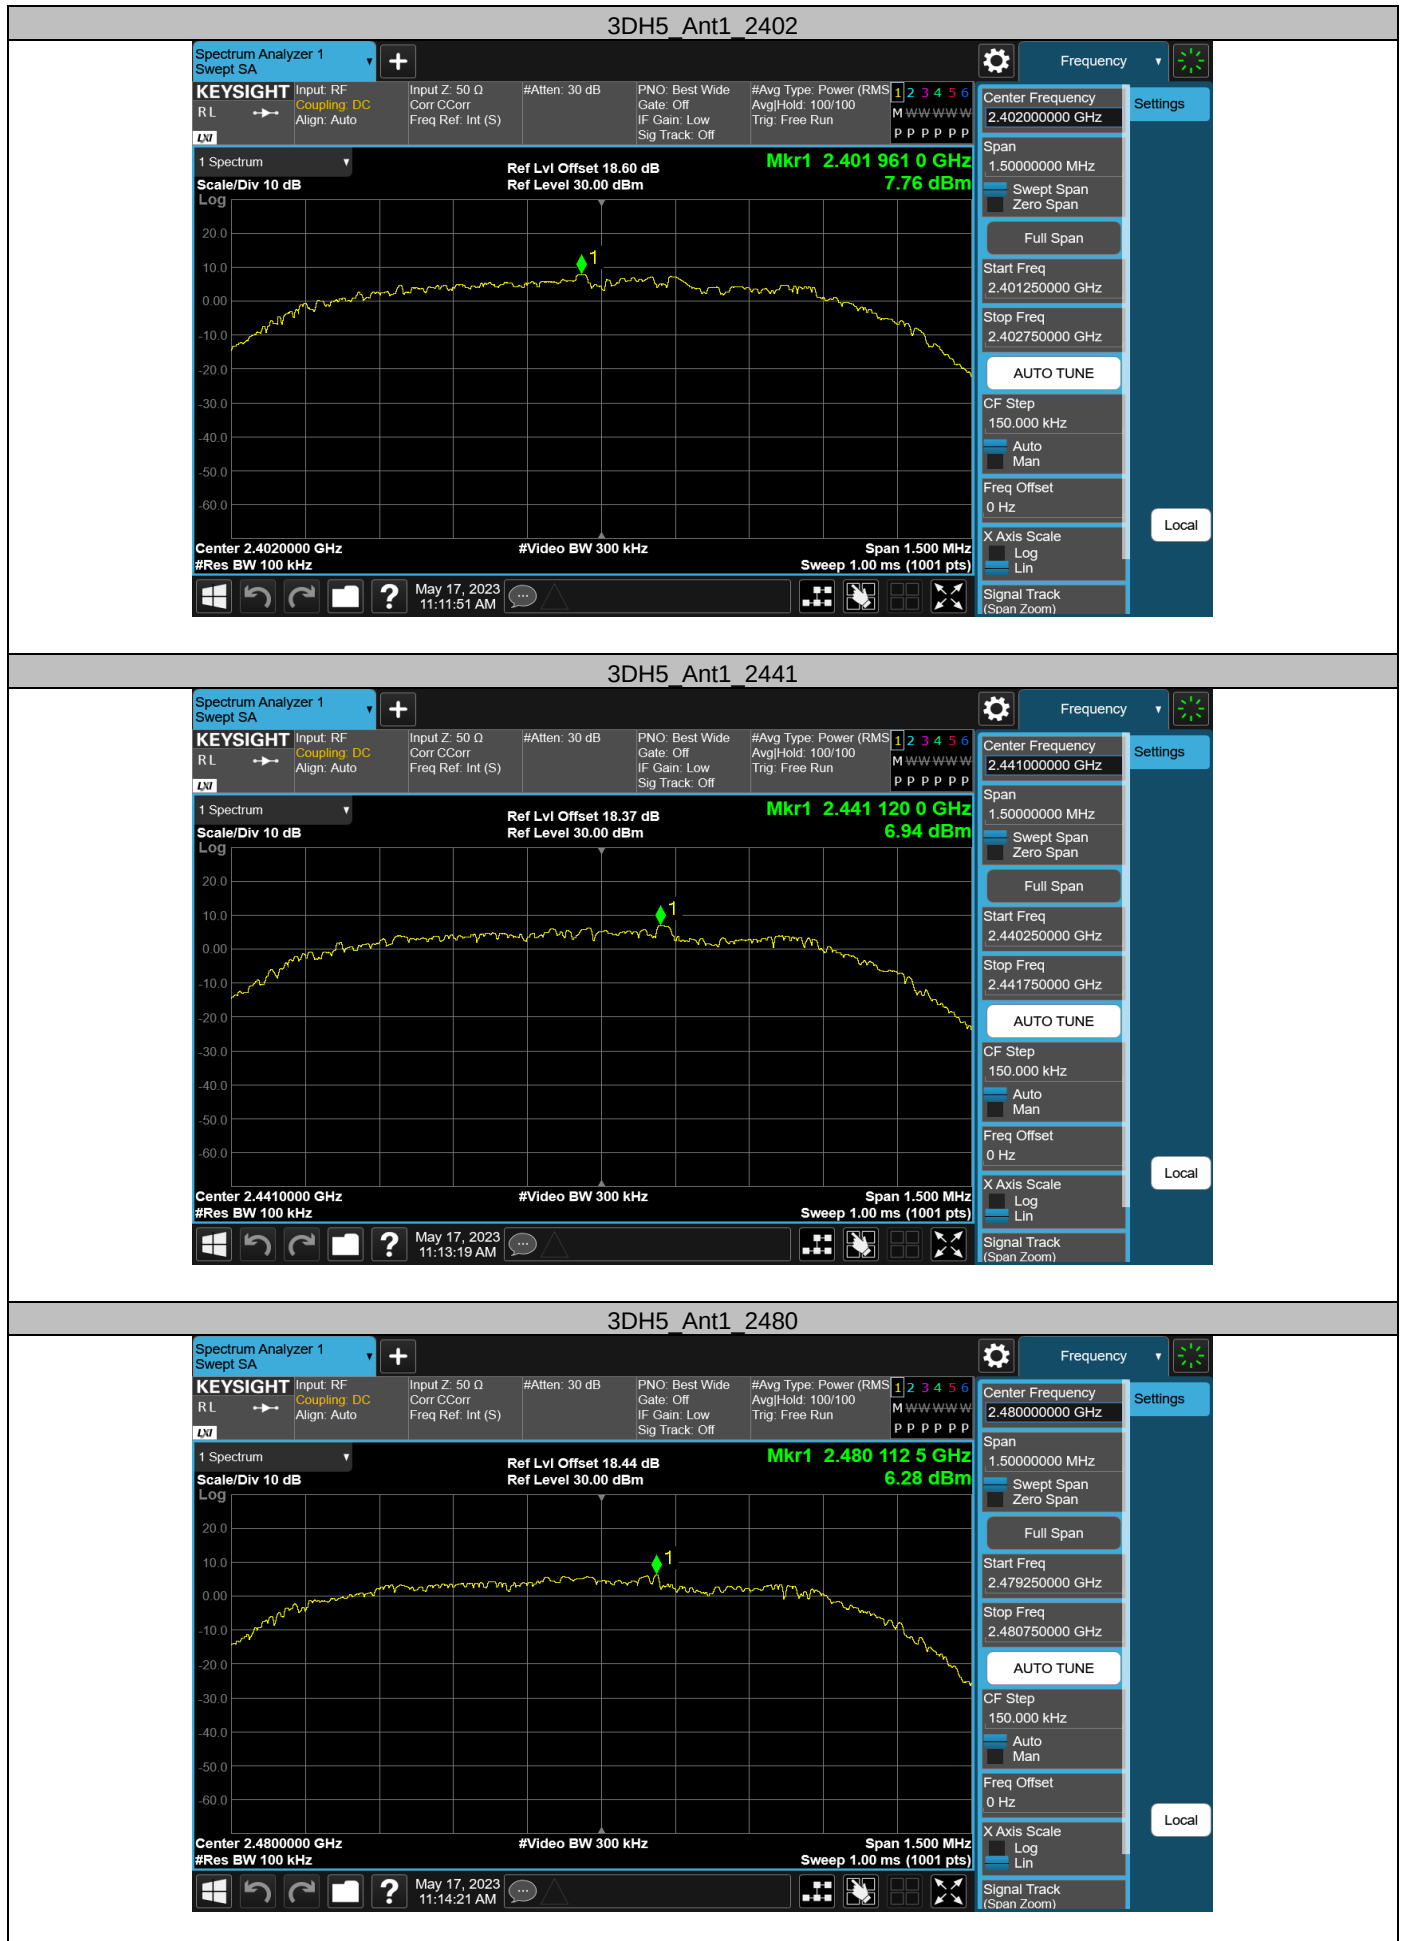
## Test Graphs

| Test Mode | Antenna | Freq(MHz) | Max.Point[MHz] | Result[dBm] |
| DH5 | Ant1 | 2402 | 2402.02 | 10.19 |
| | | 2441 | 2441.01 | 9.33 |
| | | 2480 | 2480.11 | 9.87 |
| 2DH5 | Ant1 | 2402 | 2401.82 | 7.08 |
| | | 2441 | 2440.97 | 6.86 |
| | | 2480 | 2480.11 | 6.25 |
| 3DH5 | Ant1 | 2402 | 2401.96 | 7.76 |
| | | 2441 | 2441.12 | 6.94 |
| | | 2480 | 2480.11 | 6.28 |

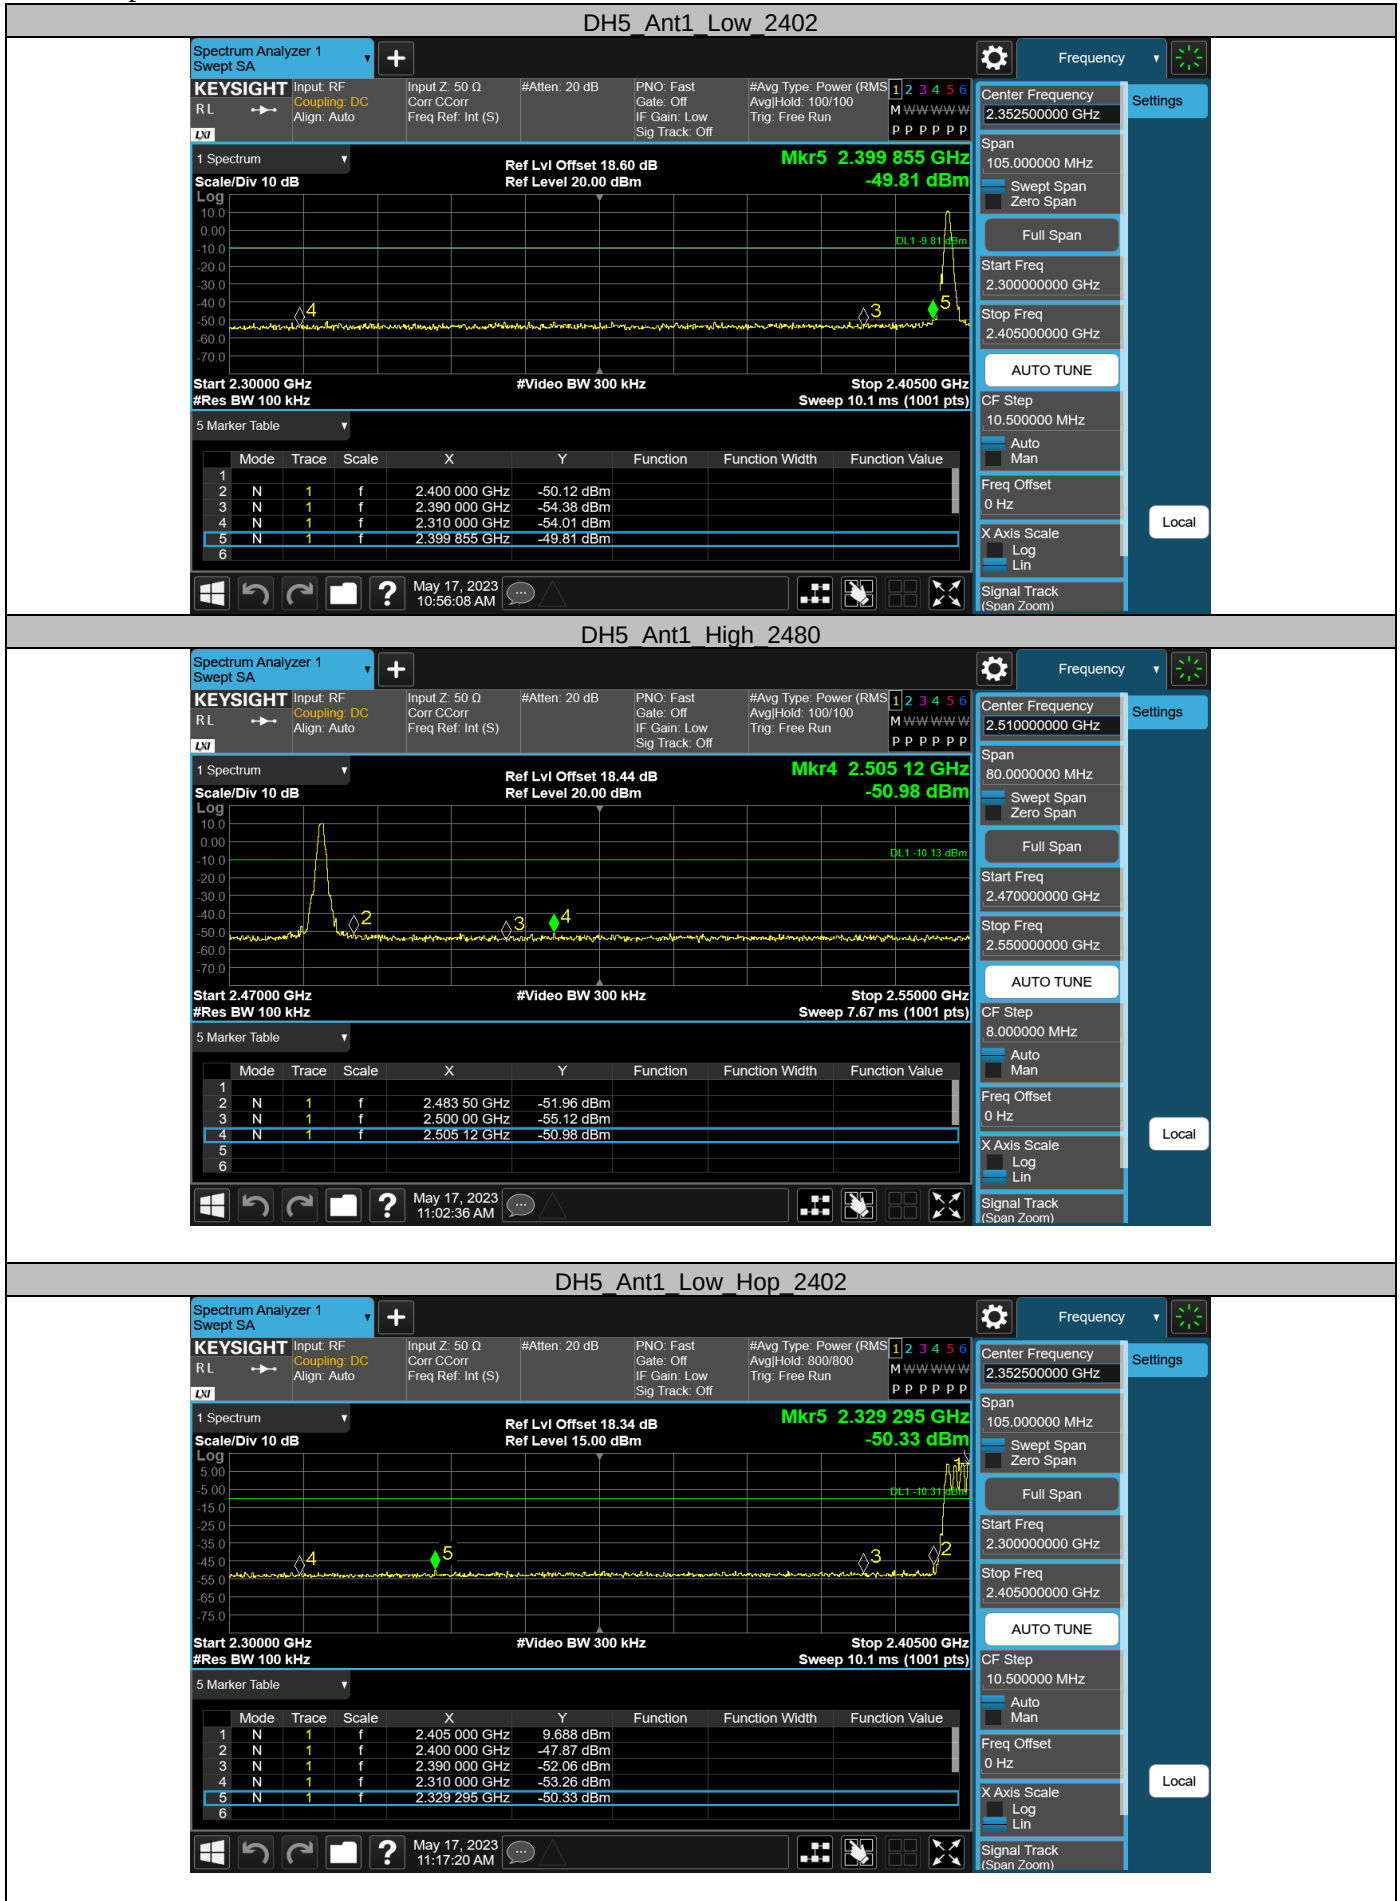
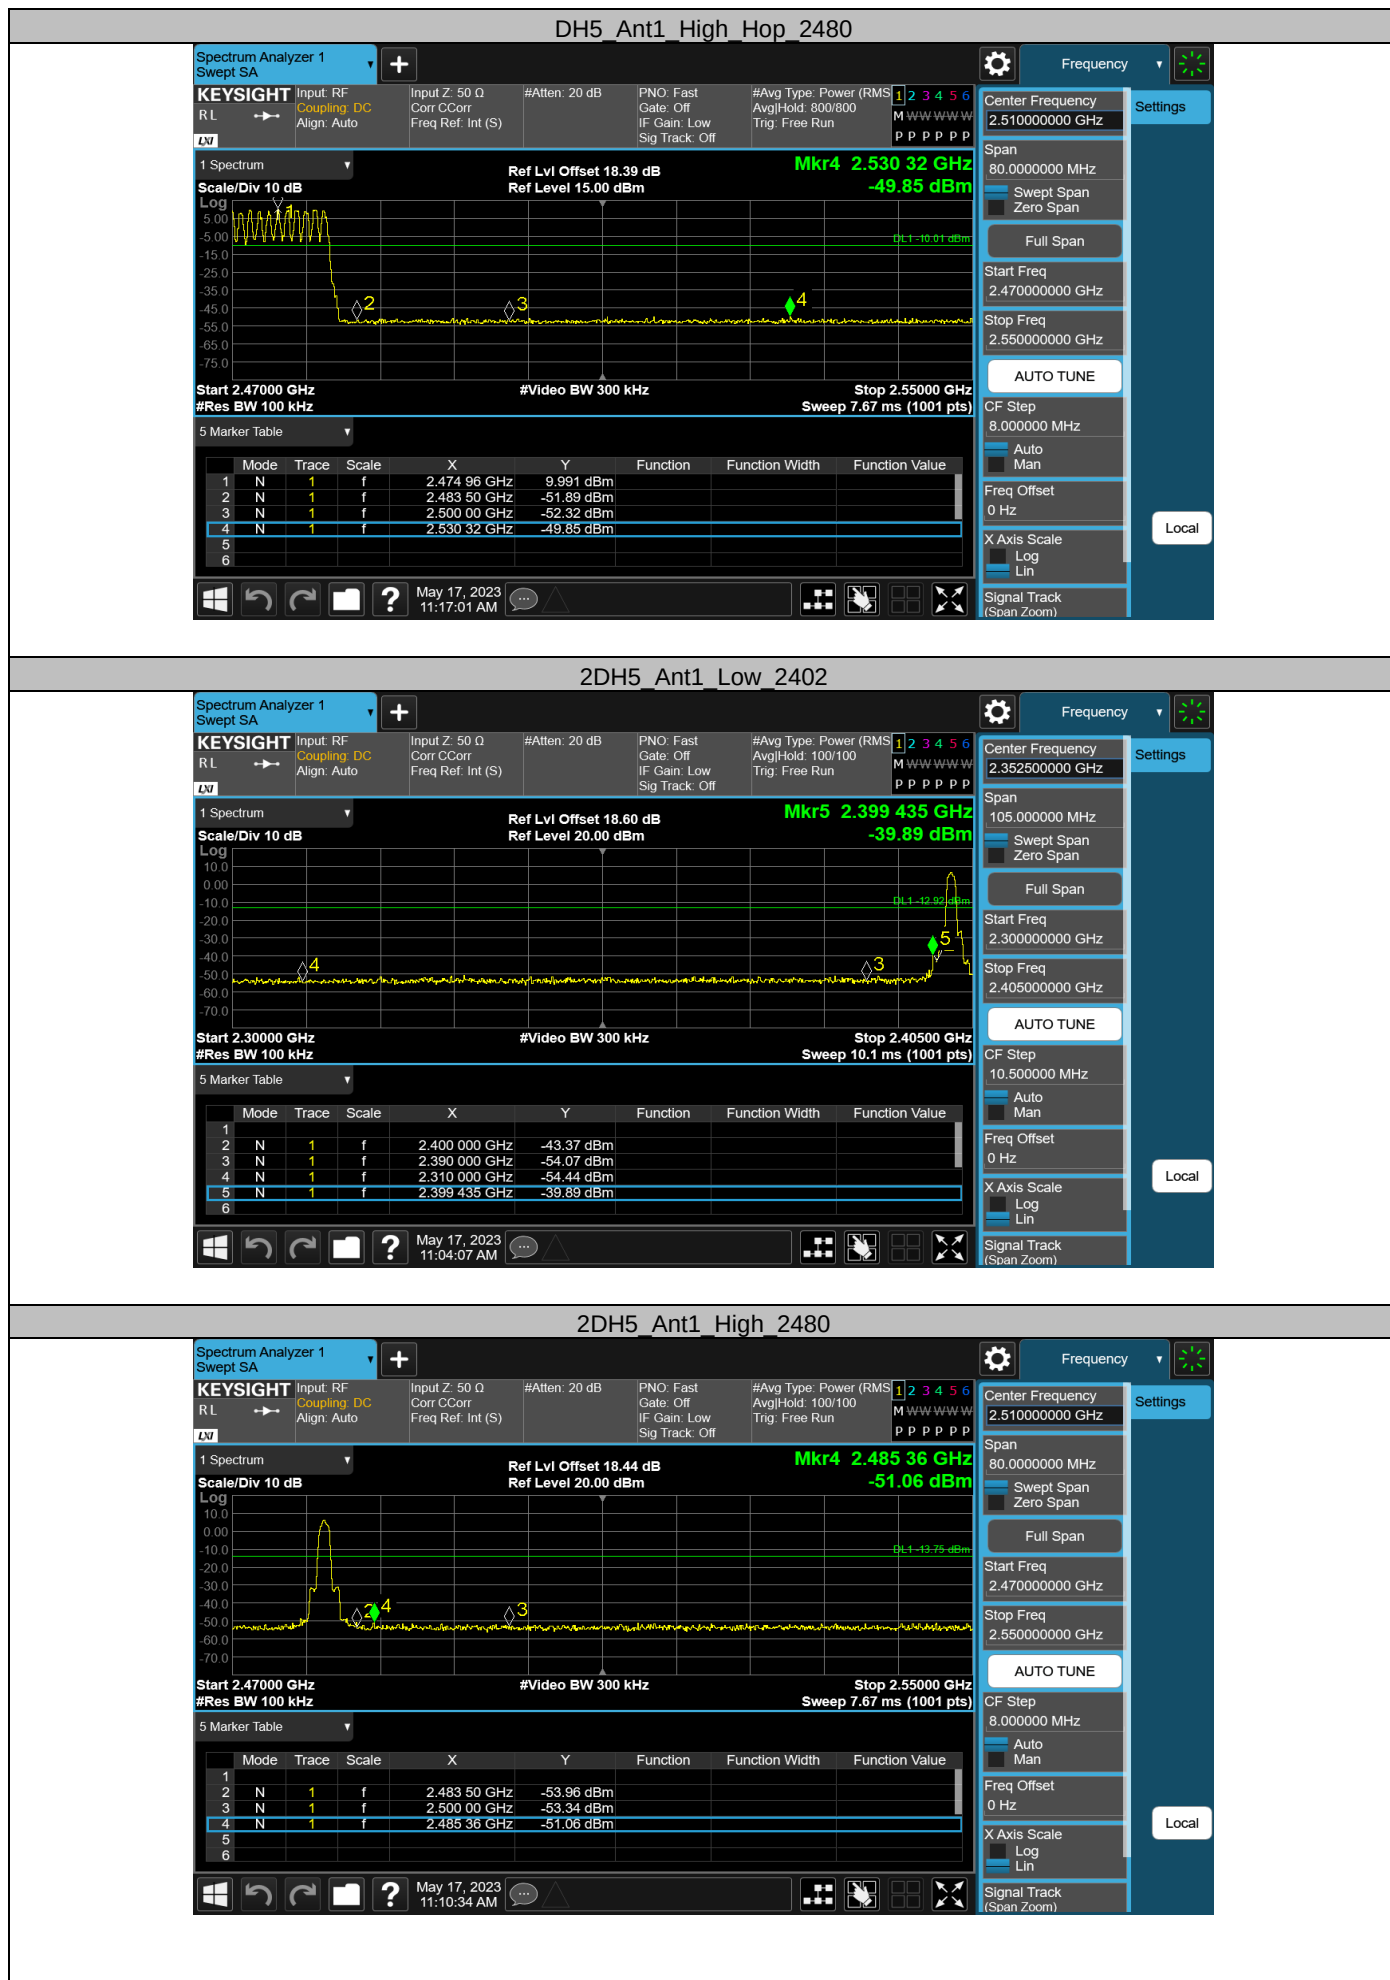
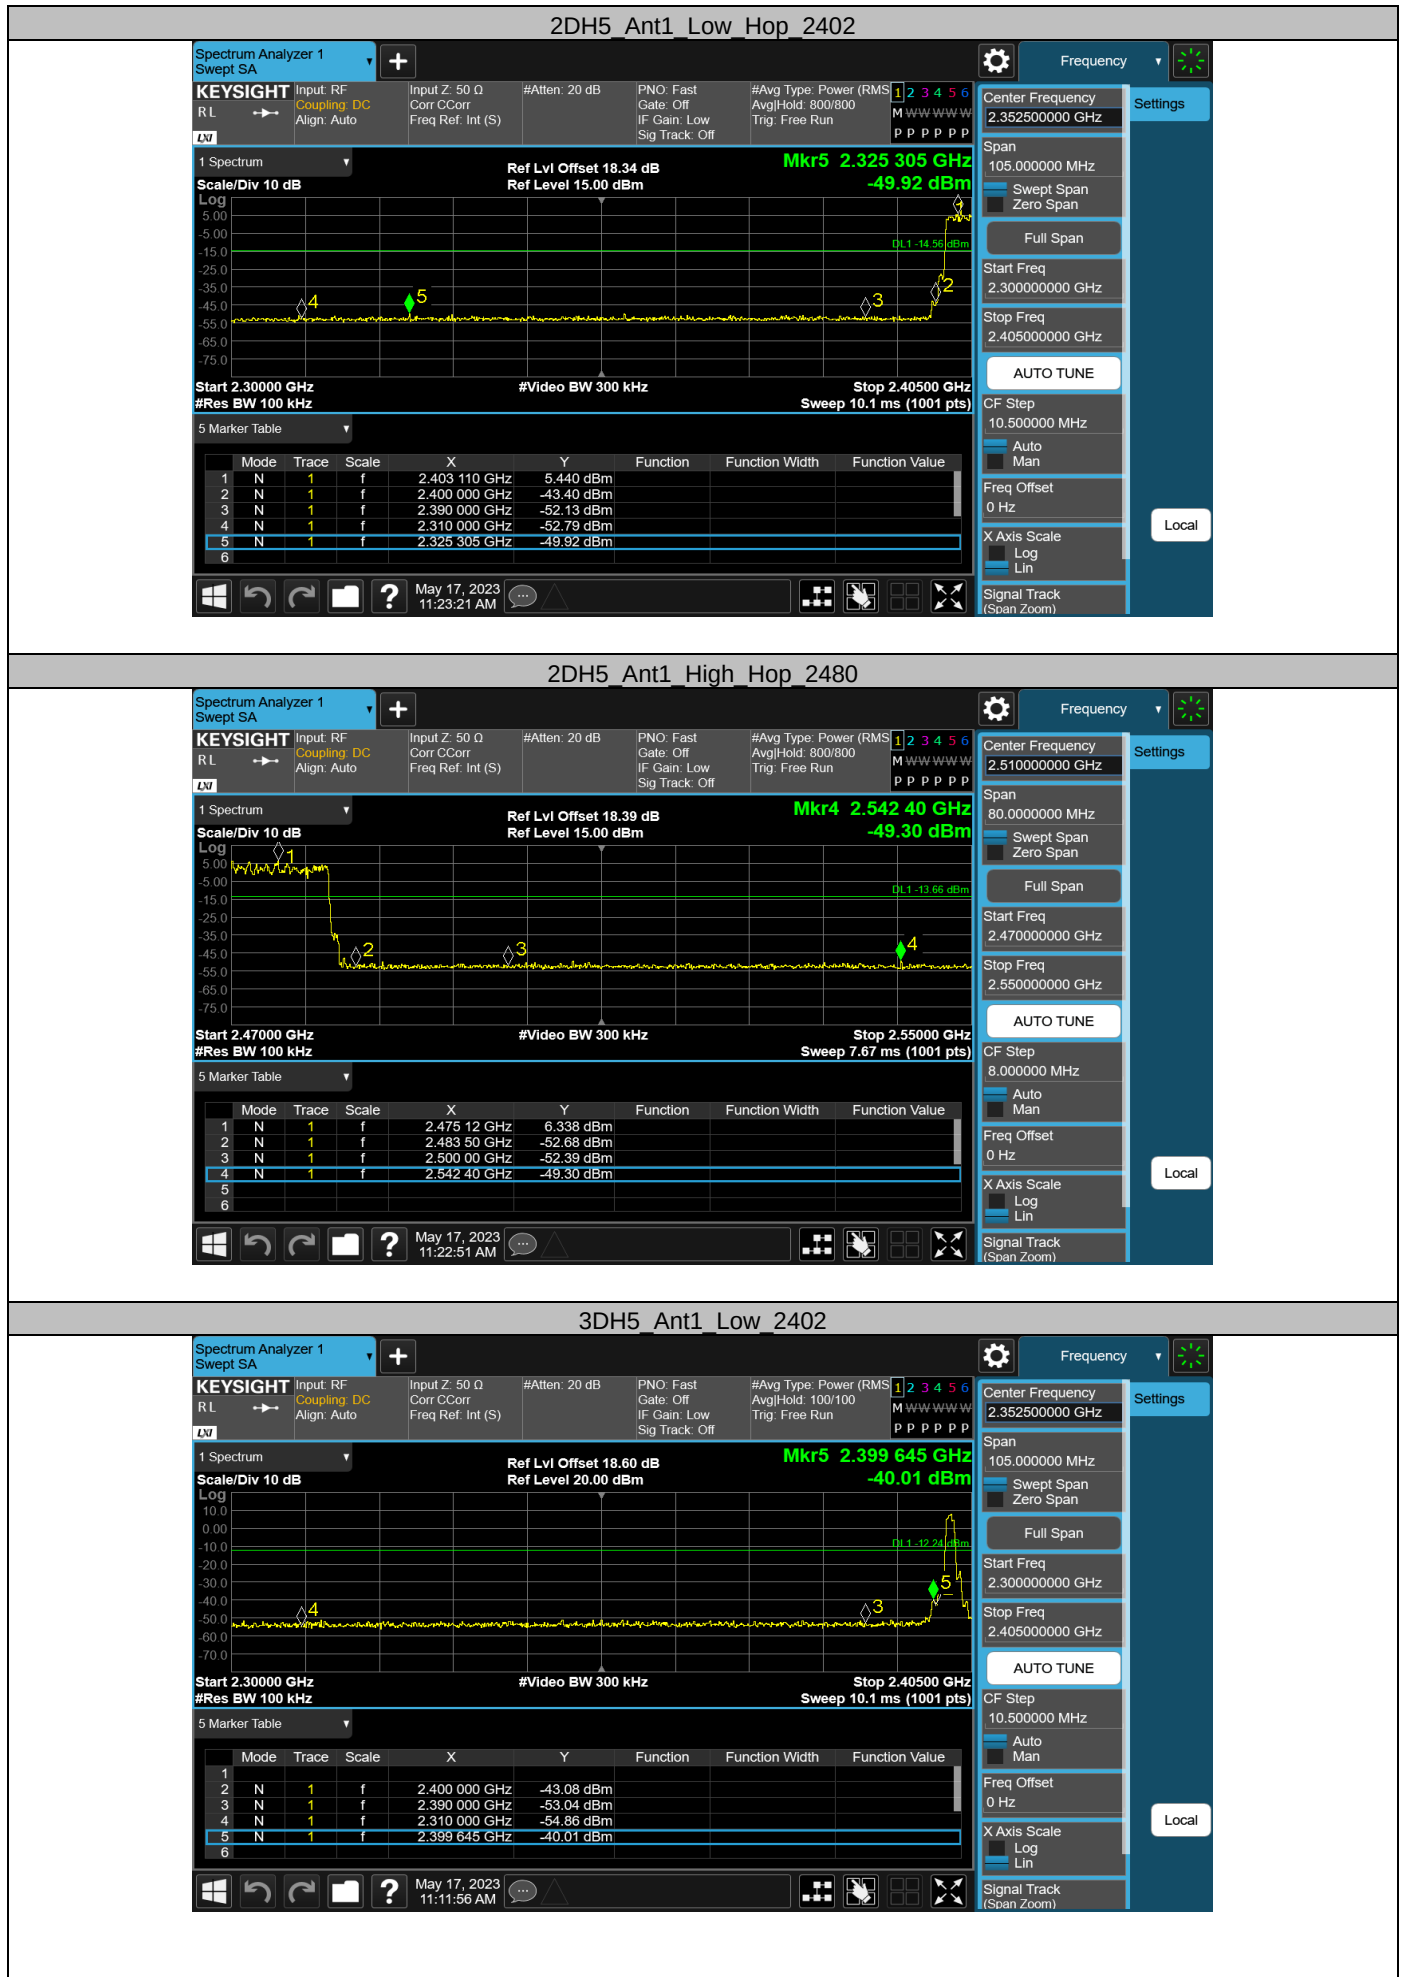
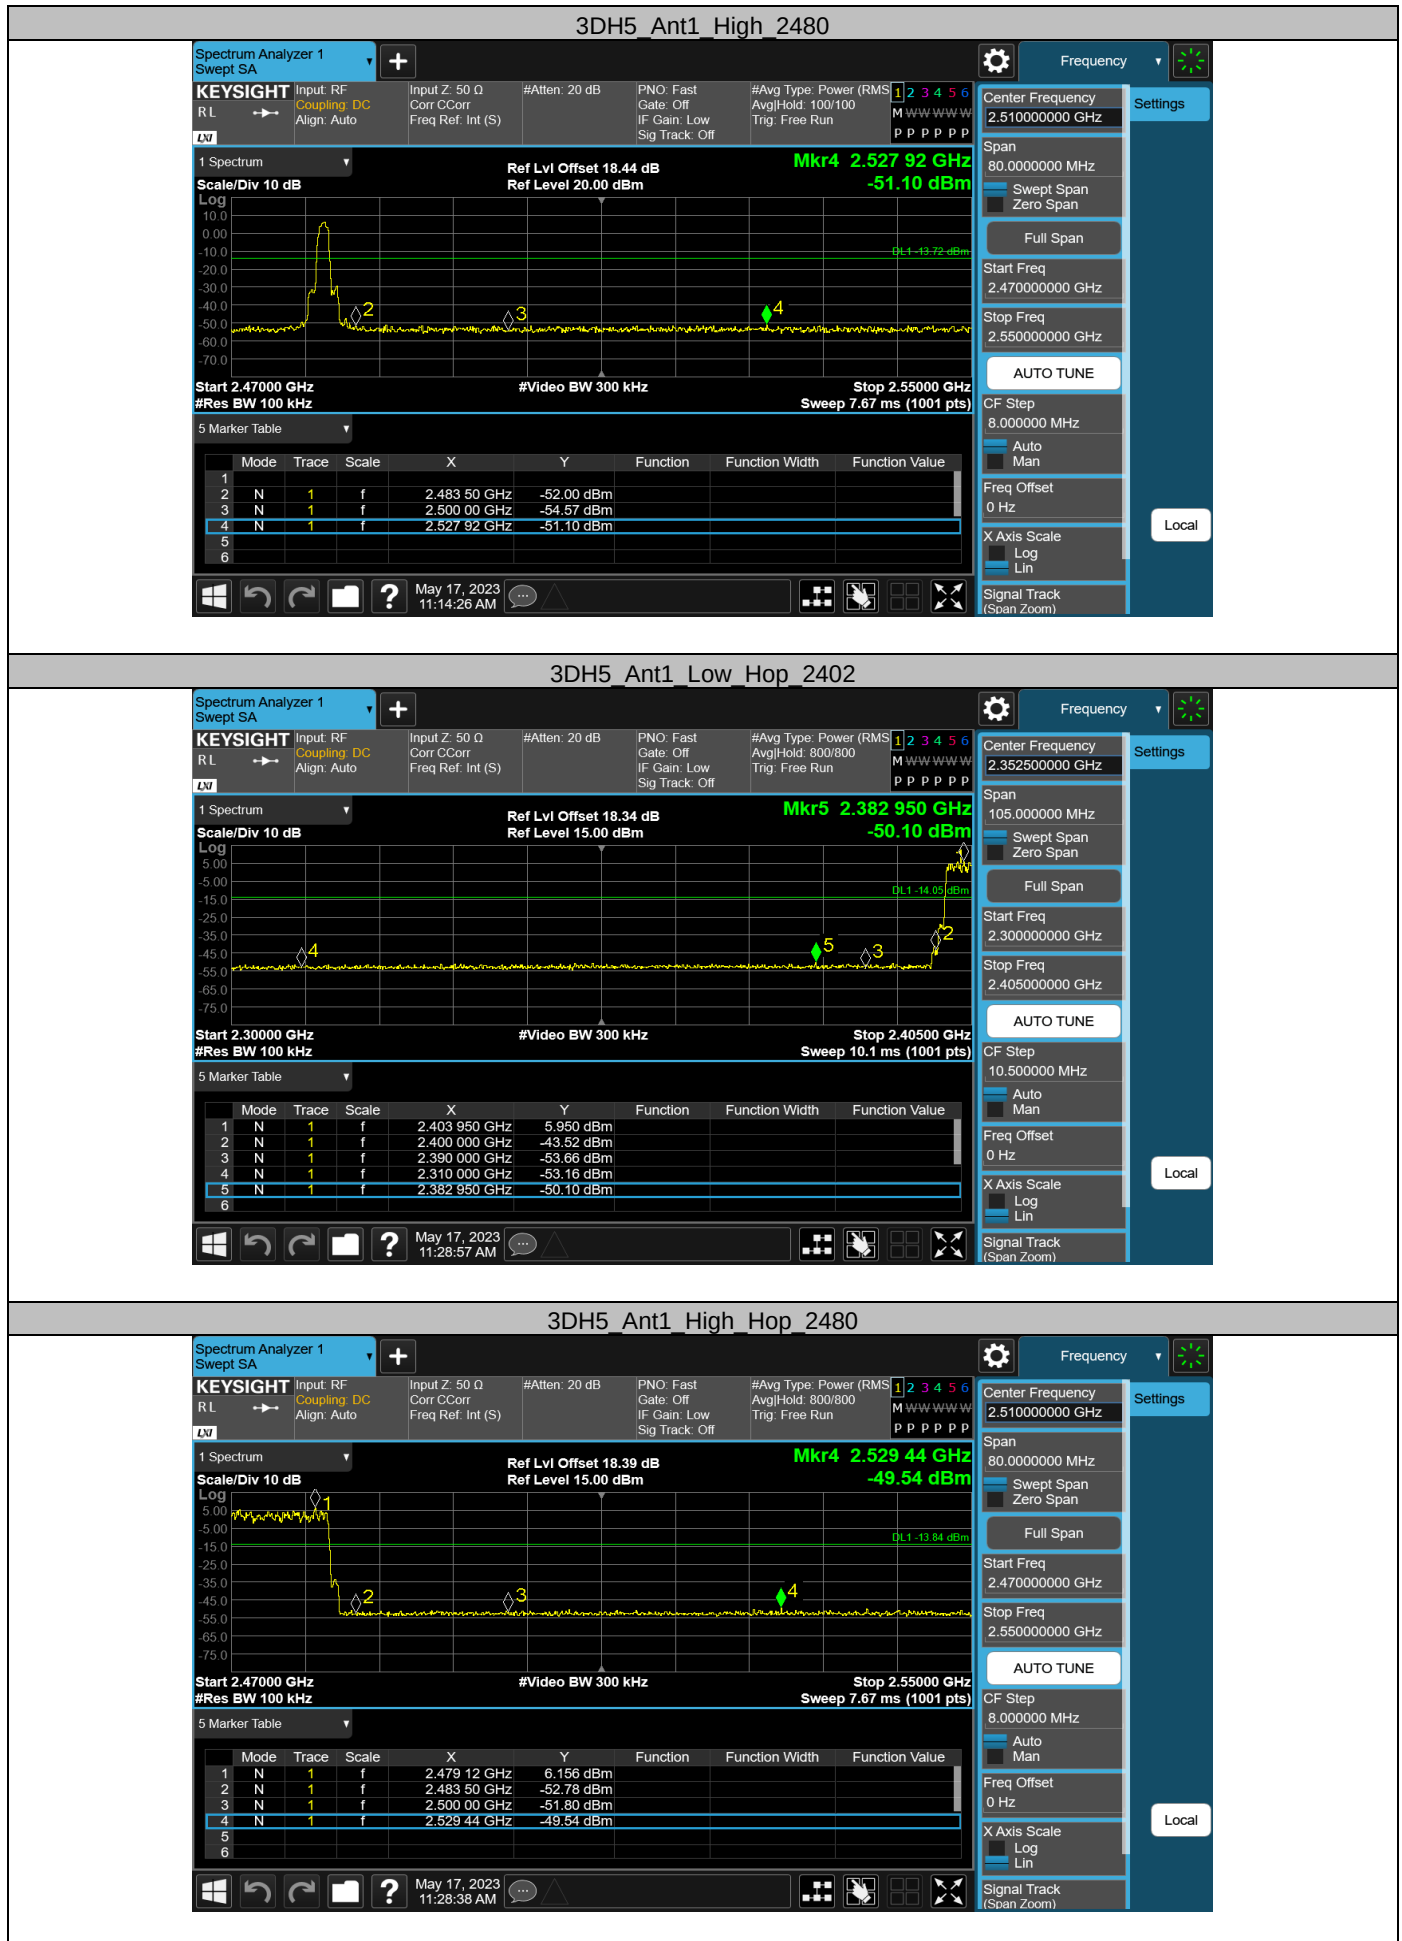
## Test Graphs

| Test Mode | Antenna | Ch Name | Freq(MHz) | Ref Level [dBm] | Result [dBm] | Limit [dBm] | Verdict |
| DH5 | Ant1 | Low | 2402 | 10.19 | -49.81 | $\leq -9.81$ | PASS |
| | | High | 2480 | 9.87 | -50.98 | $\leq -10.13$ | PASS |
| | | Low | Hop_2402 | 9.69 | -50.33 | $\leq -10.31$ | PASS |
| | | High | Hop_2480 | 9.99 | -49.85 | $\leq -10.01$ | PASS |
| 2DH5 | Ant1 | Low | 2402 | 7.08 | -39.89 | $\leq -12.92$ | PASS |
| | | High | 2480 | 6.25 | -51.06 | $\leq -13.75$ | PASS |
| | | Low | Hop_2402 | 5.44 | -49.92 | $\leq -14.56$ | PASS |
| | | High | Hop_2480 | 6.34 | -49.3 | $\leq -13.66$ | PASS |
| 3DH5 | Ant1 | Low | 2402 | 7.76 | -40.01 | $\leq -12.24$ | PASS |
| | | High | 2480 | 6.28 | -51.1 | $\leq -13.72$ | PASS |
| | | Low | Hop_2402 | 5.95 | -50.1 | $\leq -14.05$ | PASS |
| | | High | Hop_2480 | 6.16 | -49.54 | $\leq -13.84$ | PASS |
