## Appendix F: Reference level measurement

## Appendix G: Band edge measurements

## Appendix H: Conducted Spurious Emission Test Result

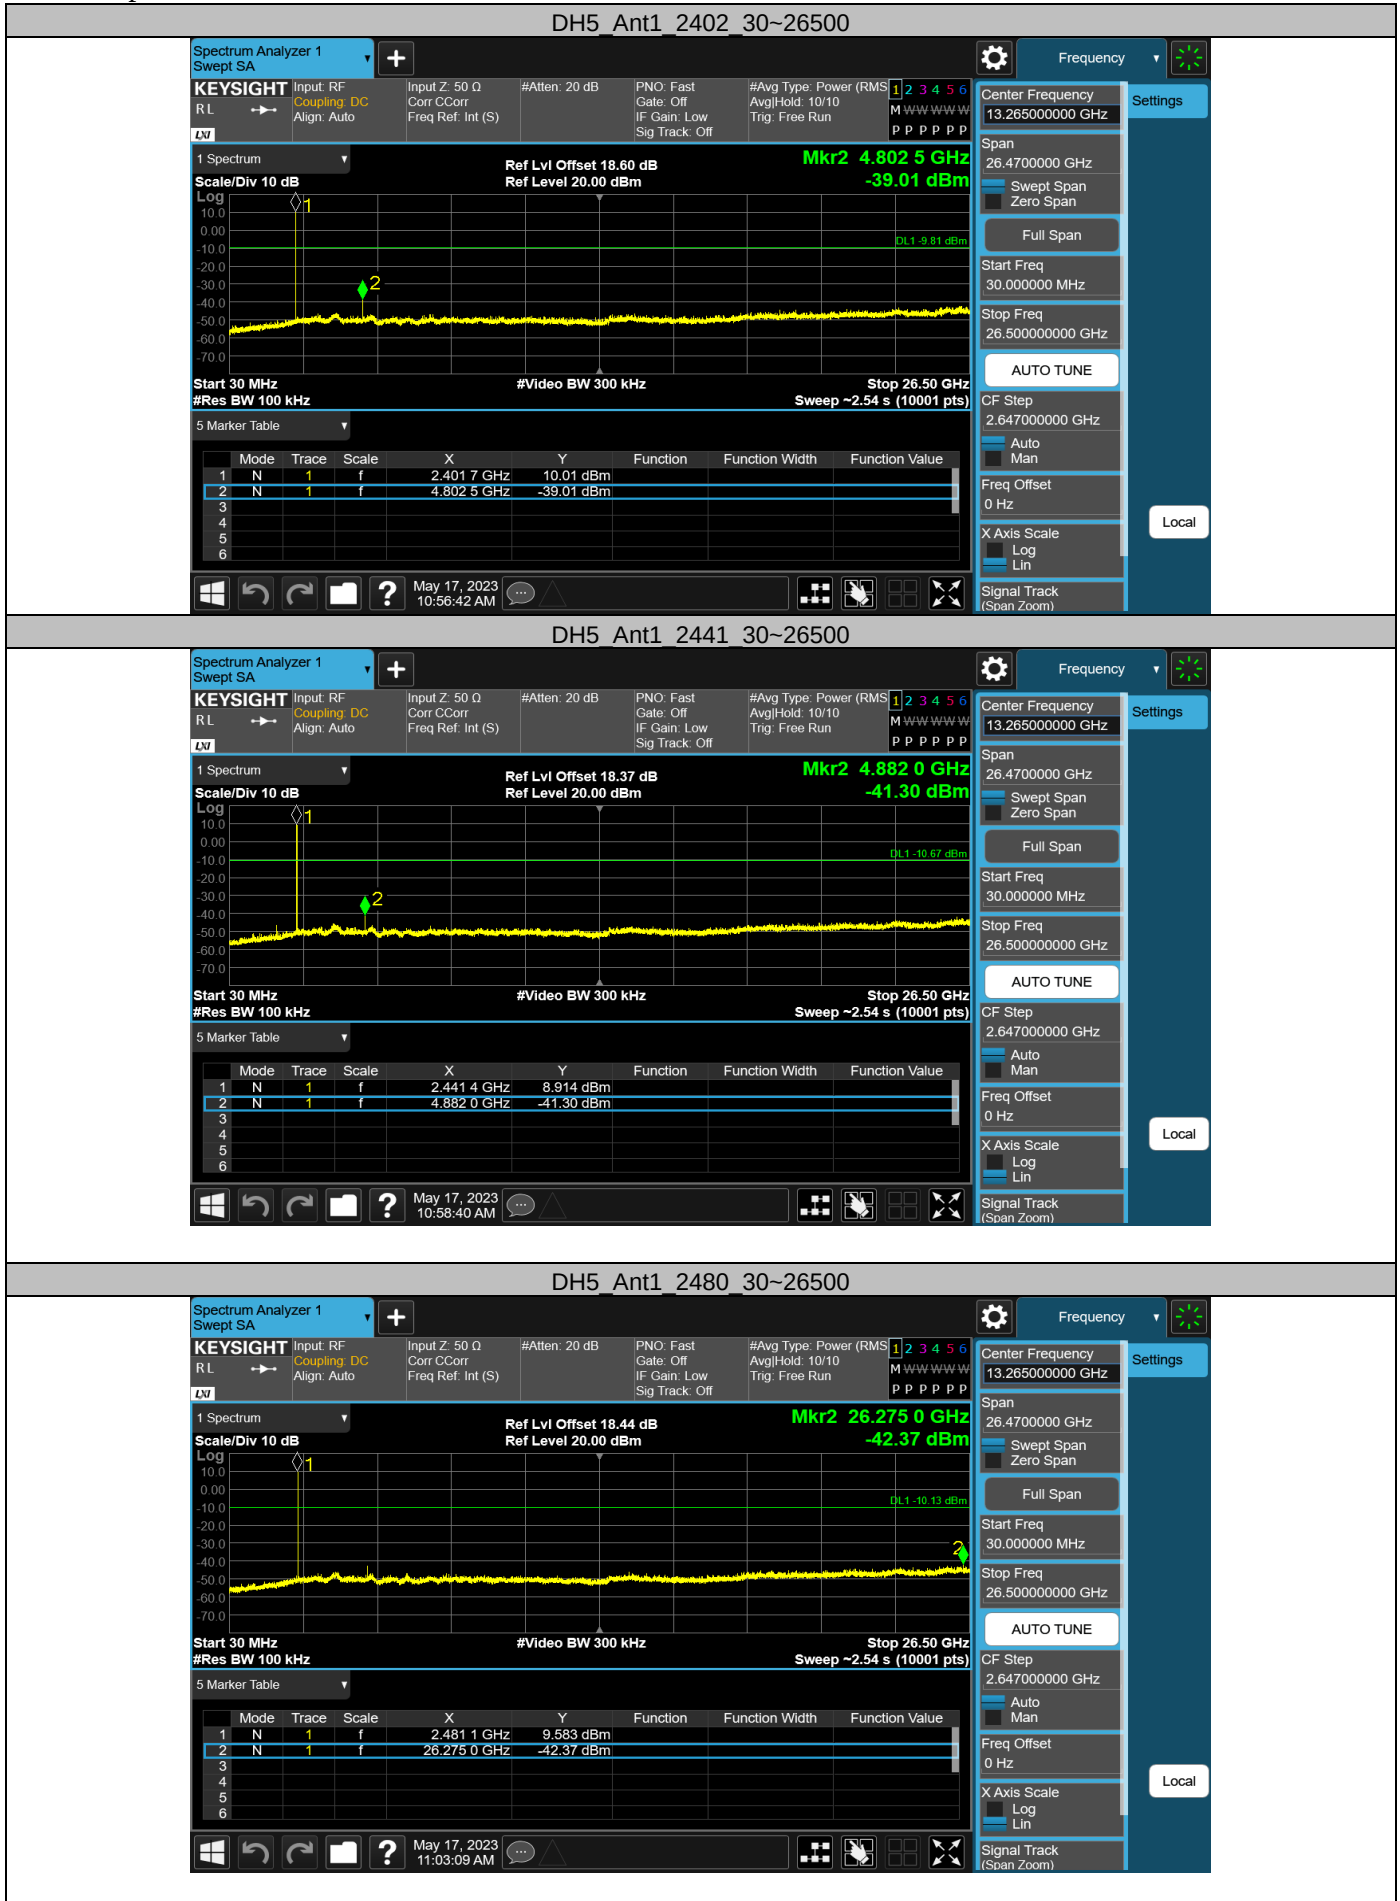
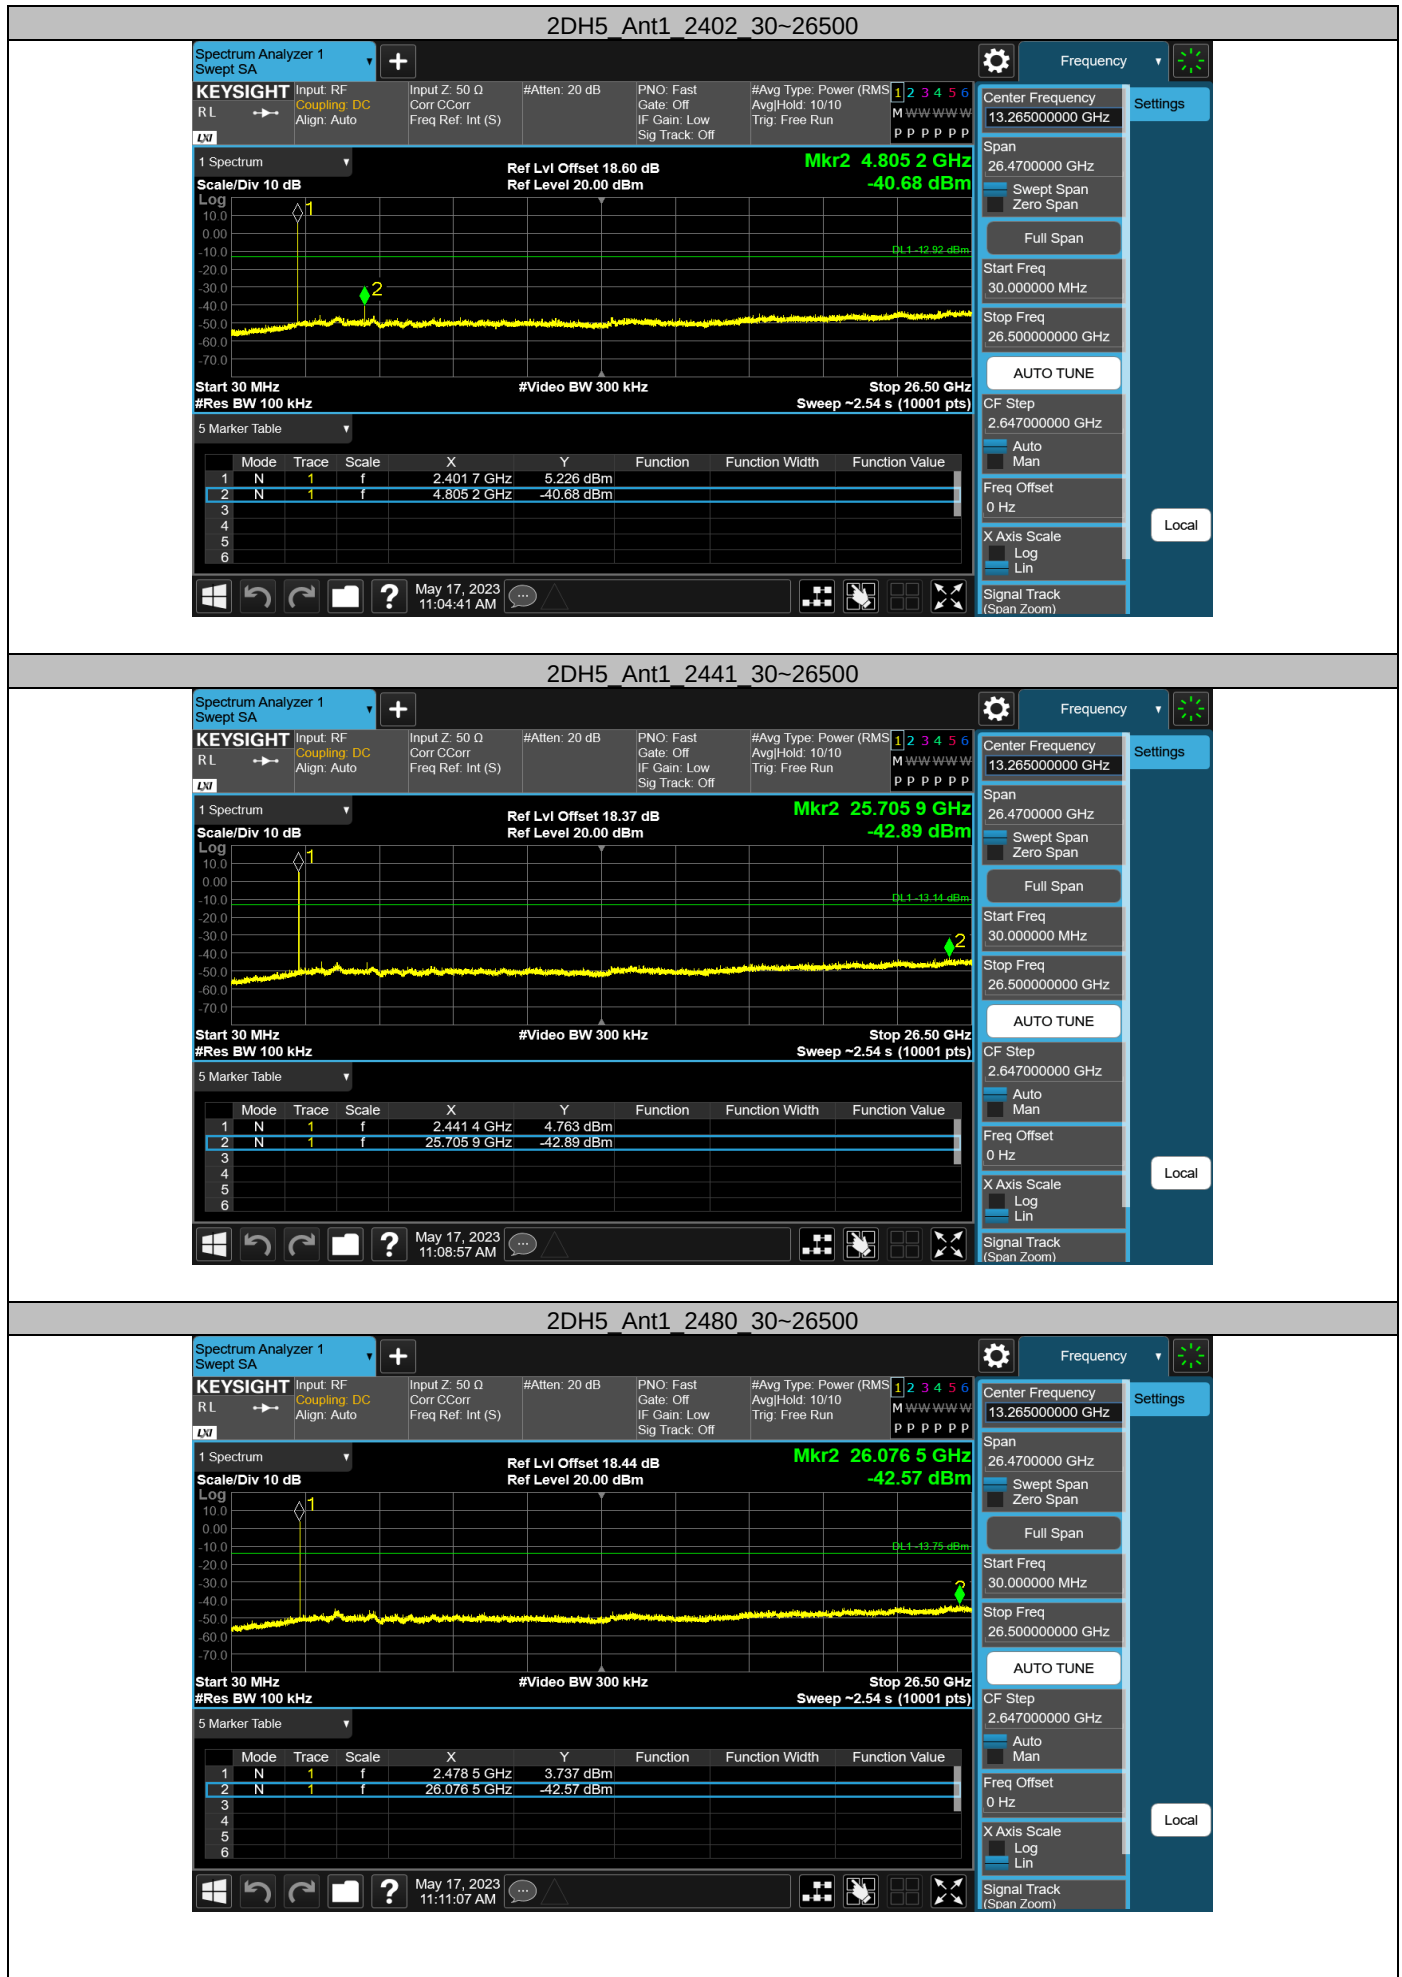
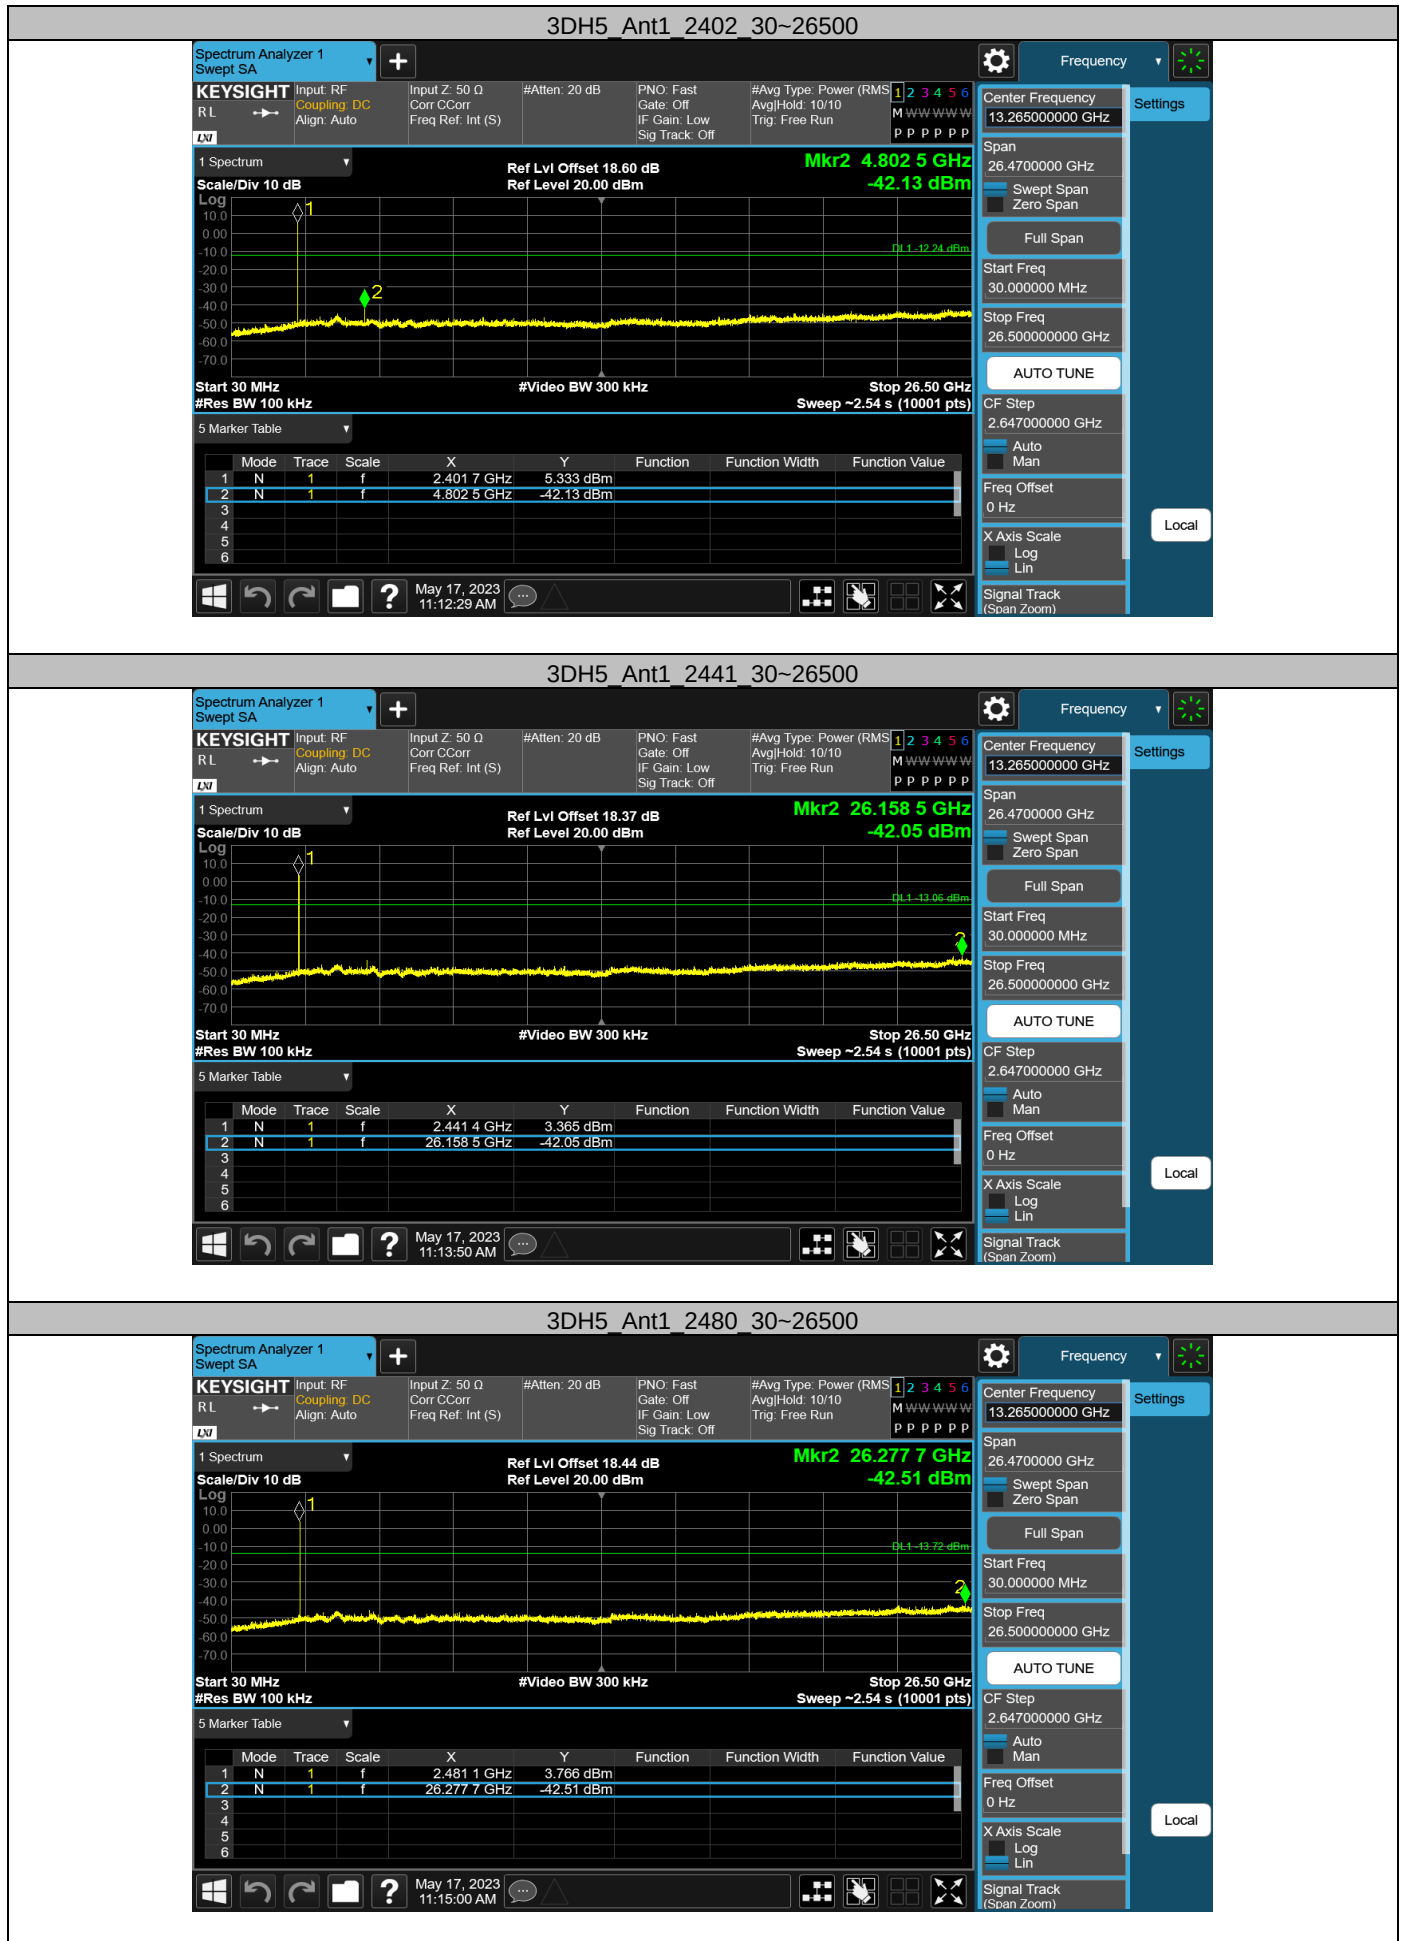
## Test Graphs

| Test Mode | Antenna | Freq(MHz) | Freq Range [MHz] | Ref Level [dBm] | Result [dBm] | Limit [dBm] | Verdict |
| DH5 | Ant1 | 2402 | 30~26500 | 10.19 | -39.01 | $\leq -9.81$ | PASS |
| | | 2441 | 30~26500 | 9.33 | -41.3 | $\leq -10.67$ | PASS |
| | | 2480 | 30~26500 | 9.87 | -42.37 | $\leq -10.13$ | PASS |
| 2DH5 | Ant1 | 2402 | 30~26500 | 7.08 | -40.68 | $\leq -12.92$ | PASS |
| | | 2441 | 30~26500 | 6.86 | -42.89 | $\leq -13.14$ | PASS |
| | | 2480 | 30~26500 | 6.25 | -42.57 | $\leq -13.75$ | PASS |
| 3DH5 | Ant1 | 2402 | 30~26500 | 7.76 | -42.14 | $\leq -12.24$ | PASS |
| | | 2441 | 30~26500 | 6.94 | -42.05 | $\leq -13.06$ | PASS |
| | | 2480 | 30~26500 | 6.28 | -42.51 | $\leq -13.72$ | PASS |

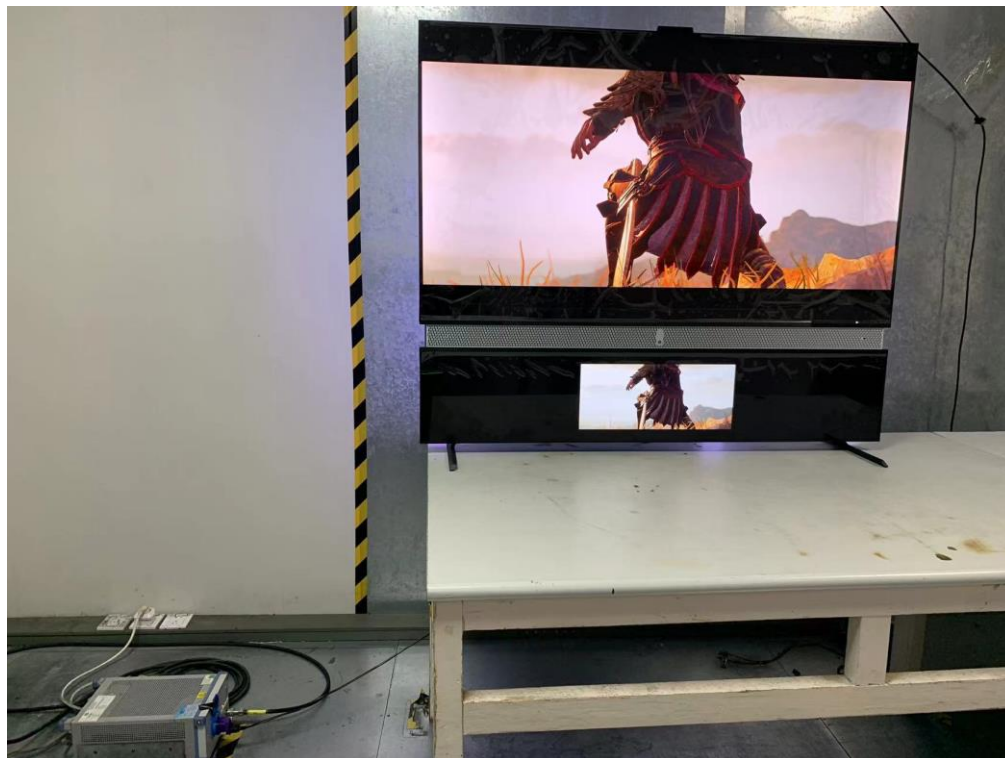
Conducted Test

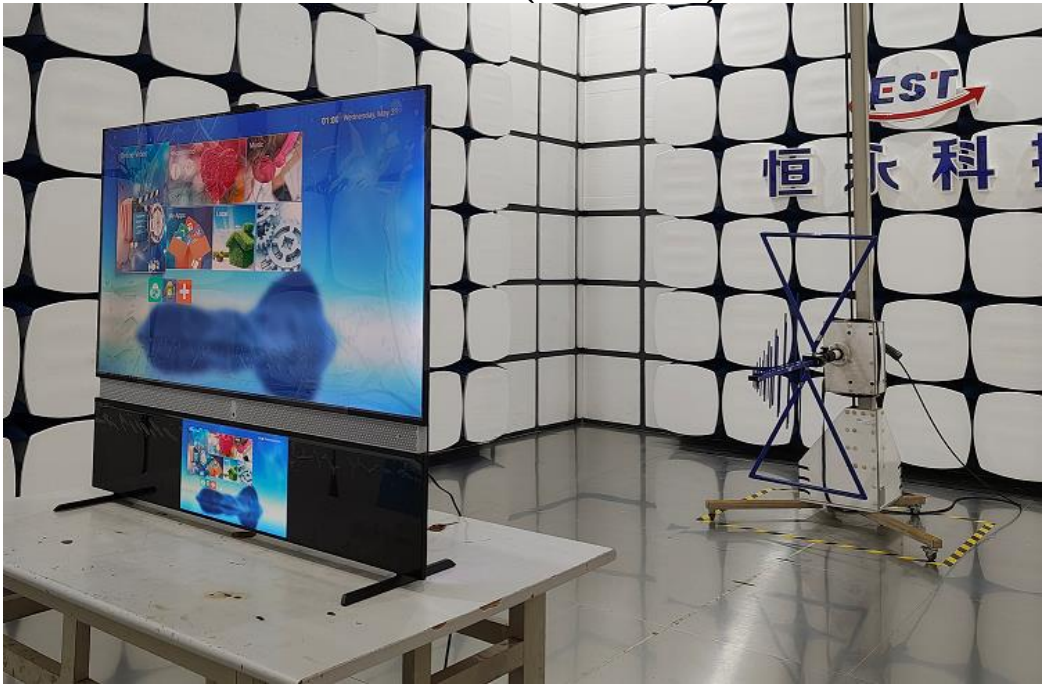
**Radiated Test (Below 1GHz)**

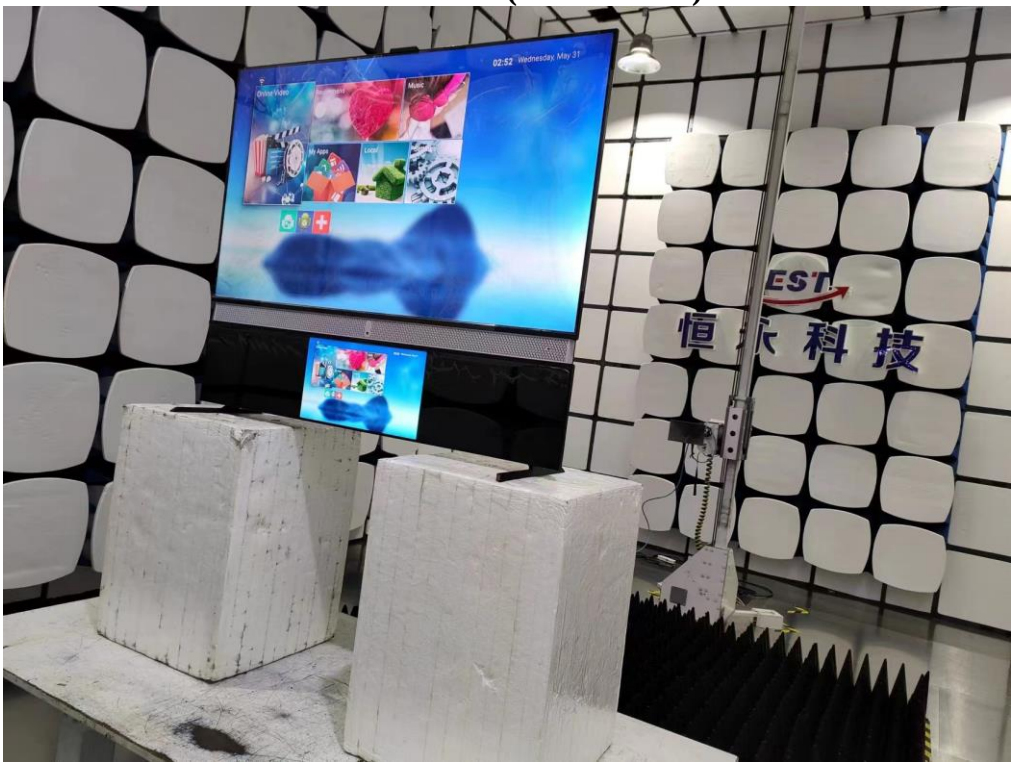
**Radiated Test (Above 1GHz)**
