# Antenna Test Report

Customer	Yinbei qi (Shenzhen) Technology Co., Ltd.
Project	YINPAGE Free 1
address	1609-1, Building A, Bantian International Center No. 5 Huancheng South Road, Ma'an Tang Community Longgang District, Shenzhen
Prepared by	15993920520
Checked by	17279710721
Date :	2023. 09. 06

This report is to measure the performance of antenna for YINPAGE Free 1The antenna operating frequency at 2400MHz0-2500MHz 。  
All test data are showed as below.

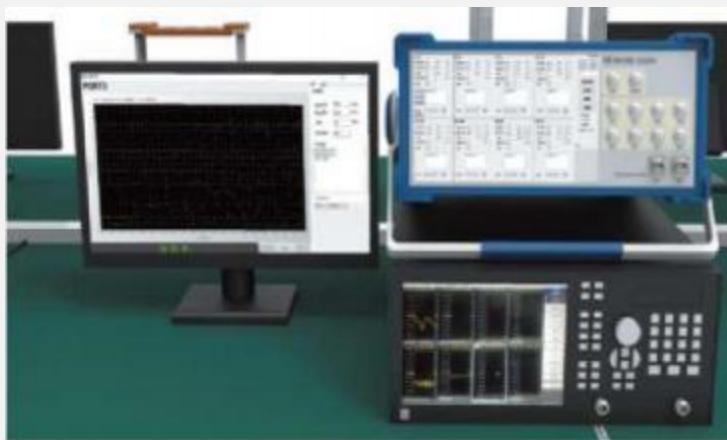
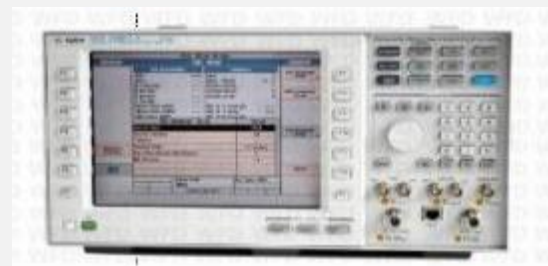
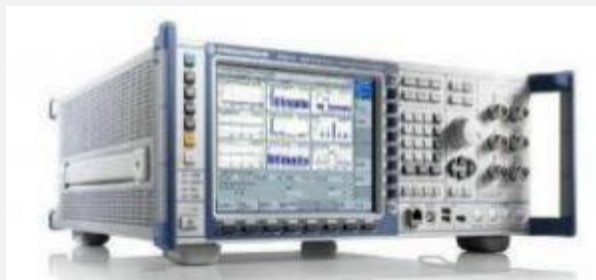
# 1. Test System

Sequence Number	Test Item	equipment
S parameter	VSWR	Agilent 5071C & Agilent 5071B
OTA Test	TRP&TIS	Agilent 8960 & CMW500 STIMO
Gain & Efficiency	Gain & Efficiency	SATIMO Agilent 5071C

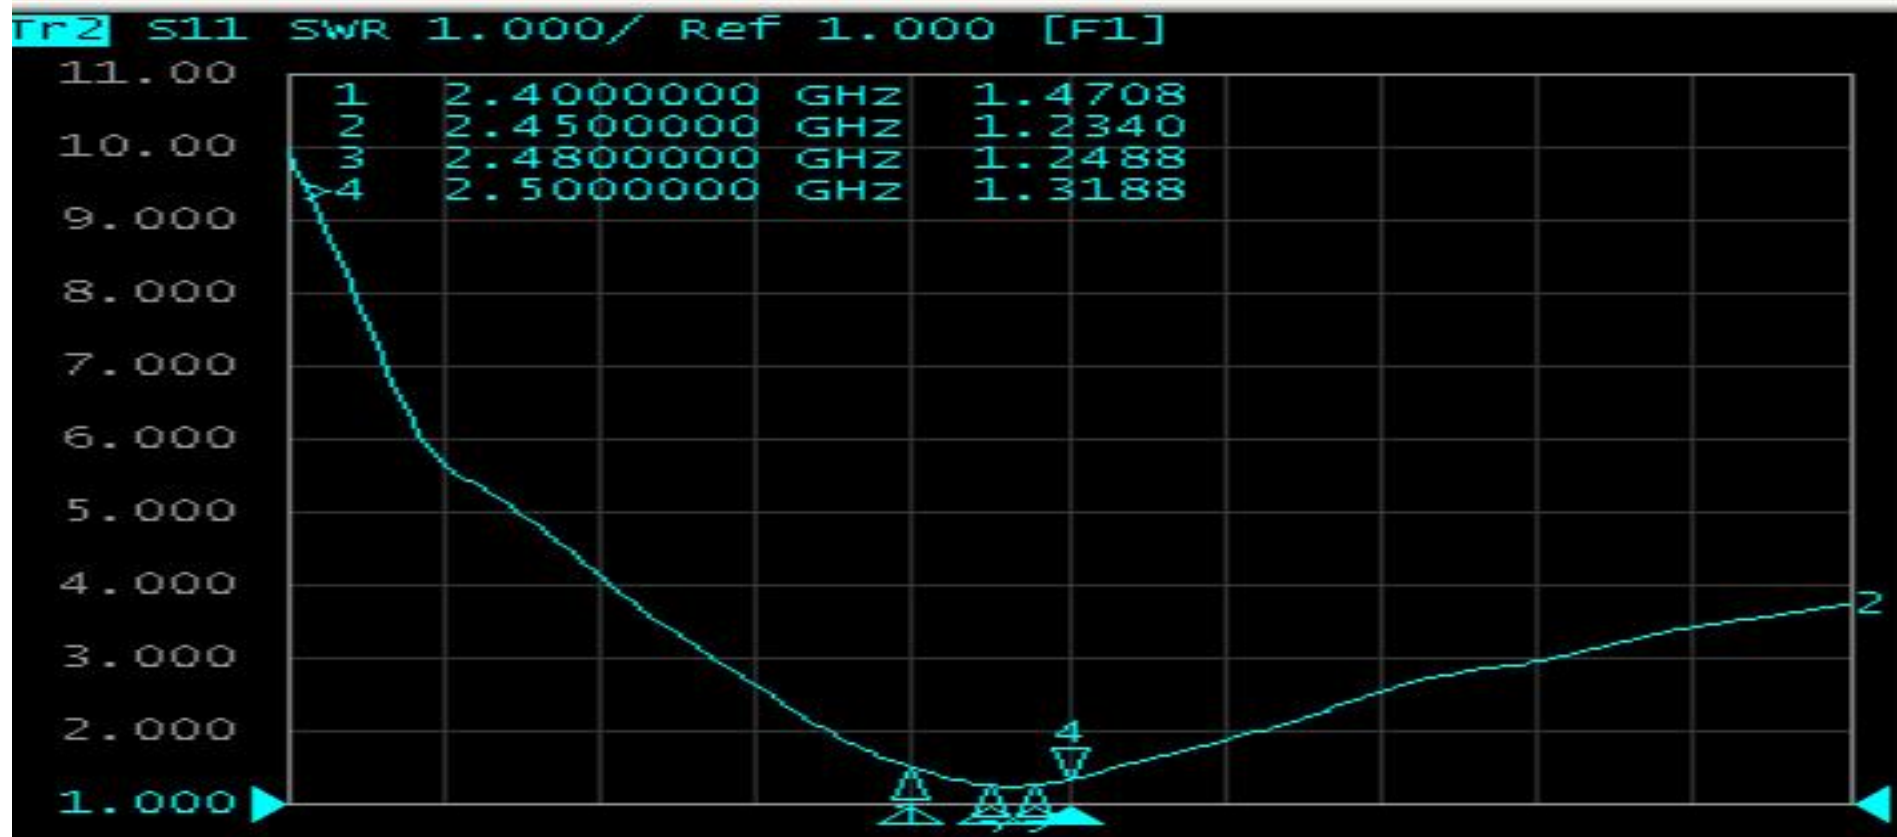
### 4.1 S11 Parameter-VSWR

Frequency (MHz)	2400	2450	2480	2500
VSWR	1.47	1.23	1.24	1.31

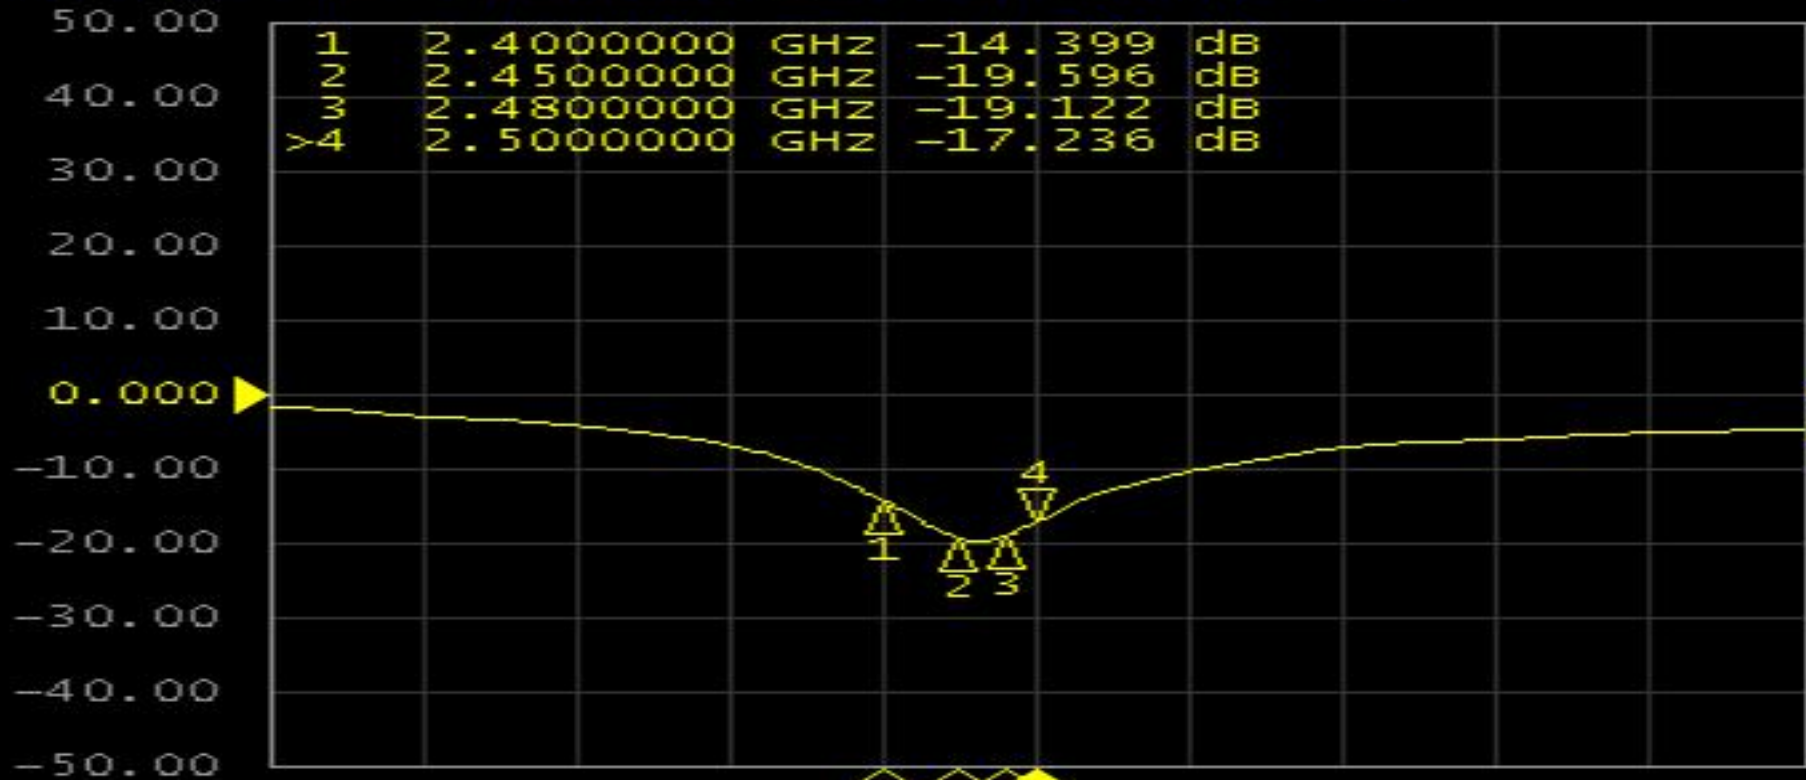
### 4.1 S11 Parameter-Log Mag

Tr1 S11 Log Mag 10.00dB/ Ref 0.000dB [F1]

Frequency (MHz)	2400	2450	2480	2500
Log Mag	-14.39	-19.59	-19.12	-17.23
