## APPENDIX F: SAR TEST SETUP PHOTOGRAPHS

<b>FCC ID</b> A3LGTI9505

<b>SAR EVALUATION REPORT</b>

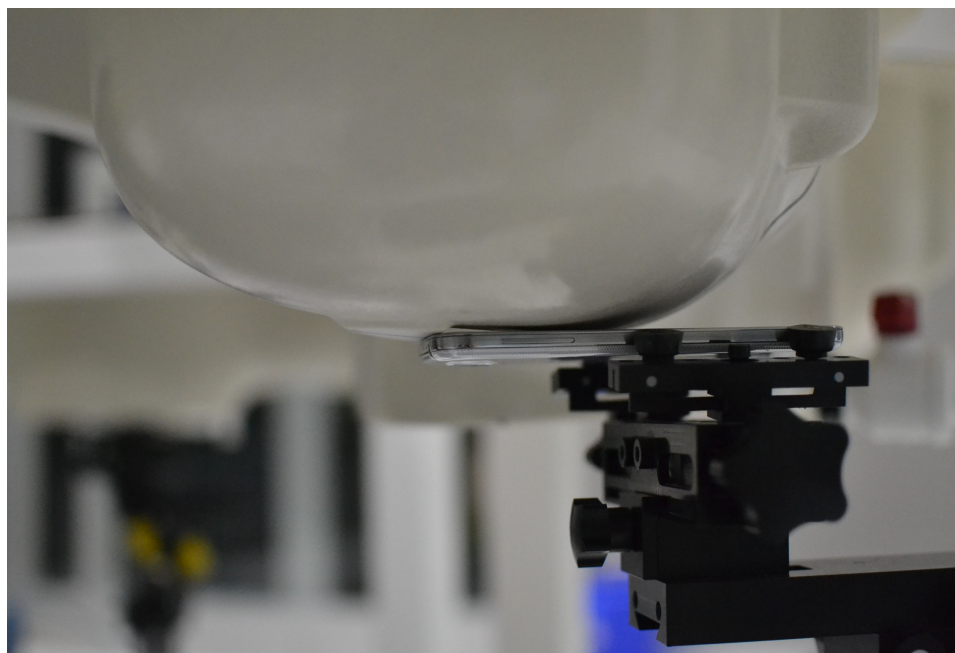
**SAR Test Setup Photo 1 – Right Cheek**

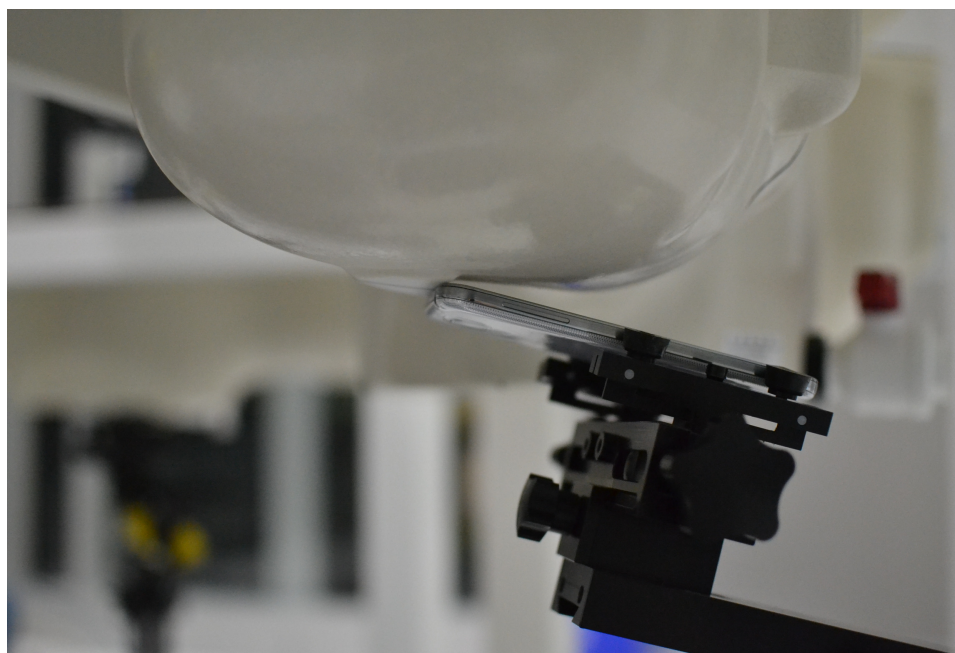
**SAR Test Setup Photo 2 – Right Tilt**

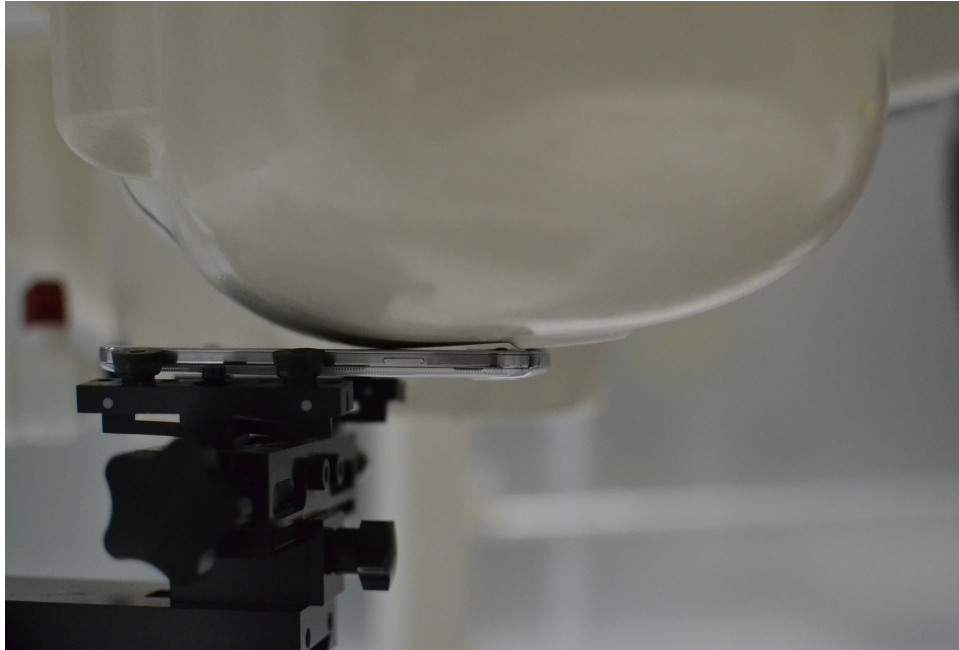
**SAR Test Setup Photo 3 – Left Cheek**

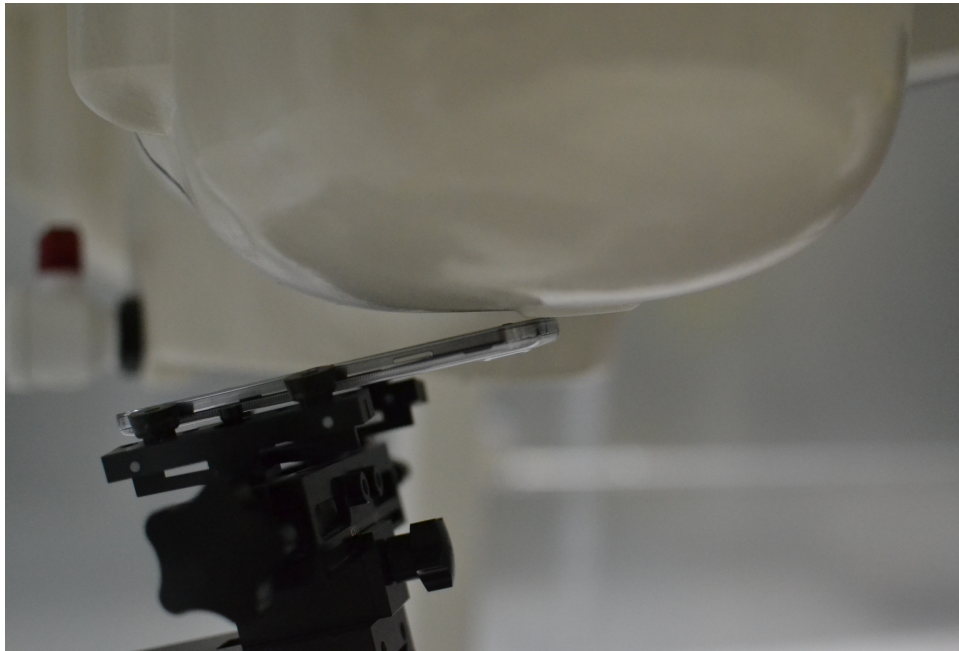
**SAR Test Setup Photo 4 – Left Tilt**

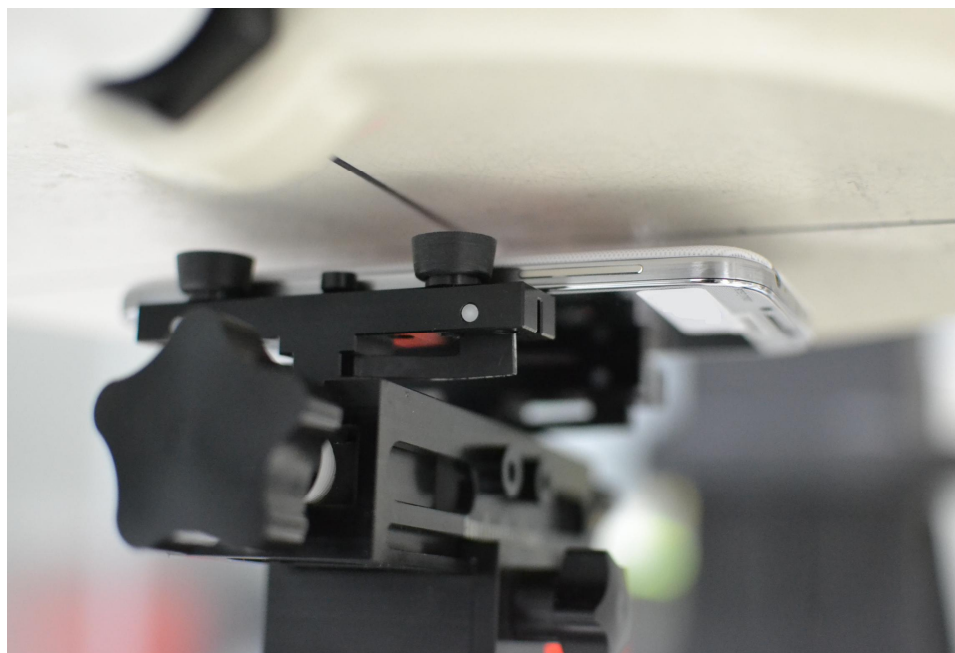
**SAR Test Setup Photo 5 – Back Side at 10 mm**

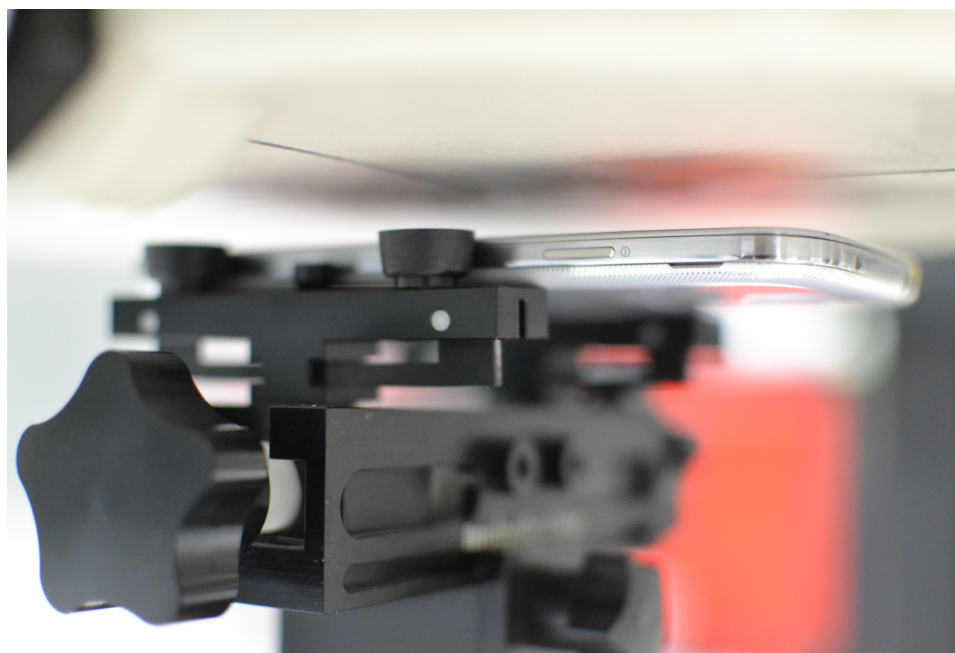
**SAR Test Setup Photo 6 – Front Side at 10 mm**
