APPENDIX 3: Photographs of test setup

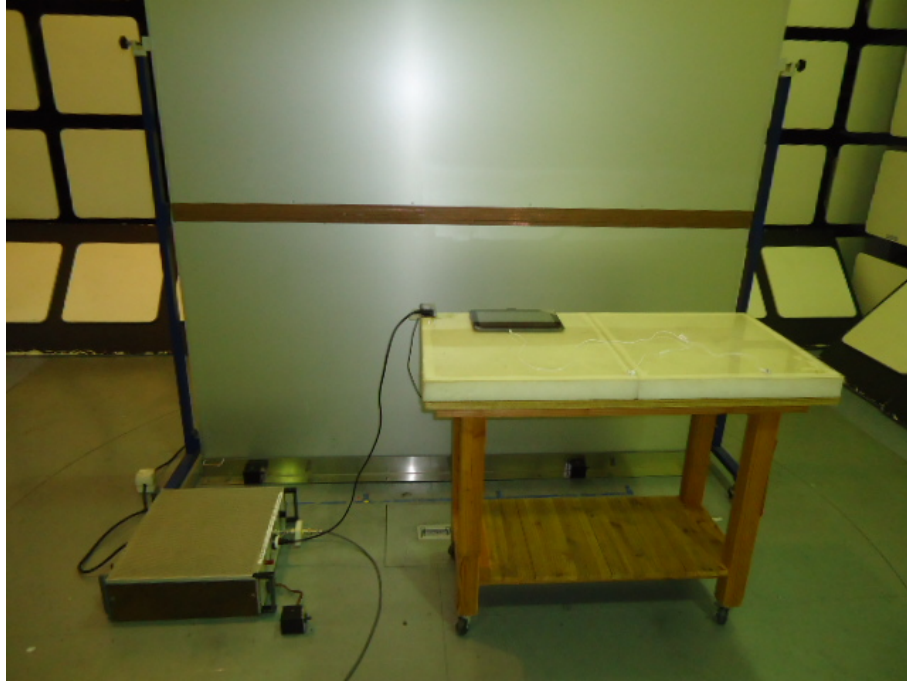
Photo 1

Conducted Emission

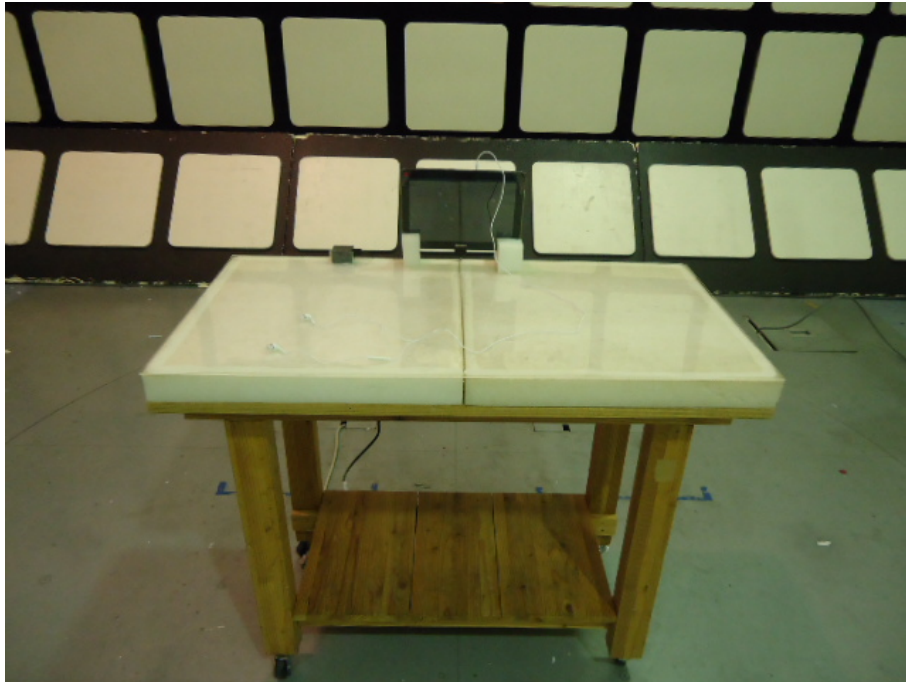
Photo 1

Radiated Spurious Emission

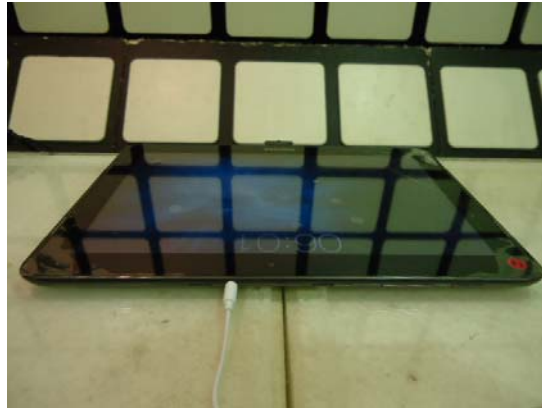
X-axis

Worst Case Position

Below 1GHz: (Horizontal: X-axis/ Vertical:X-axis)

Above 1GHz: (Horizontal: Y-axis/ Vertical:X-axis)
