1. Changer Description

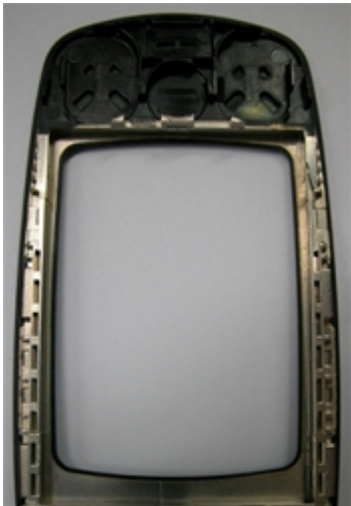
(5) Folder Lower

Added two sponges

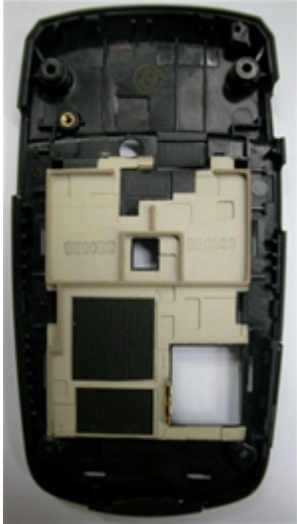
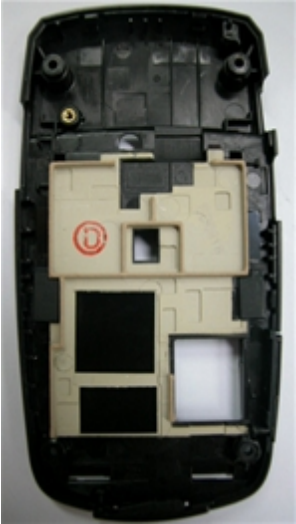
(7) Rear Cover

<ol style="list-style-type: none"> 1. Removed finger 2. Two sponges were changed to two insulation tapes. 3. Added two rubbers
