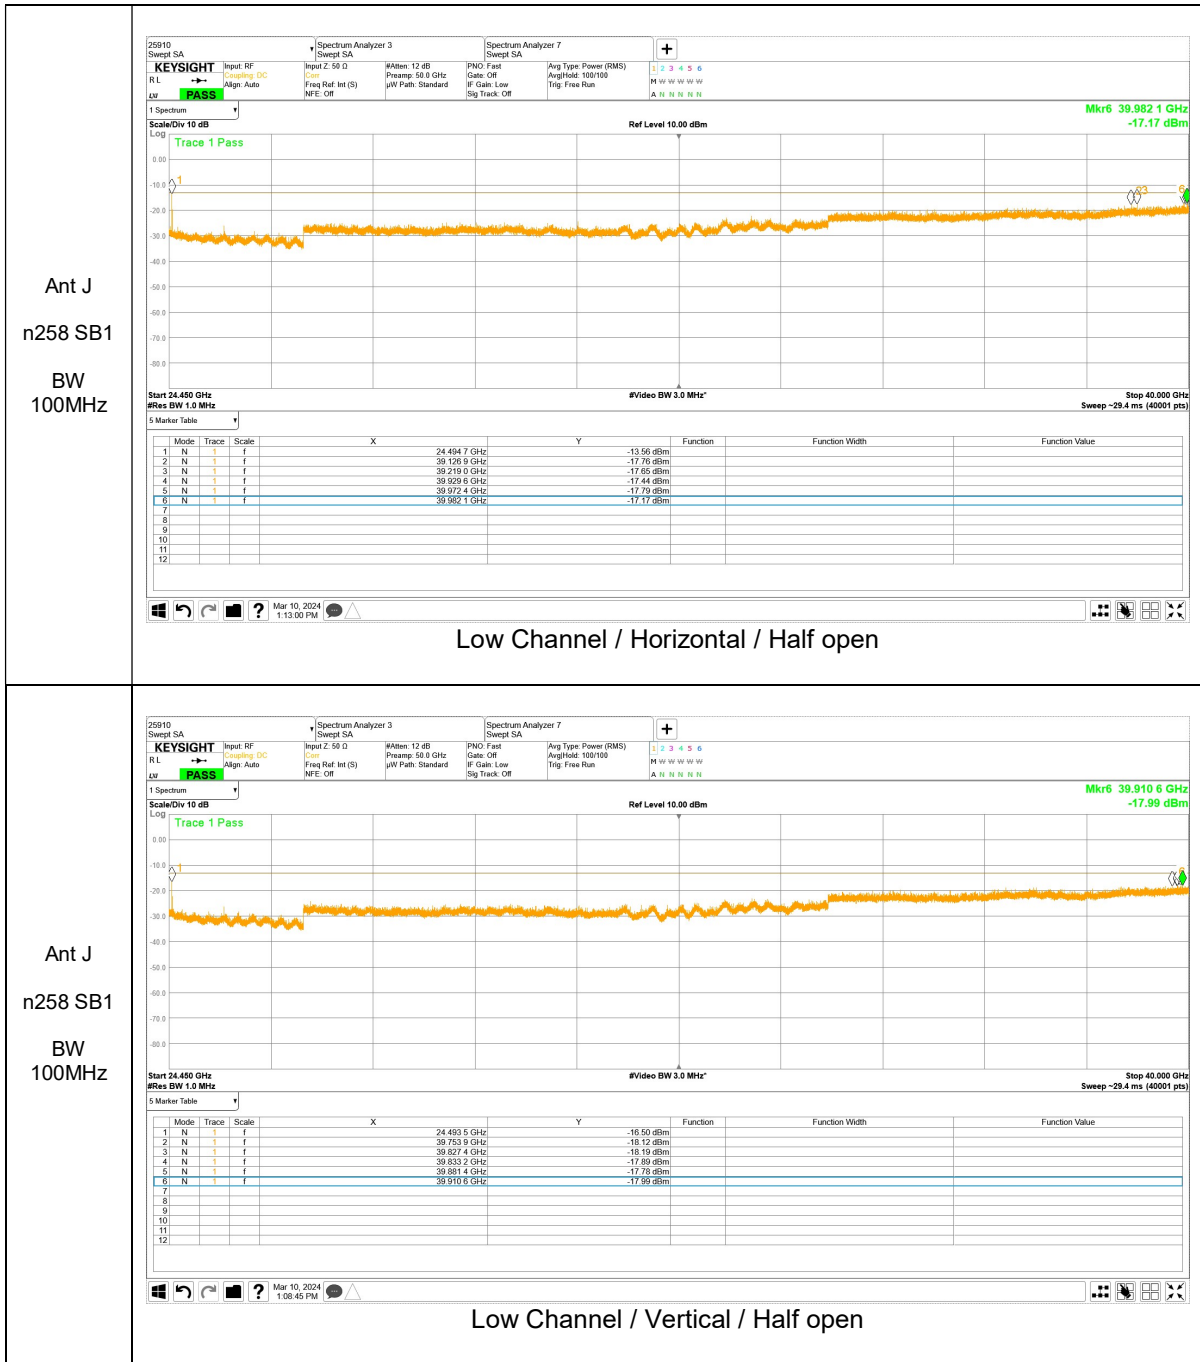
Note. After pre-scan, a zoom scan was performed on the identified spurious emissions.

Frequency [GHz]	Bandwidth [MHz]	EUT Beam	Modulation	Ant pol [H/V]	X-Axis [degree]	Y-Axis [degree]	EIRP [dBm]	Limit [dBm]	Margin [dB]
24.495	100	SISO-Dual	QPSK	H	100.1	288.0	-19.90	-13	6.90
