11. ANNEX A_ TEST SETUP PHOTO

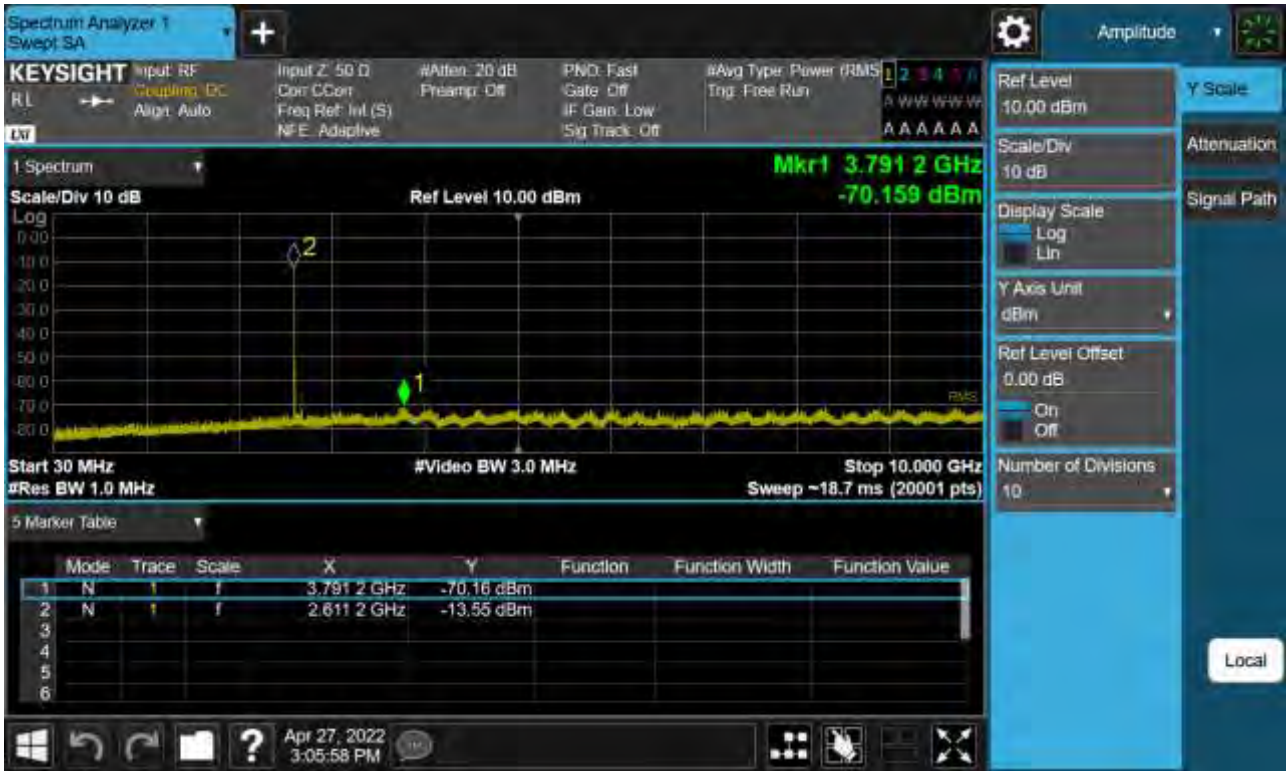
Sub6 n41. Conducted Spurious Plot 1 (80 MHz Ch.52998 BPSK RB 1)

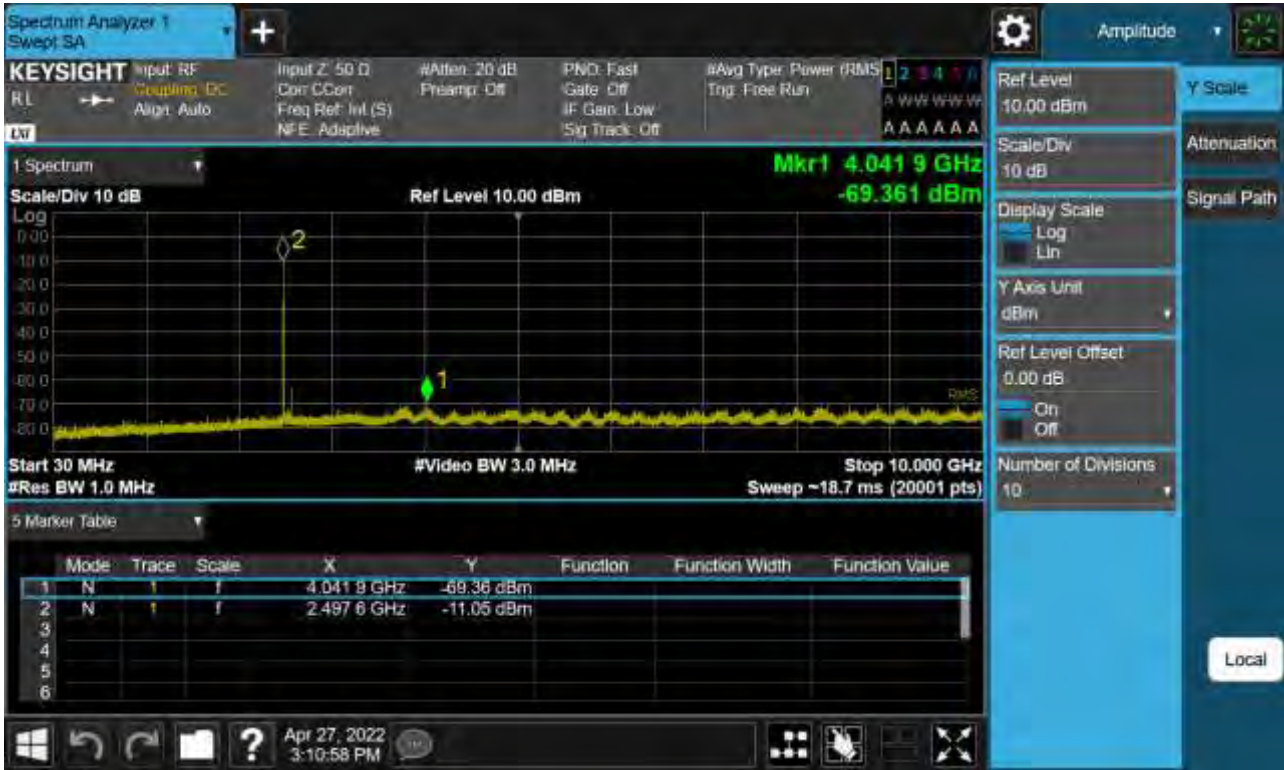
Sub6 n41. Conducted Spurious Plot 1 (90 MHz Ch.508200 BPSK RB 1)

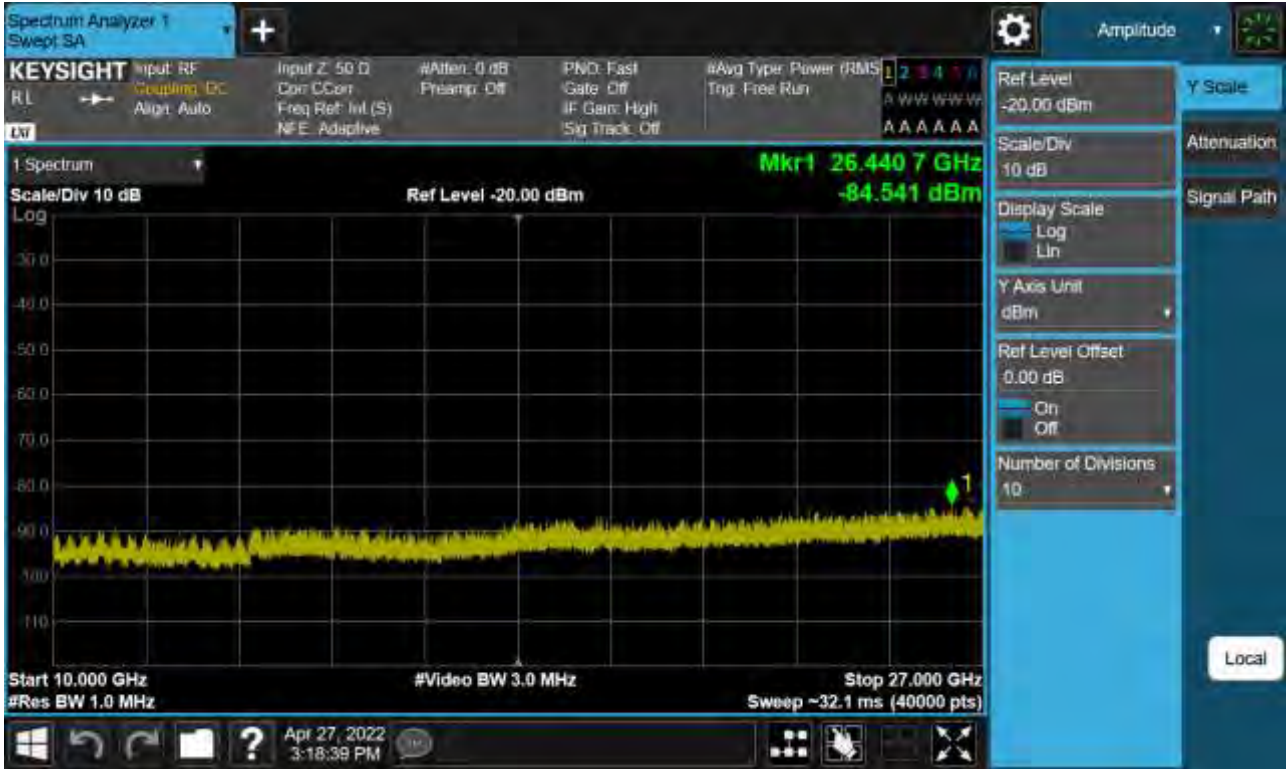
Sub6 n41. Conducted Spurious Plot 2 (90 MHz Ch. 518598 BPSK RB 1)

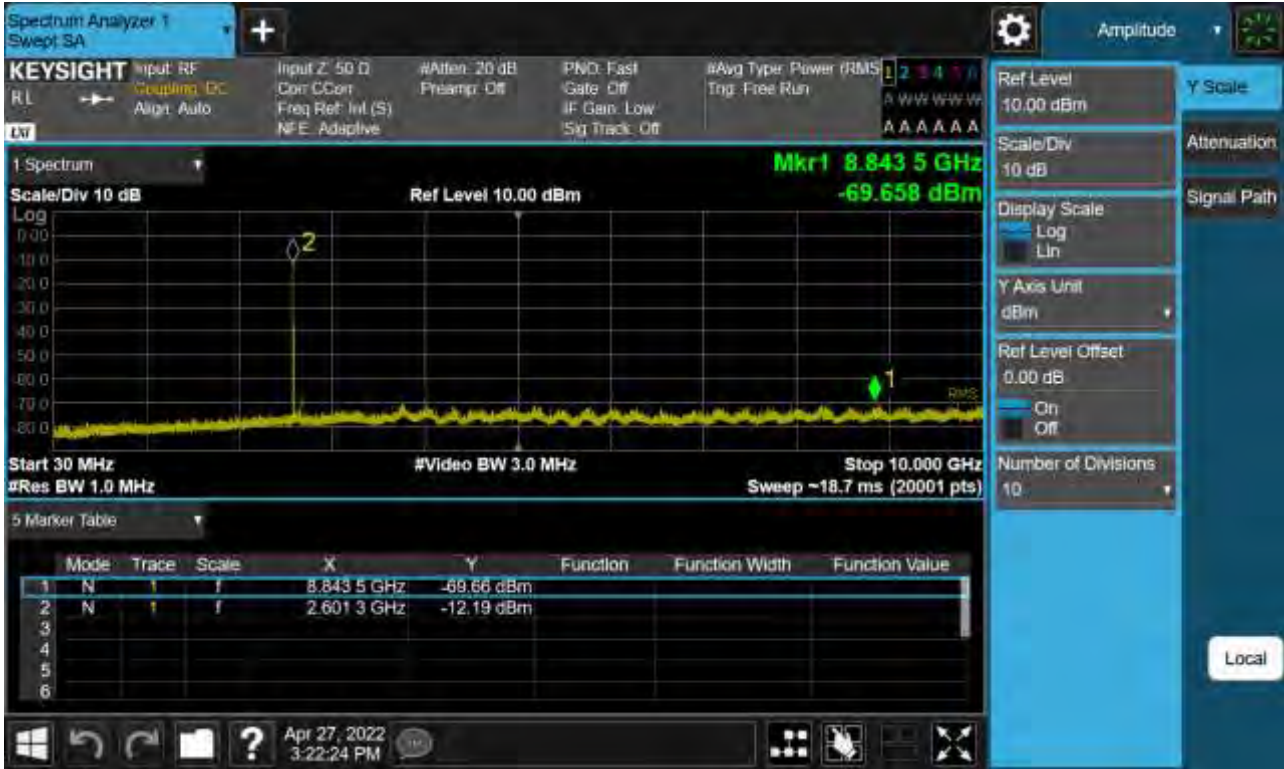
Sub6 n41. Conducted Spurious Plot 1 (90 MHz Ch.528996 BPSK RB 1)

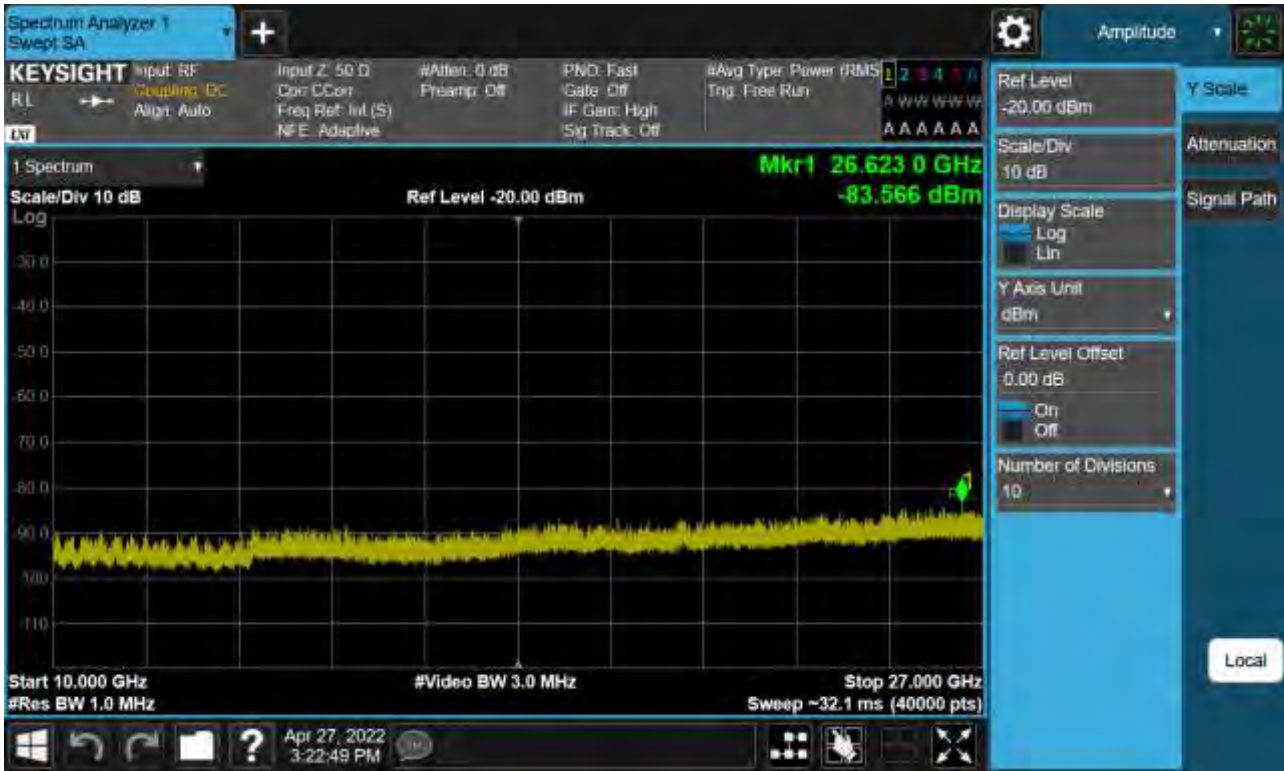
Sub6 n41. Conducted Spurious Plot 2 (90 MHz Ch.528996 BPSK RB 1)

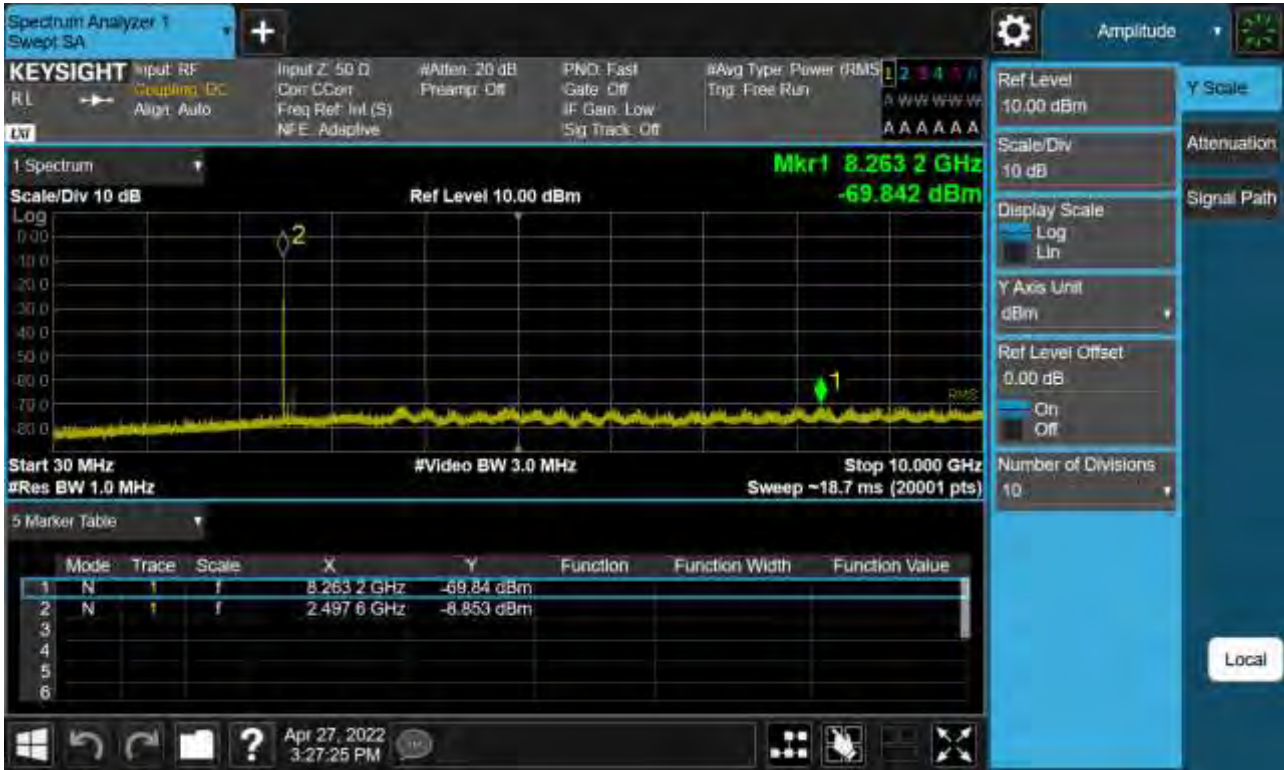
Sub6 n41. Conducted Spurious Plot 1 (100 MHz Ch.509202 BPSK RB 1)

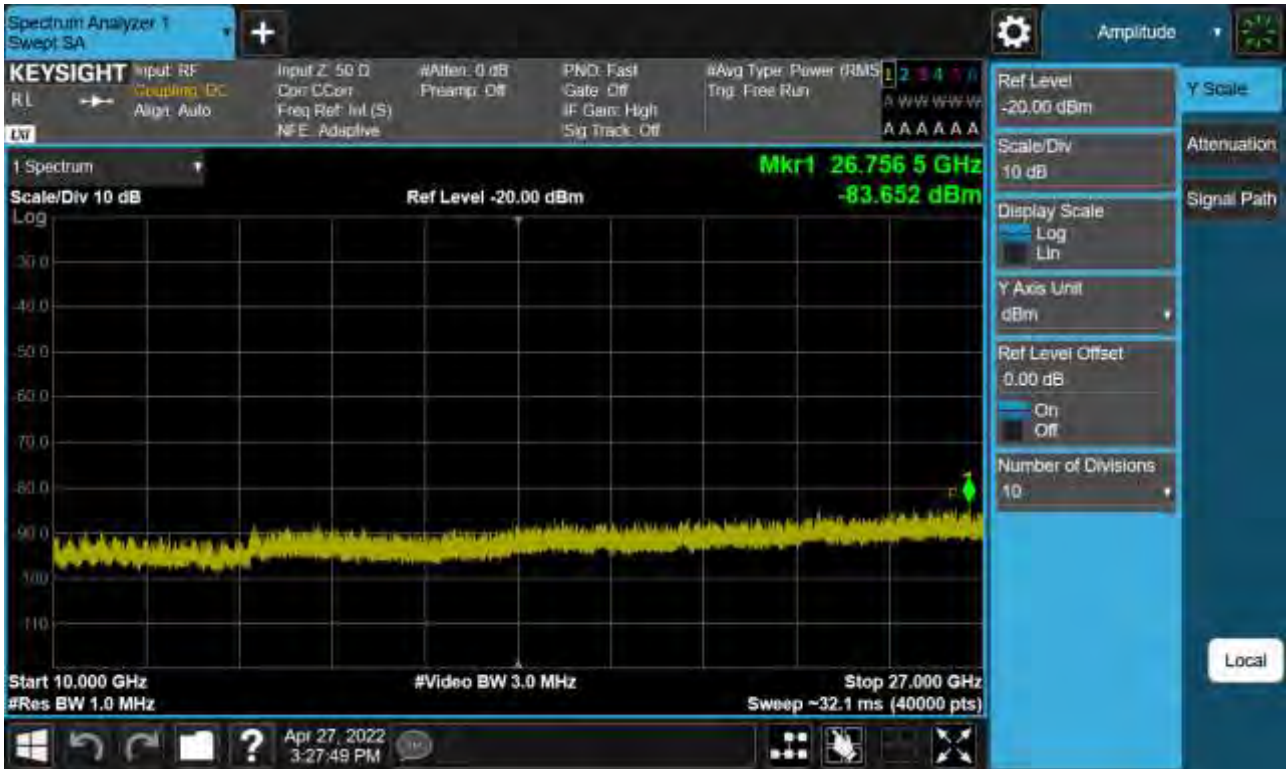
Sub6 n41. Conducted Spurious Plot 2 (100 MHz Ch.509202 BPSK RB 1)

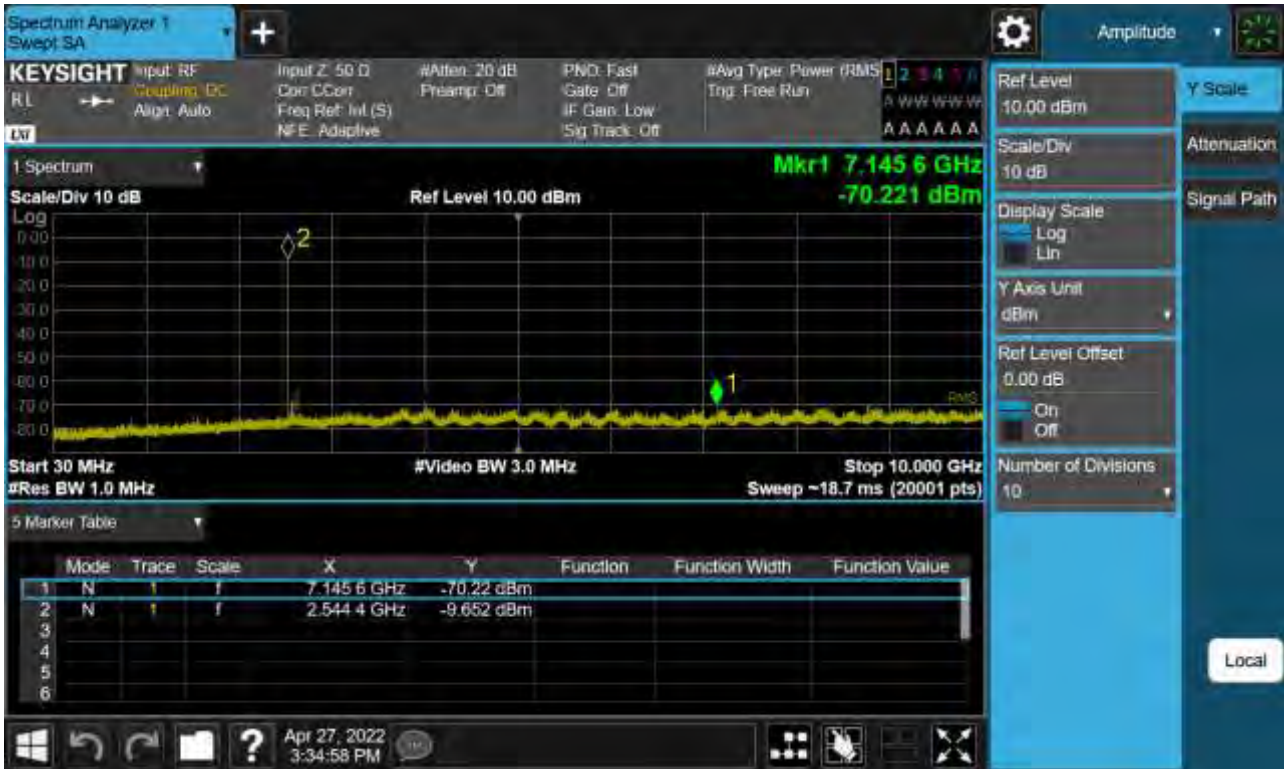
Sub6 n41. Conducted Spurious Plot 1 (100 MHz Ch.518598 BPSK RB 1)

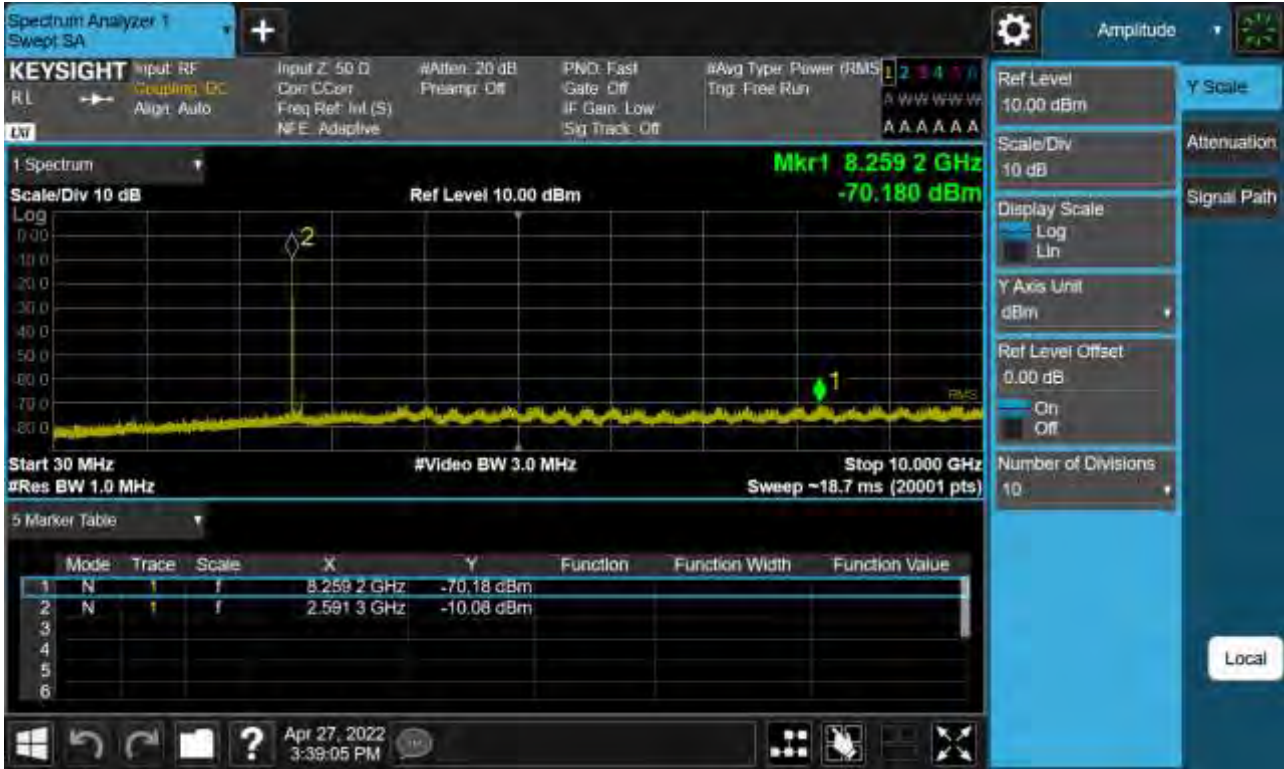
Sub6 n41. Conducted Spurious Plot 1 (100 MHz Ch.528000 BPSK RB 1)
