# APPENDIX F: SAR TEST SETUP PHOTOGRAPHS

<b>FCC ID:</b> A3LSMN900

<b>PCTEST</b> <small>ENGINEERING LABORATORY, INC.</small>	<b>SAR EVALUATION REPORT</b>

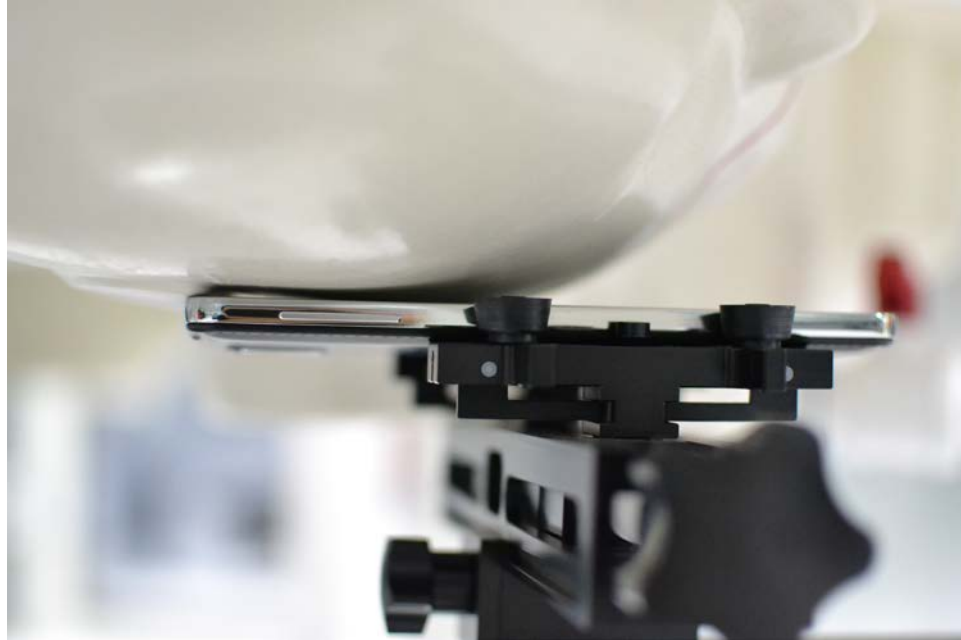
**SAR Test Setup Photo 1 - Right Cheek**

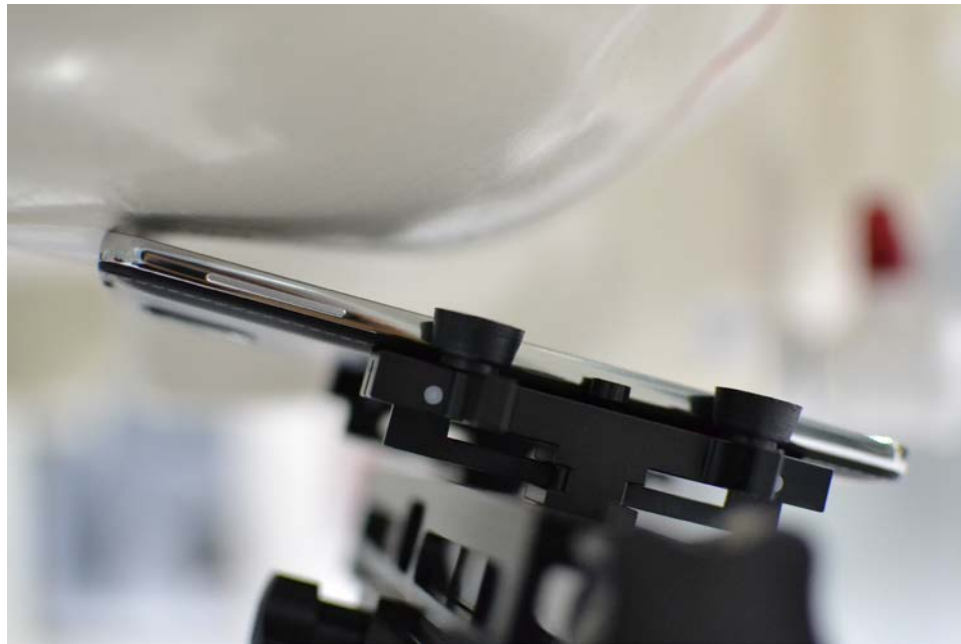
**SAR Test Setup Photo 2 - Right Tilt**

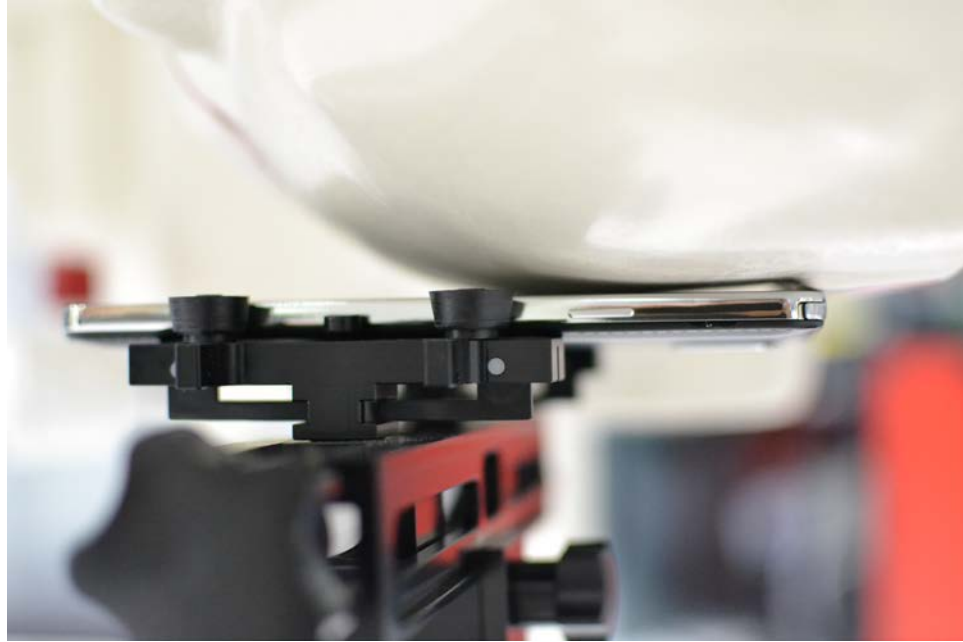
**SAR Test Setup Photo 3 - Left Cheek**

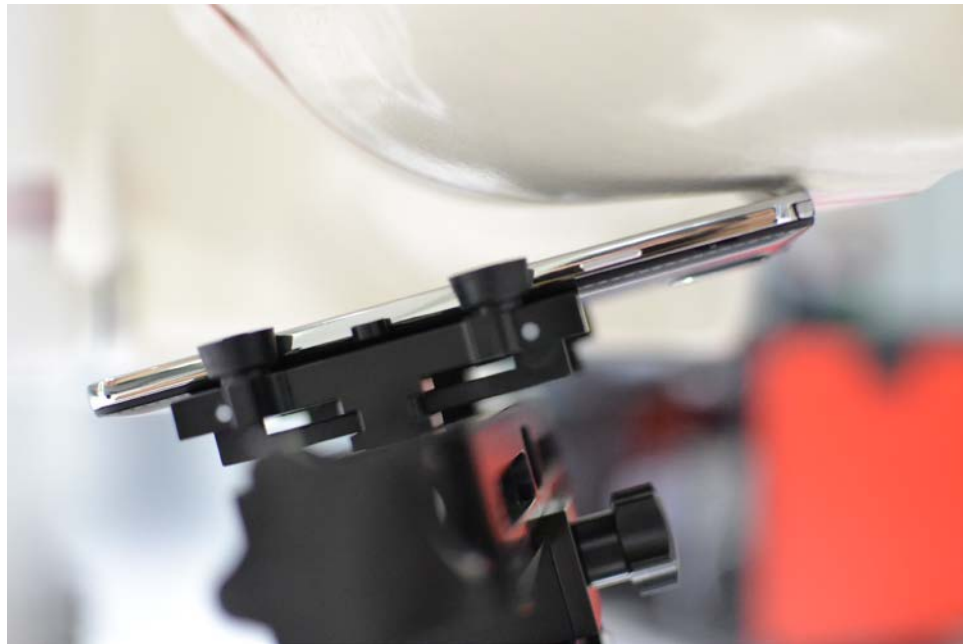
**SAR Test Setup Photo 4 - Left Tilt**

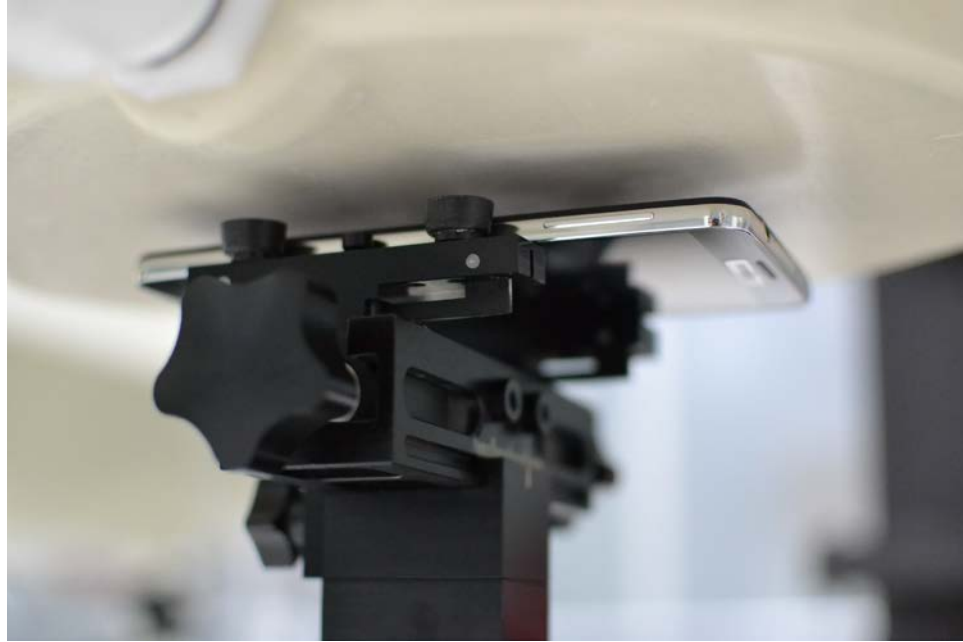
**SAR Test Setup Photo 5 - Back Side at 1.0 cm**

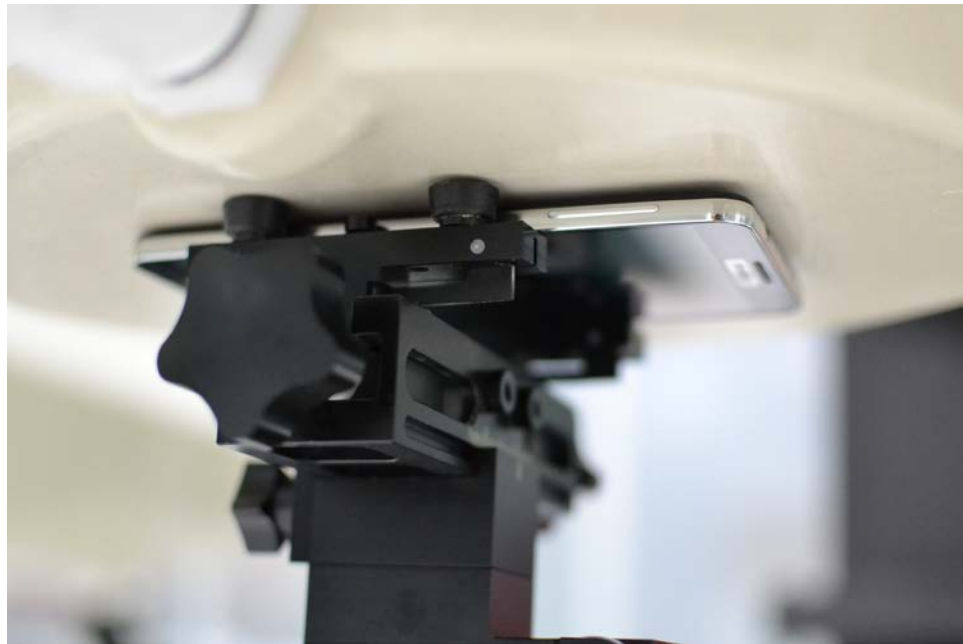
**SAR Test Setup Photo 6 - Back Side at 0.0 cm**

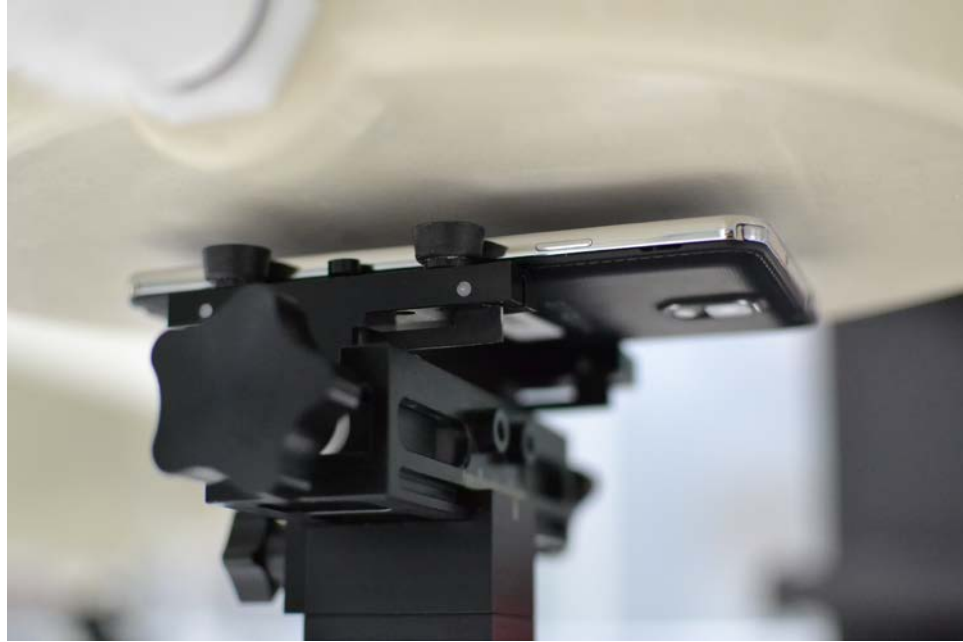
**SAR Test Setup Photo 7 - Front Side at 1.0 cm**

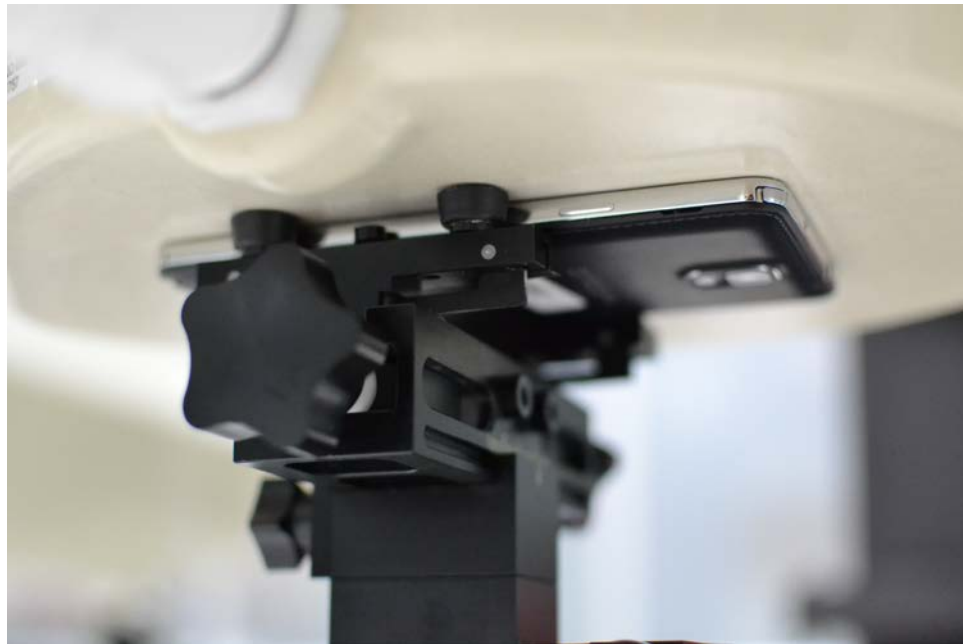
**SAR Test Setup Photo 8 - Front Side at 1.0 cm**

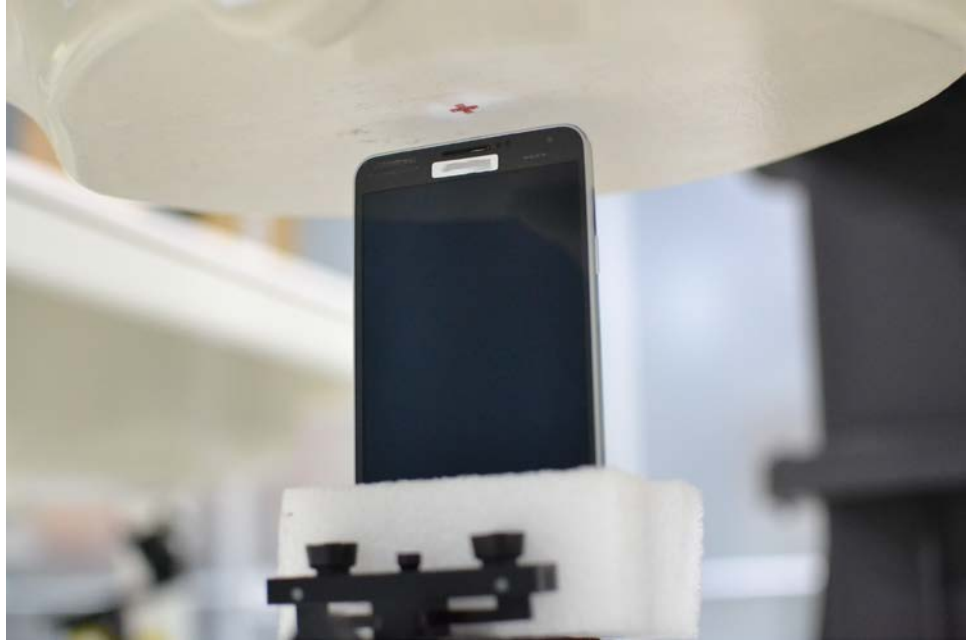
**SAR Test Setup Photo 9 - Top Edge at 1.0 cm**

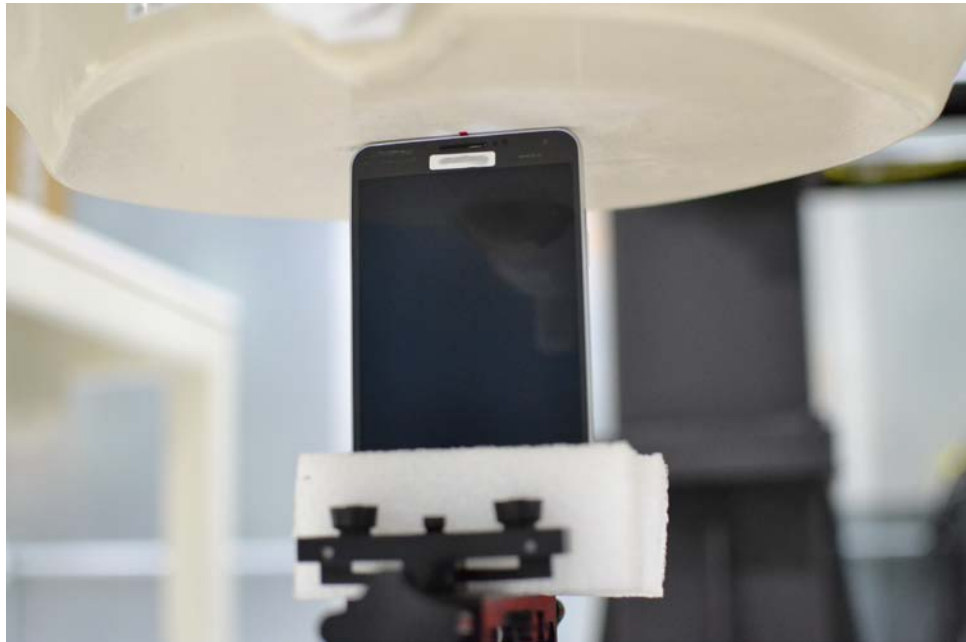
**SAR Test Setup Photo 10 - Top Edge at 0.0 cm**

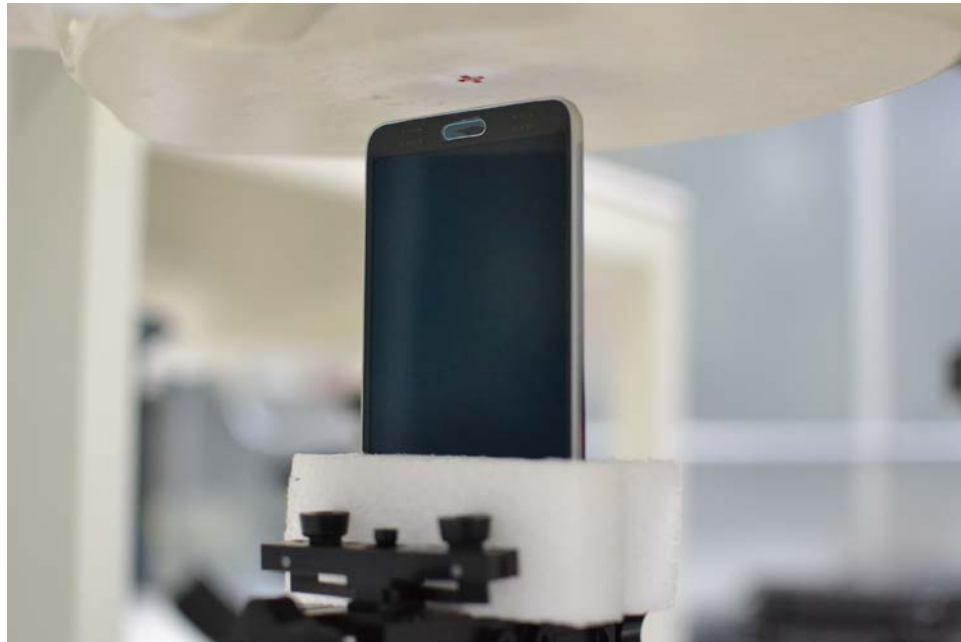
**SAR Test Setup Photo 11 - Bottom Edge at 1.0 cm**

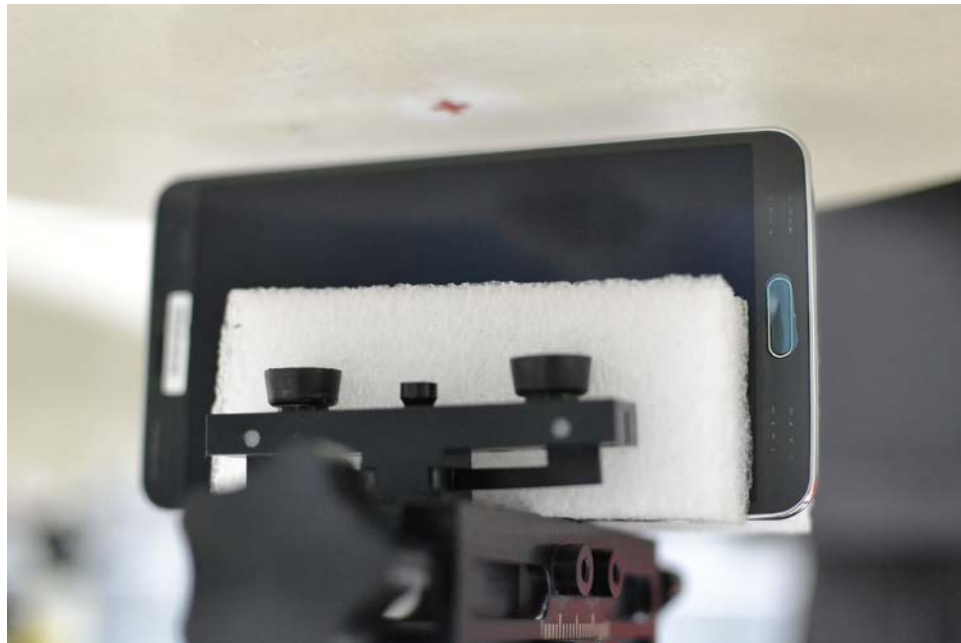
**SAR Test Setup Photo 12 - Right Edge at 1.0 cm**

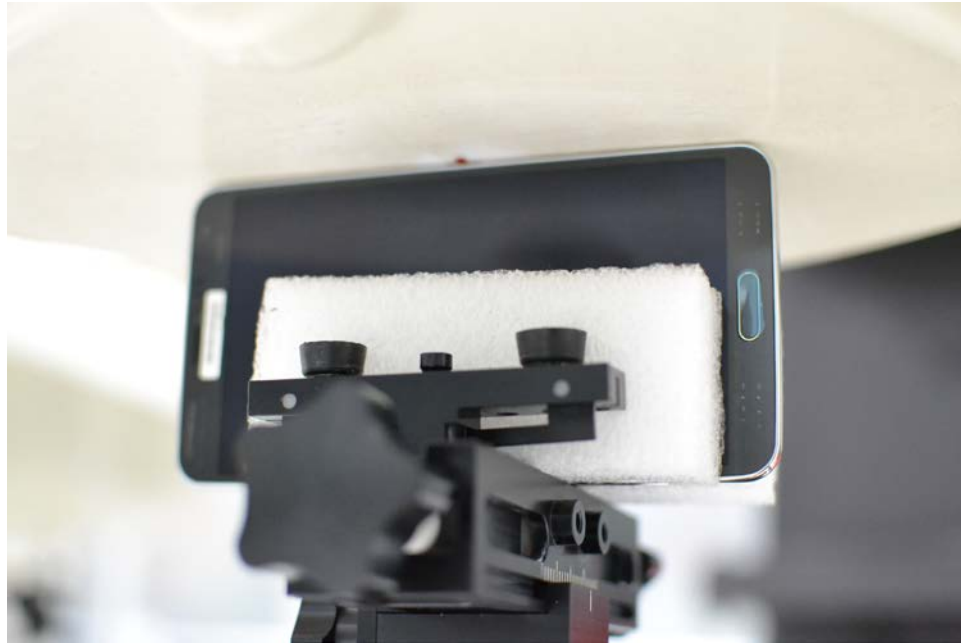
**SAR Test Setup Photo 13 - Right Edge at 0.0 cm**

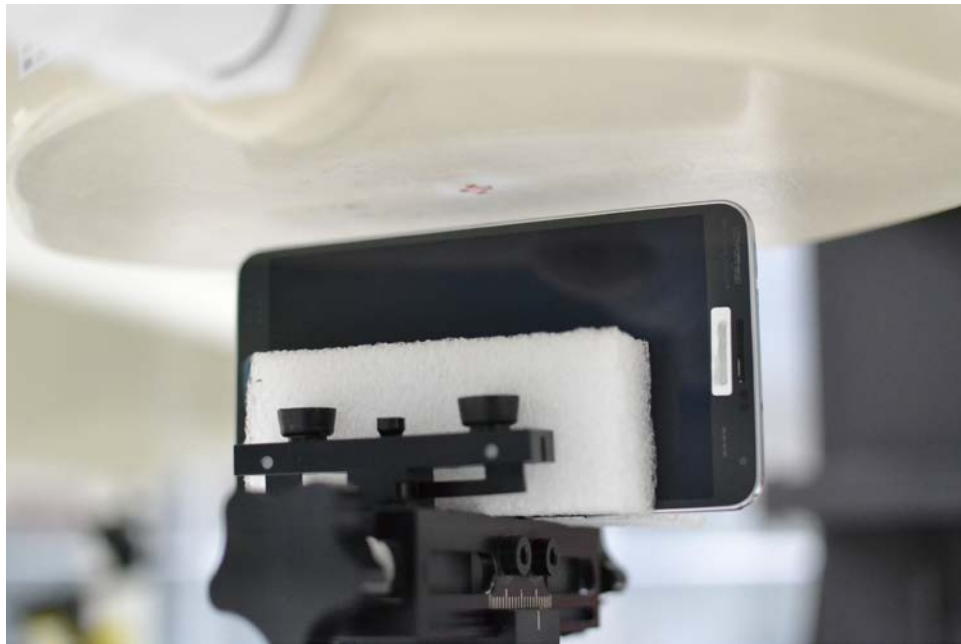
**SAR Test Setup Photo 14 - Left Edge at 1.0 cm**

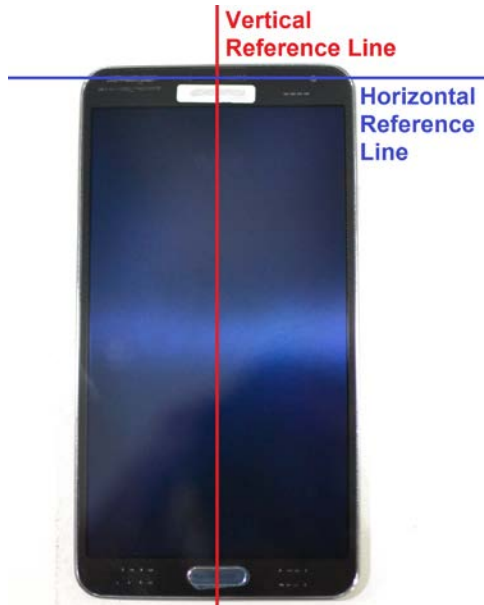
**SAR Test Setup Photo 15 - Horizontal and Vertical Reference Lines**
