**Appendix C. #Antenna Location & Distance**

Report No.:  
KR21-SPF0032-A  
Page (177) of (180)

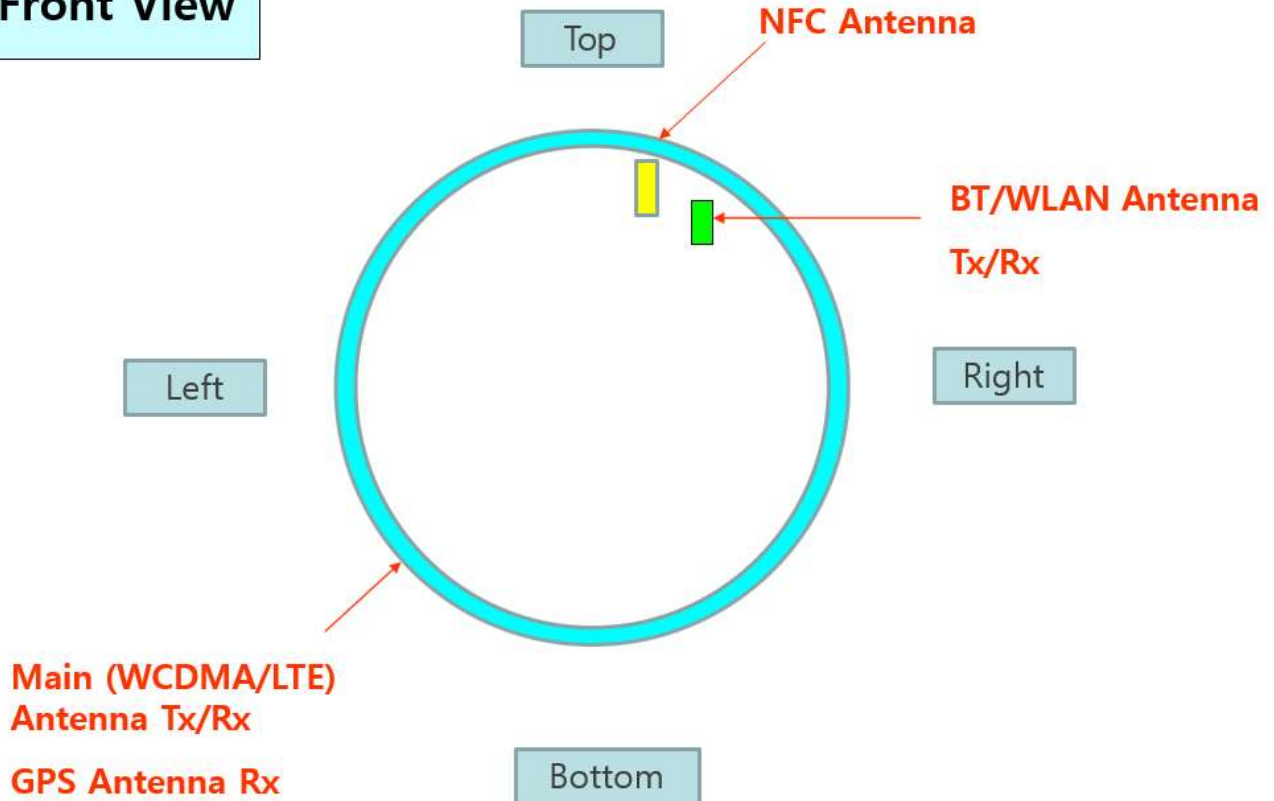
**Front View**

\* Distance between Main antenna and edge

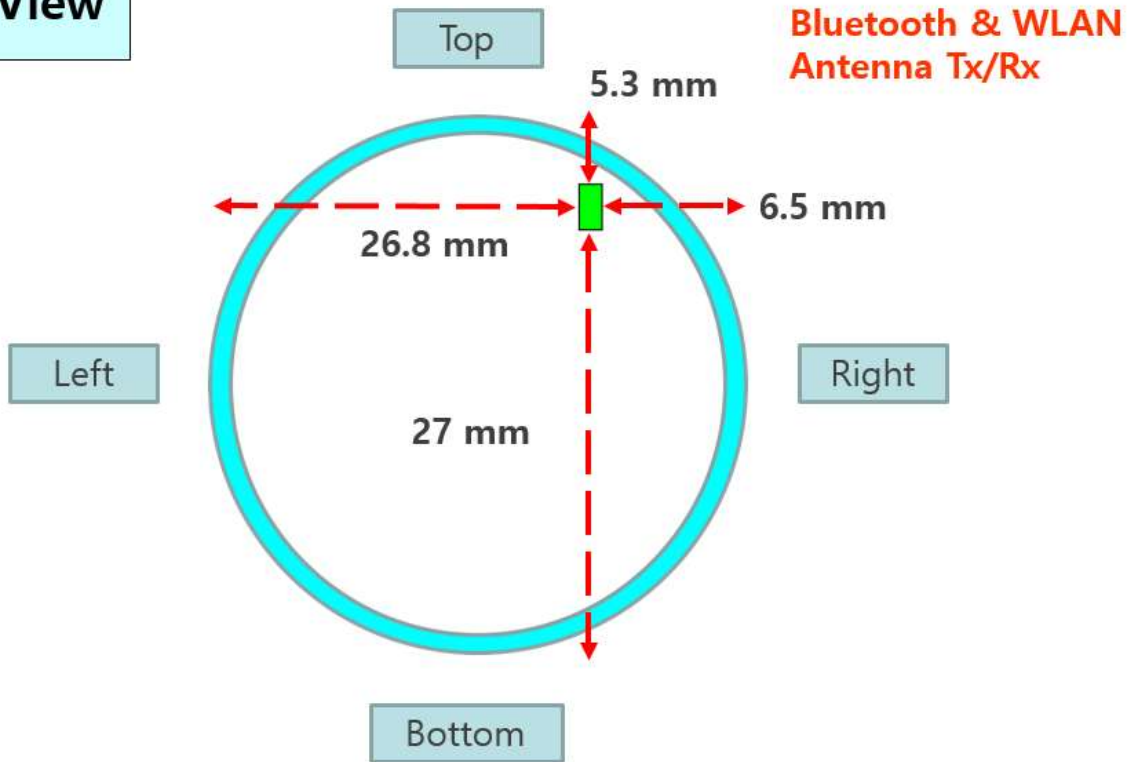
**Front View**

**\* Distance between Bluetooth antenna and edge**

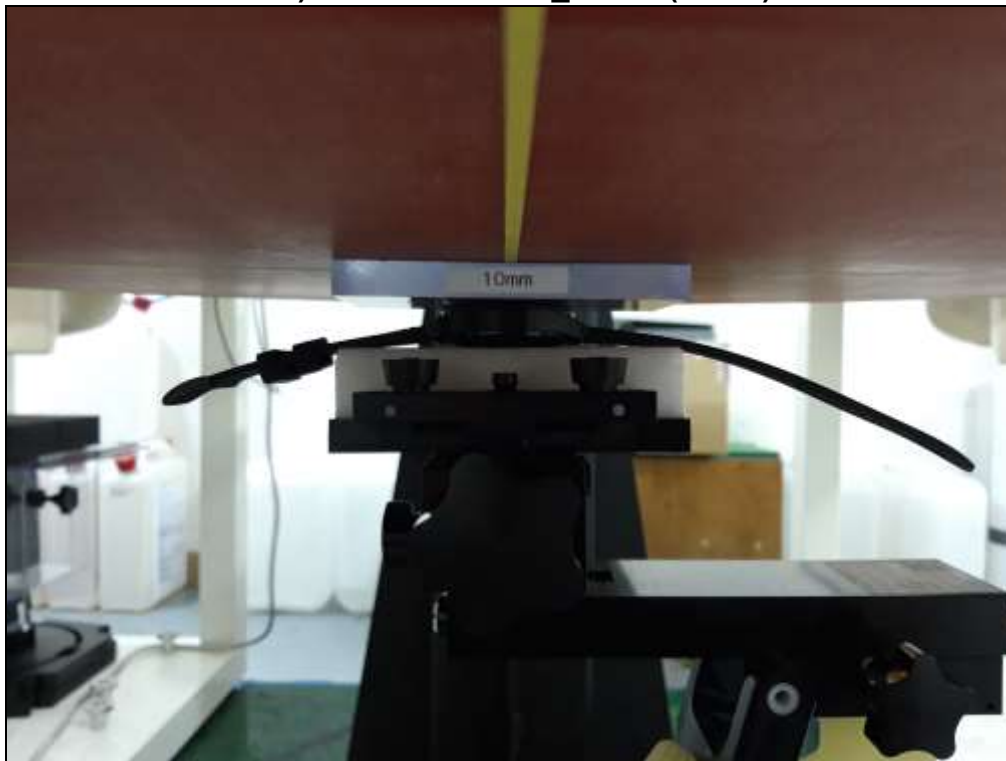
E.1) Next to Mouth\_Front (10 mm)

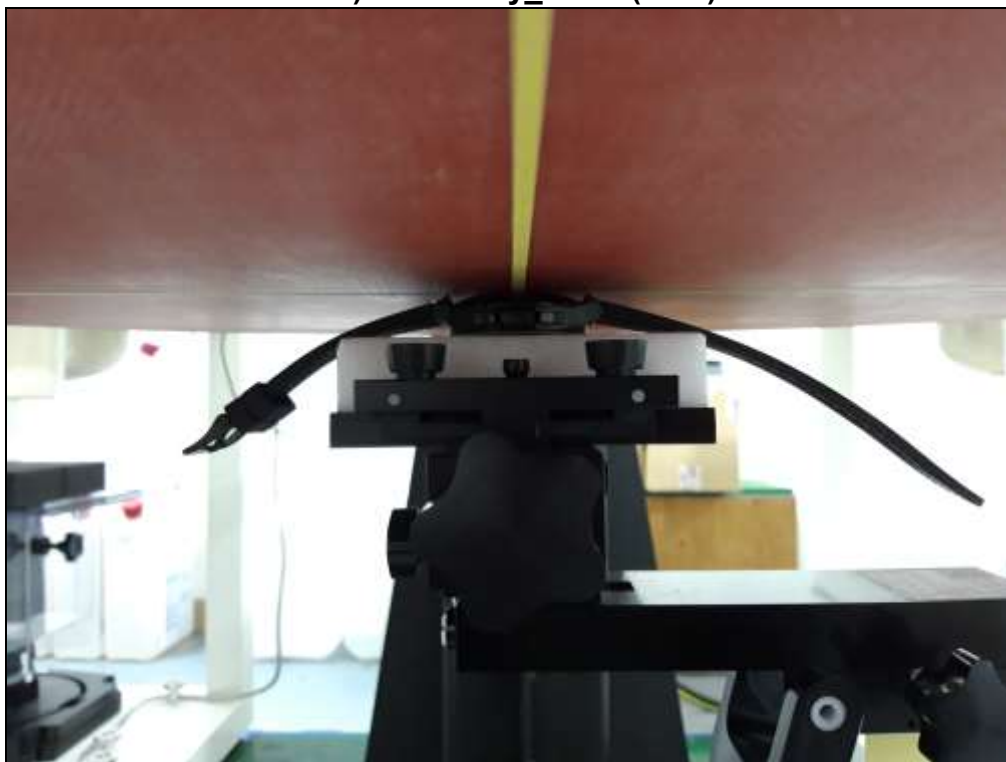
E.2) Extremity\_Rear (0 mm)
