Appendix C. #Antenna Location & Distance

Report No.:
KR22-SPF0027-A
Page (194) of (198)

Appendix D. EUT Photo

Appendix E. Test Setup Photo

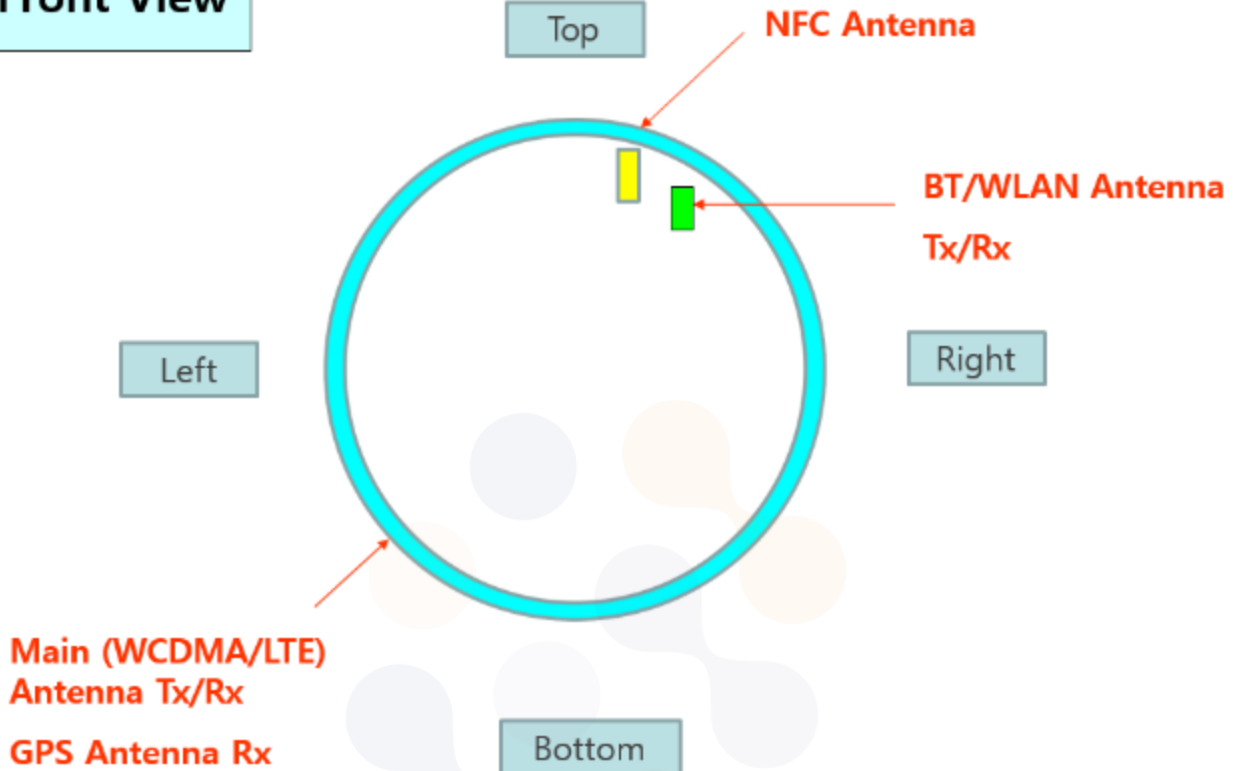
Front View

• **Placement of each antenna**

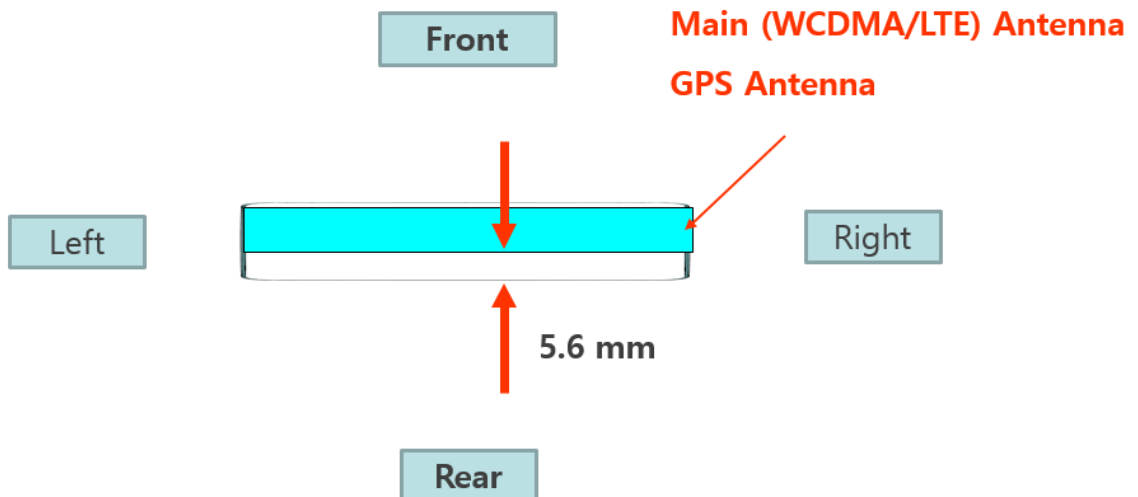
Top View

* **Distance between Main antenna and edge**

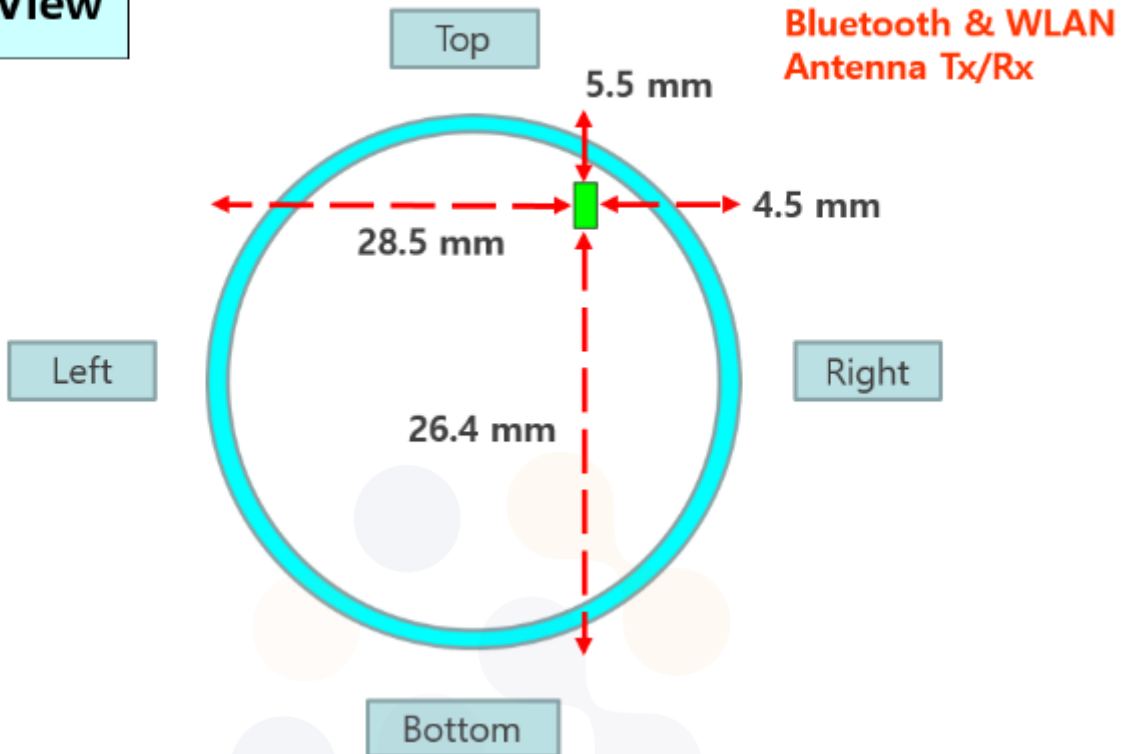
Front View

*** Distance between Bluetooth antenna and edge**

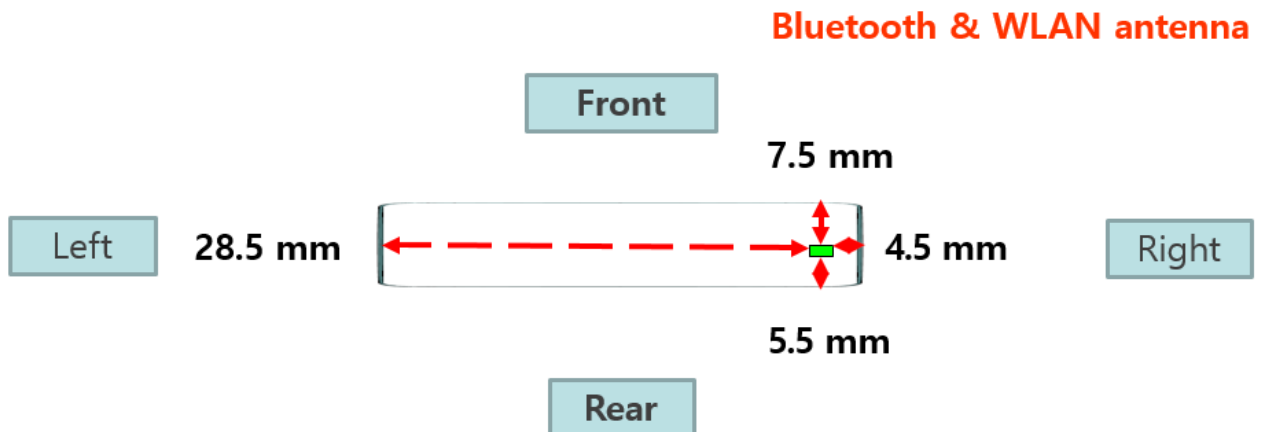
Top View

*** Distance between Bluetooth antenna and edge**

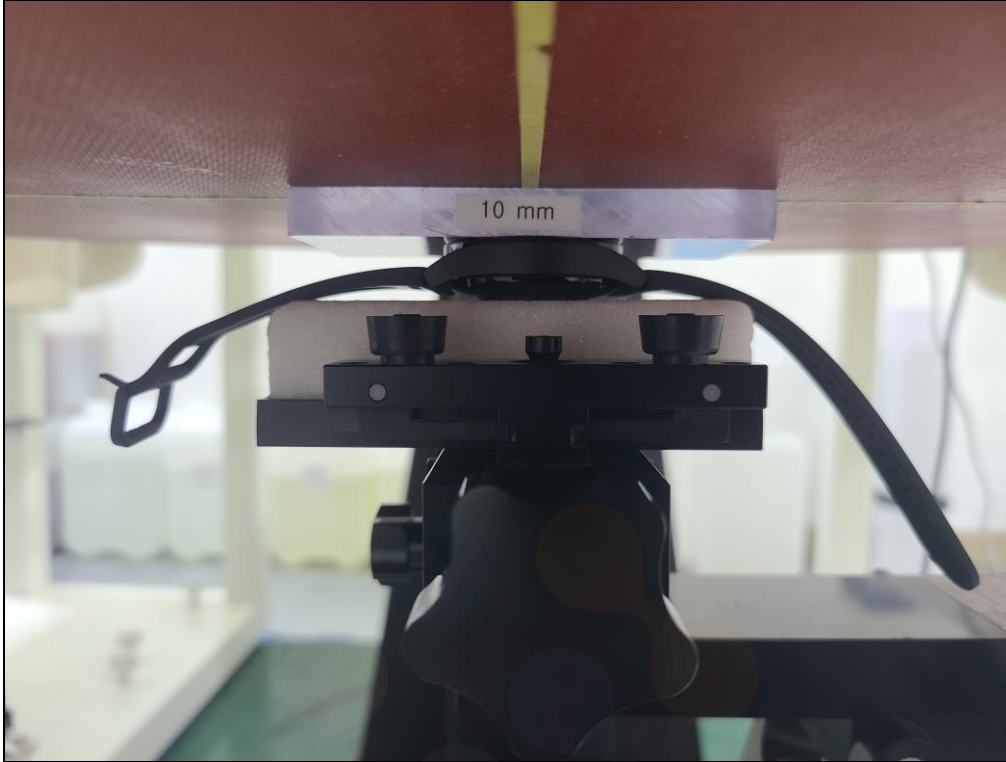
E.1) Next to Mouth_Front (10 mm)

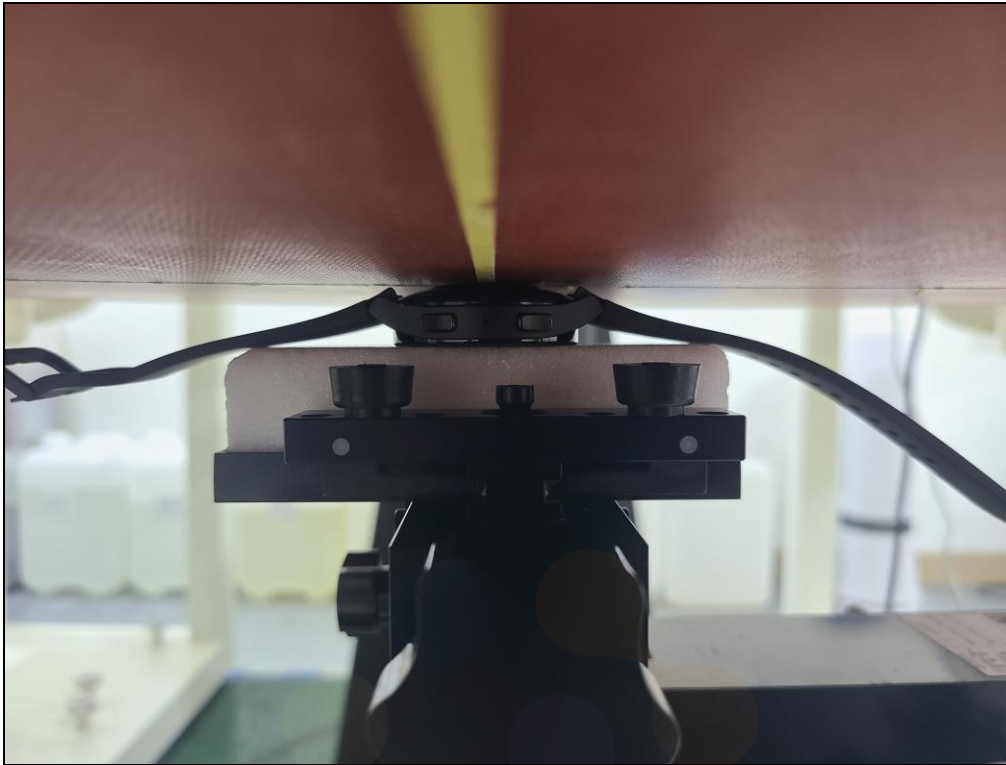
E.2) Extremity_Rear (0 mm)
