21 SAR TEST SETUP PHOTOGRAPHS

| FCC ID: A3LSWDSC02C | | SAR COMPLIANCE REPORT | | Reviewed by: Quality Manager |
| Filename: 0Y1104200782-R1.A3L | Test Dates: 05/02/11 - 05/04/11 | EUT Type: 850/1900 GSM/GPRS/EDGE Phone with Bluetooth and WLAN | Page 40 of 45 | |

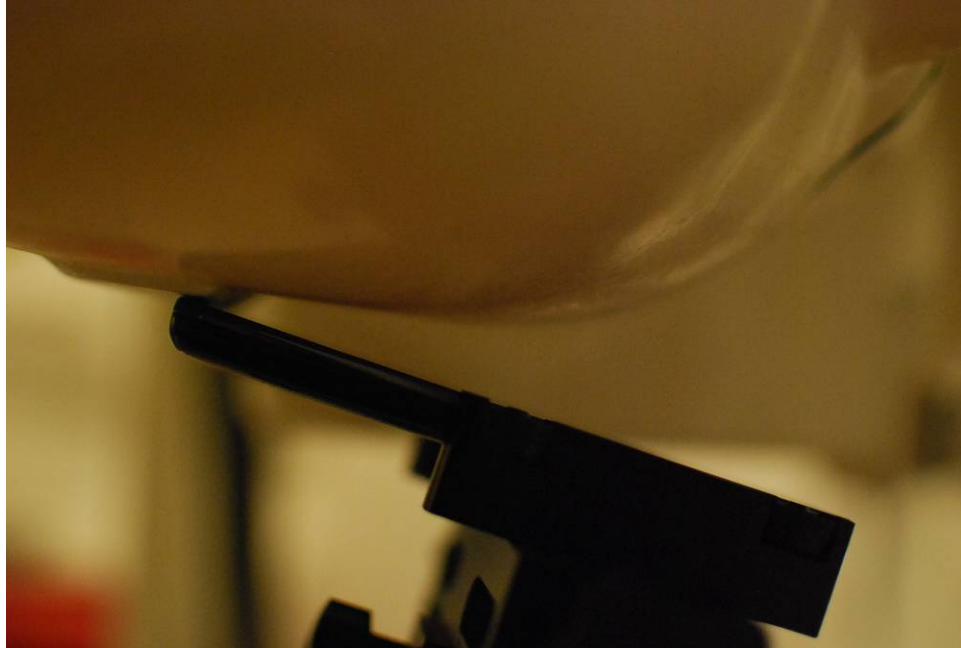
**Figure 21-1
SAR Test Setup Photo 1 – Right Touch**

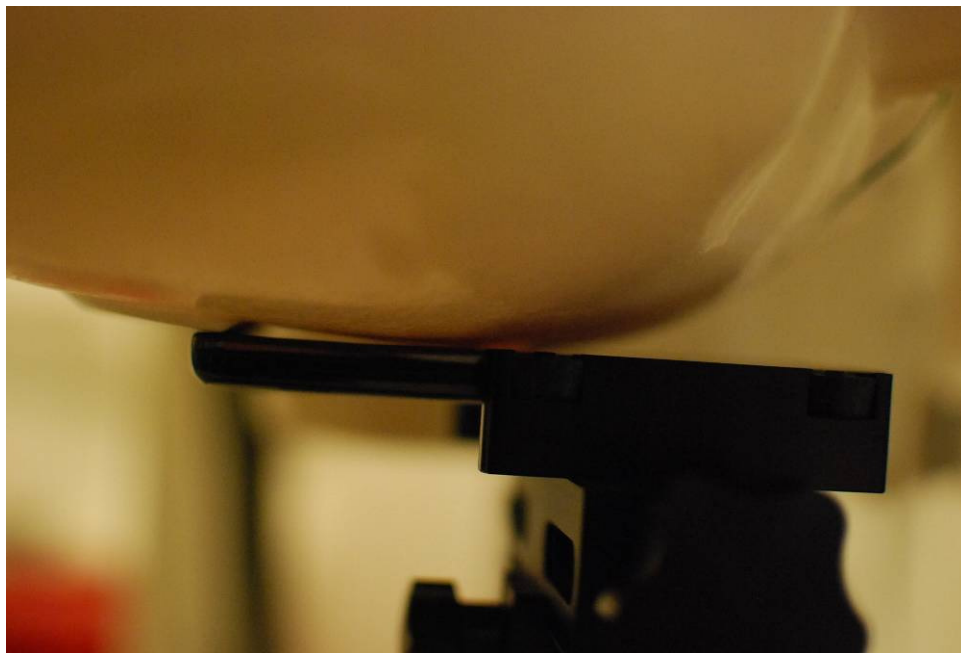
**Figure 21-2
SAR Test Setup Photo 2 – Right Tilt**

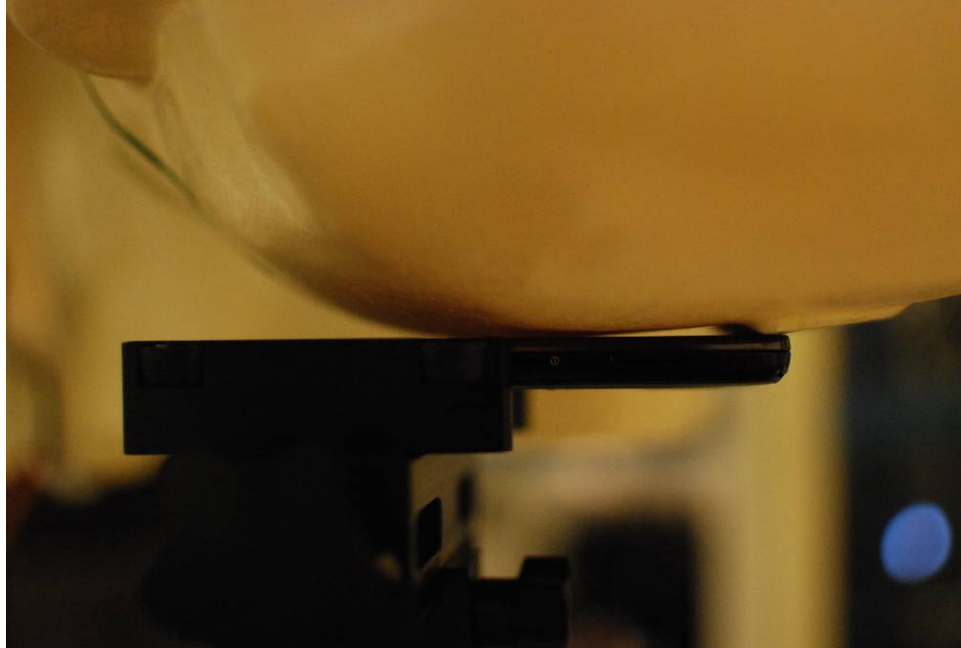
Figure 21-3
SAR Test Setup Photo 3 – Left Touch

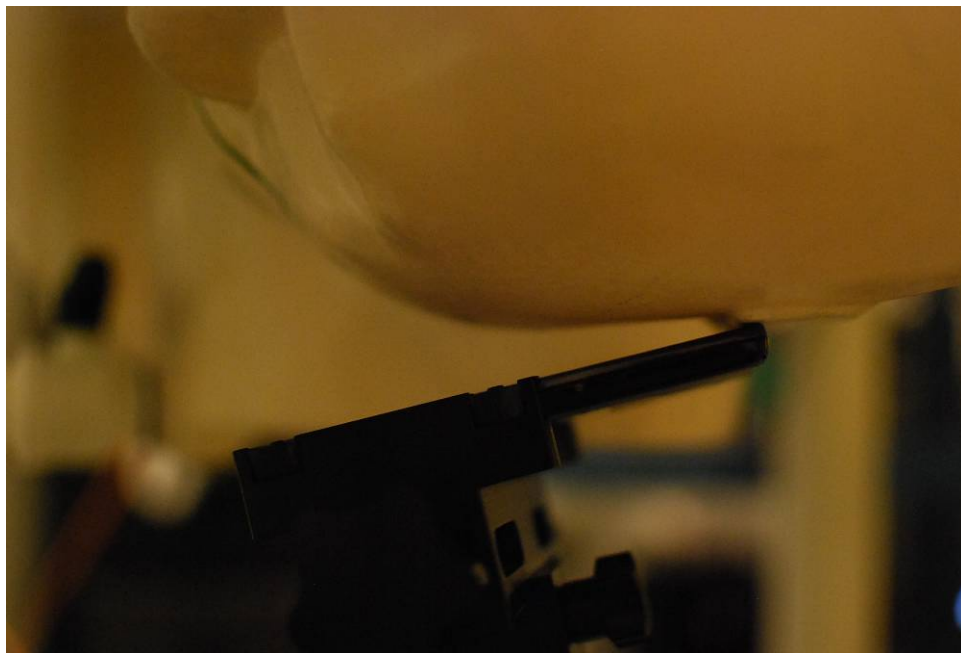
Figure 21-4
SAR Test Setup Photo 4 – Left Tilt

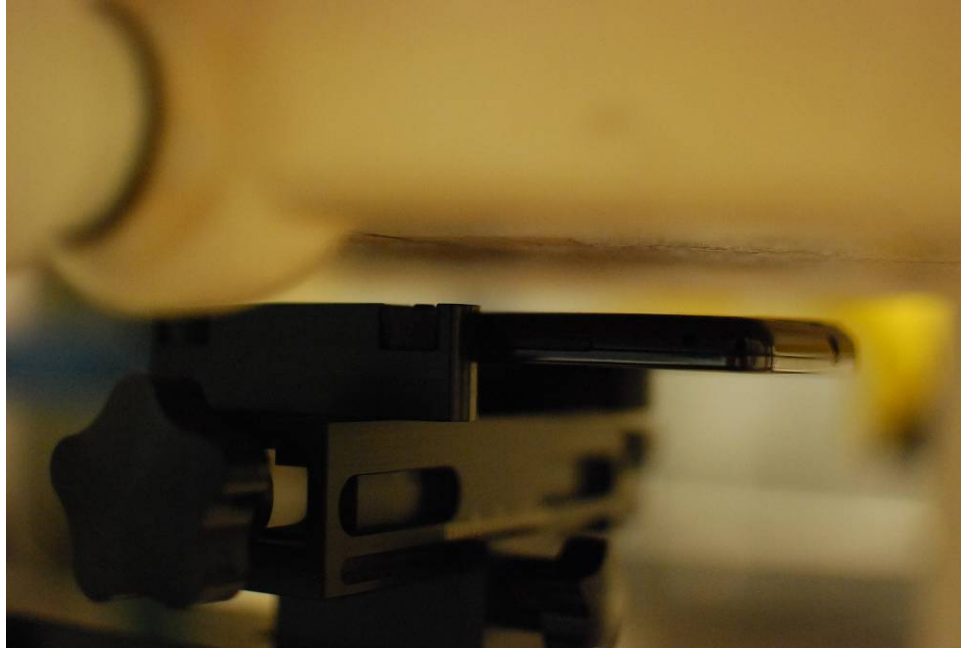
Figure 21-5
SAR Test Setup Photo 5 – Back at 1.0 cm

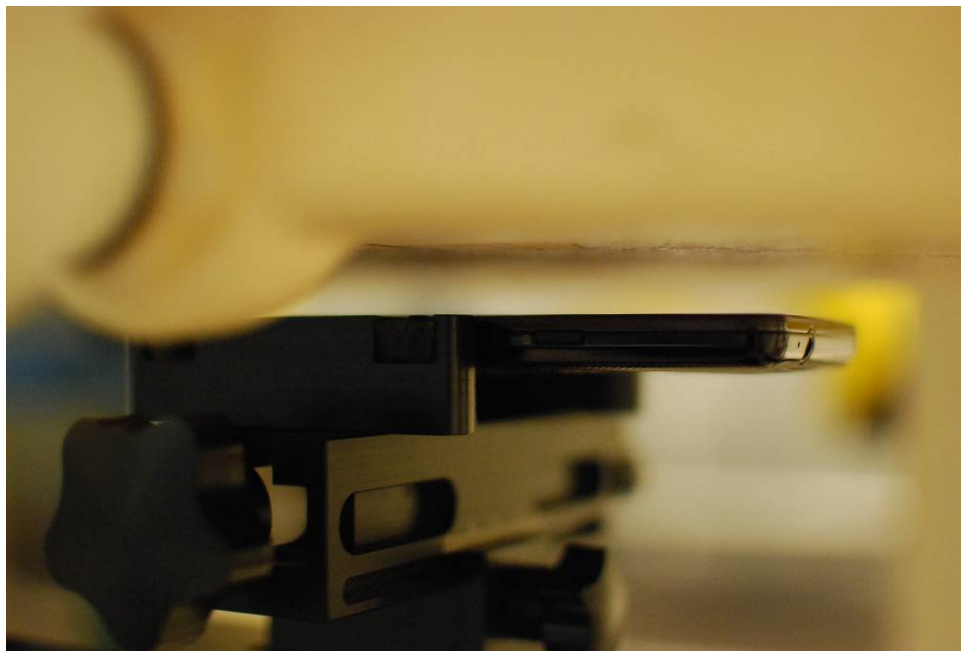
Figure 21-6
SAR Test Setup Photo 6 – Front at 1.0 cm

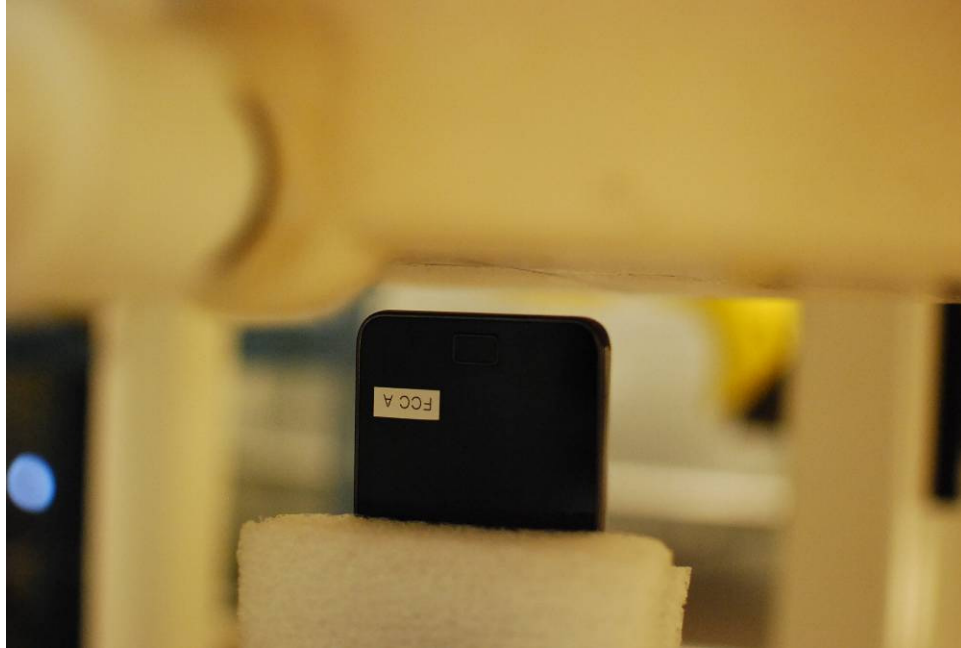
Figure 21-7
SAR Test Setup Photo 7 – Bottom at 1.0 cm

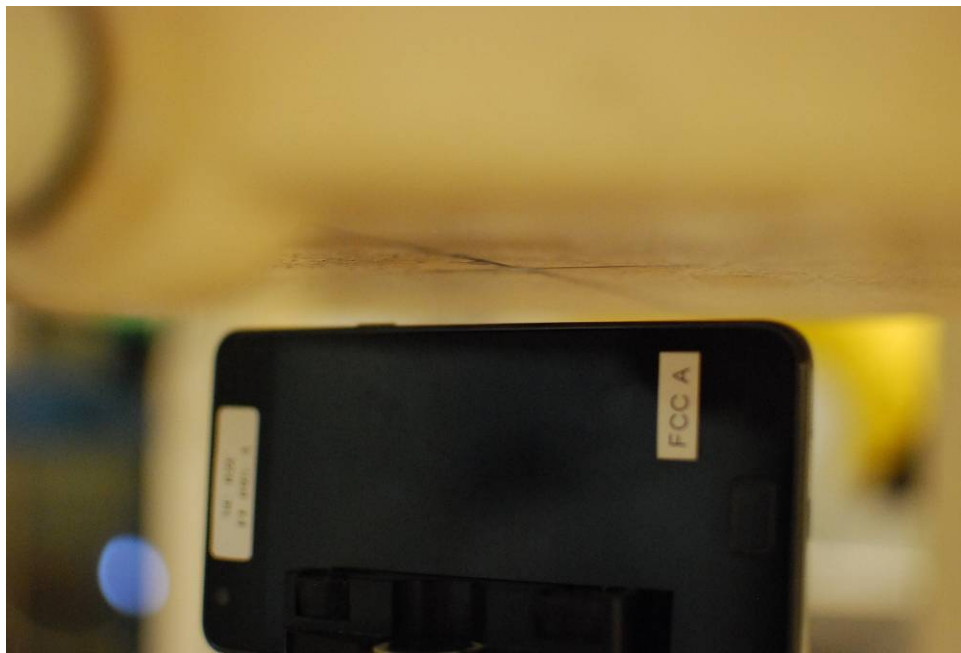
Figure 21-8
SAR Test Setup Photo 8 – Right at 1.0 cm

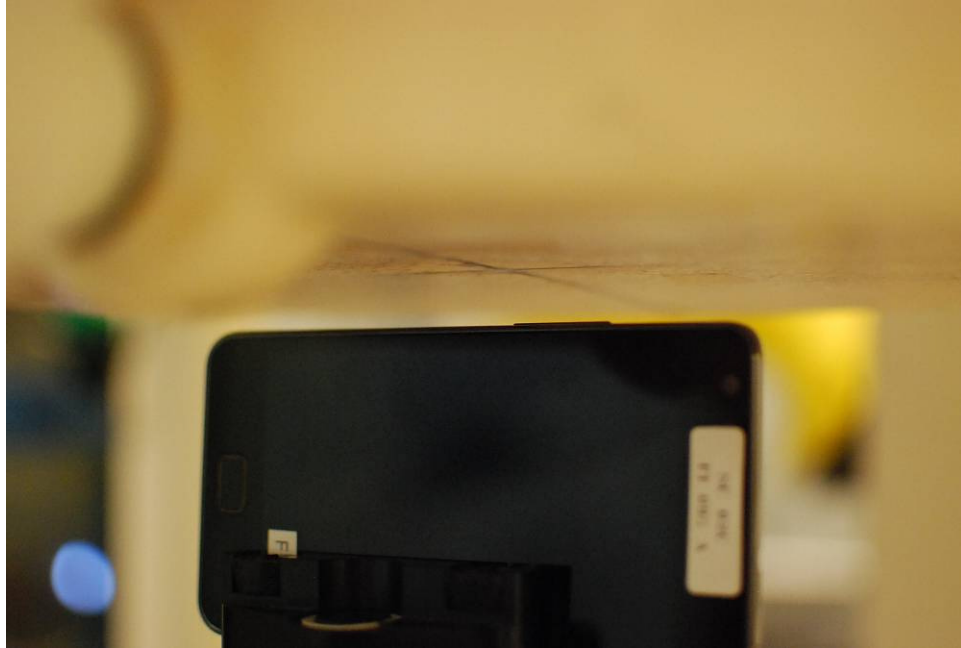
Figure 21-9
SAR Test Setup Photo 9 – Left at 1.0 cm
