**Product: Bose A94412568**

# Design Compliance Engineering – Analysis

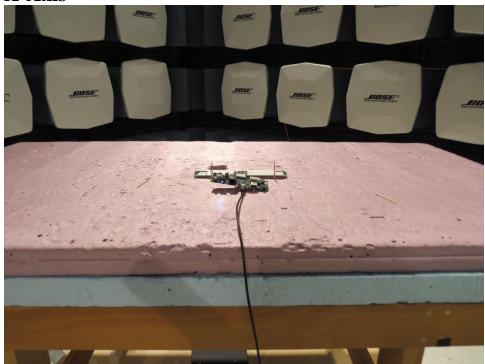
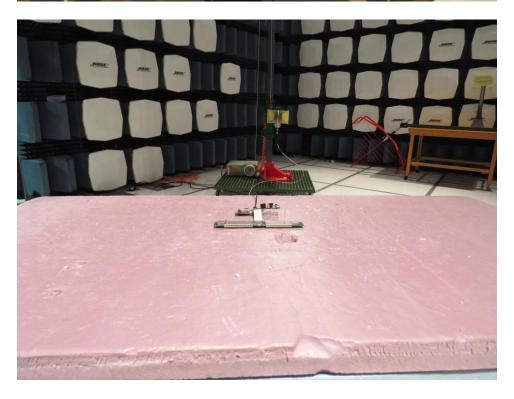
### X-Axis

#### **Radiated emissions**

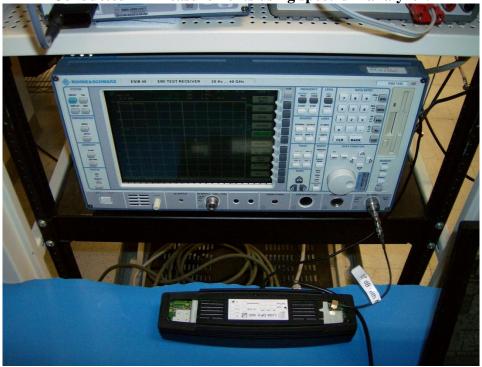
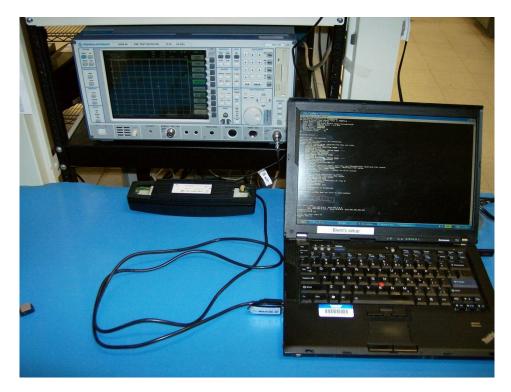
Conducted RF measurements using spectrum analyzer.

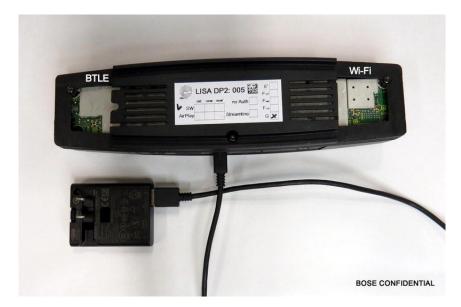
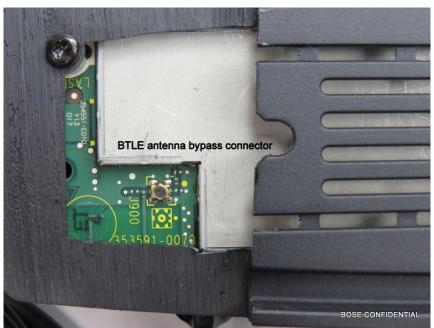
Location of test points for conducted RF measurement
