Report No.: 0602987  
Receiving mode  
(169.505MHz)  
AC Mains

Tested By:Hong, Report No.:0602987

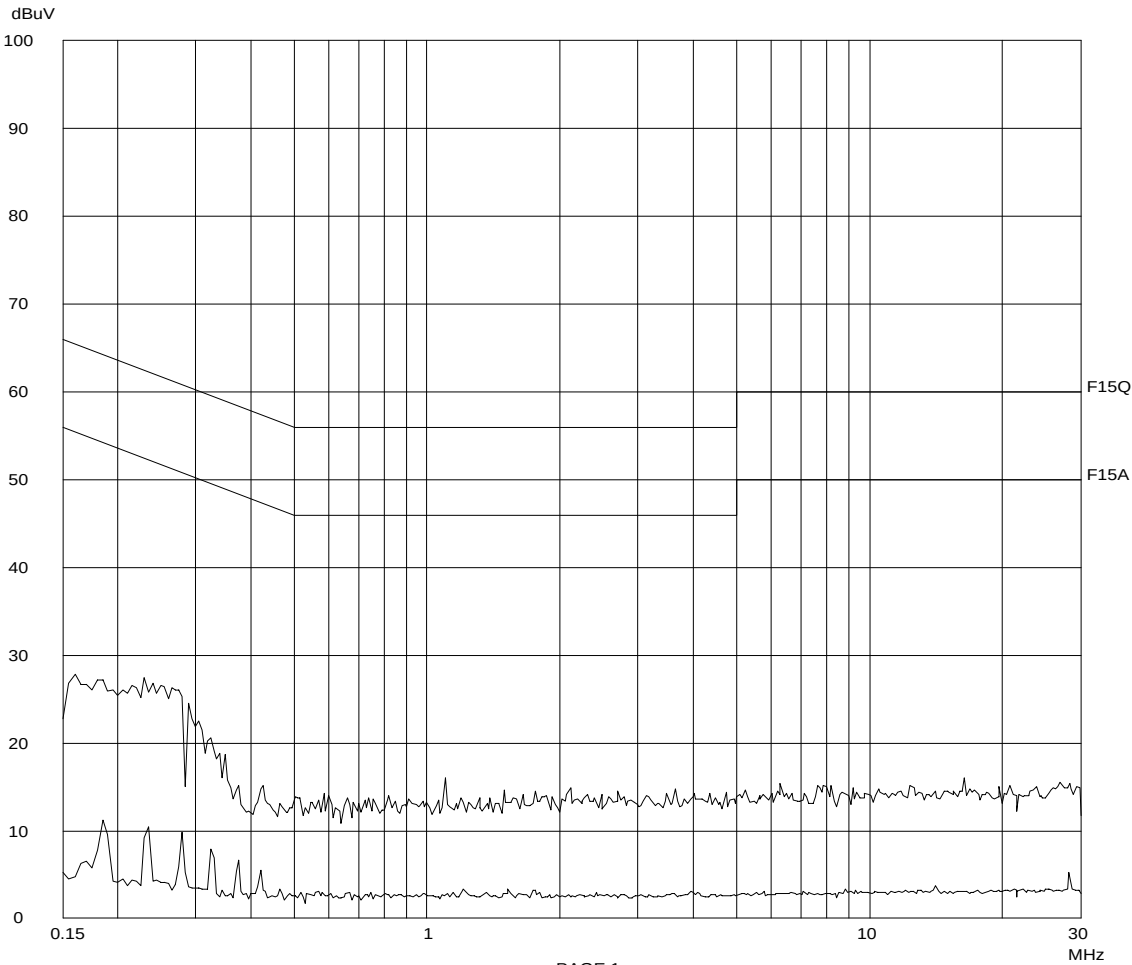
| Frequencies | | | | Receiver Settings | | | | |
|---|---|---|---|---|---|---|---|---|
| 150k | 30M | 5k | 10k | PK+AV | 10ms | AUTO | LN OFF | 60dB |

Final Measurement: x QP / + AV  
Meas Time: 1 s  
Subranges: 16  
Acc Margin: 20dB

no Results

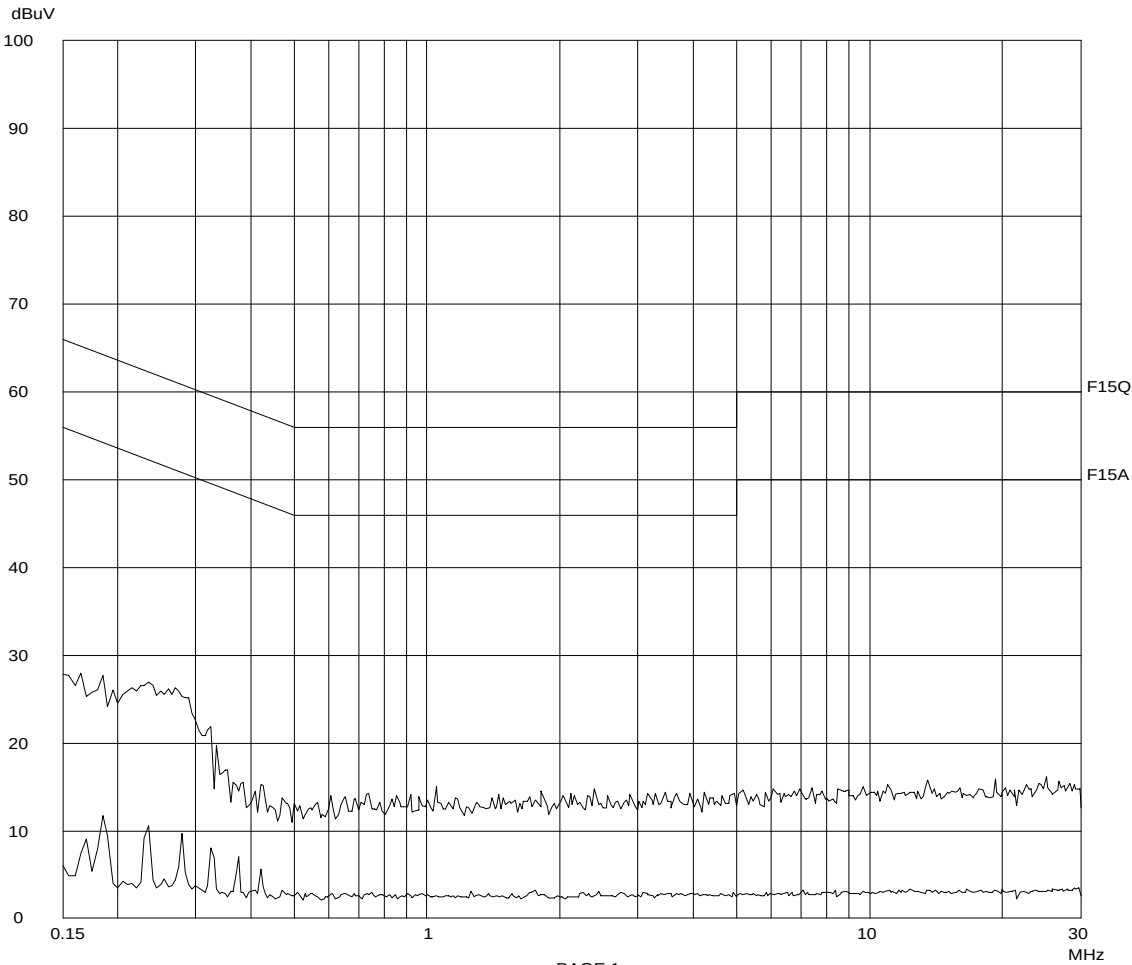
Report No.: 0602987  
Receiving mode  
(171.905MHz)  
AC Mains

| Frequencies | | | | Receiver Settings | | | | |
|---|---|---|---|---|---|---|---|---|
| 150k | 30M | 5k | 10k | PK+AV | 10ms | AUTO | LN OFF | 60dB |

Final Measurement: x QP / + AV  
Meas Time: 1 s  
Subranges: 16  
Acc Margin: 20dB

no Results
