Intertek Testing Services

Mode = Tx

Report No.: 9912828

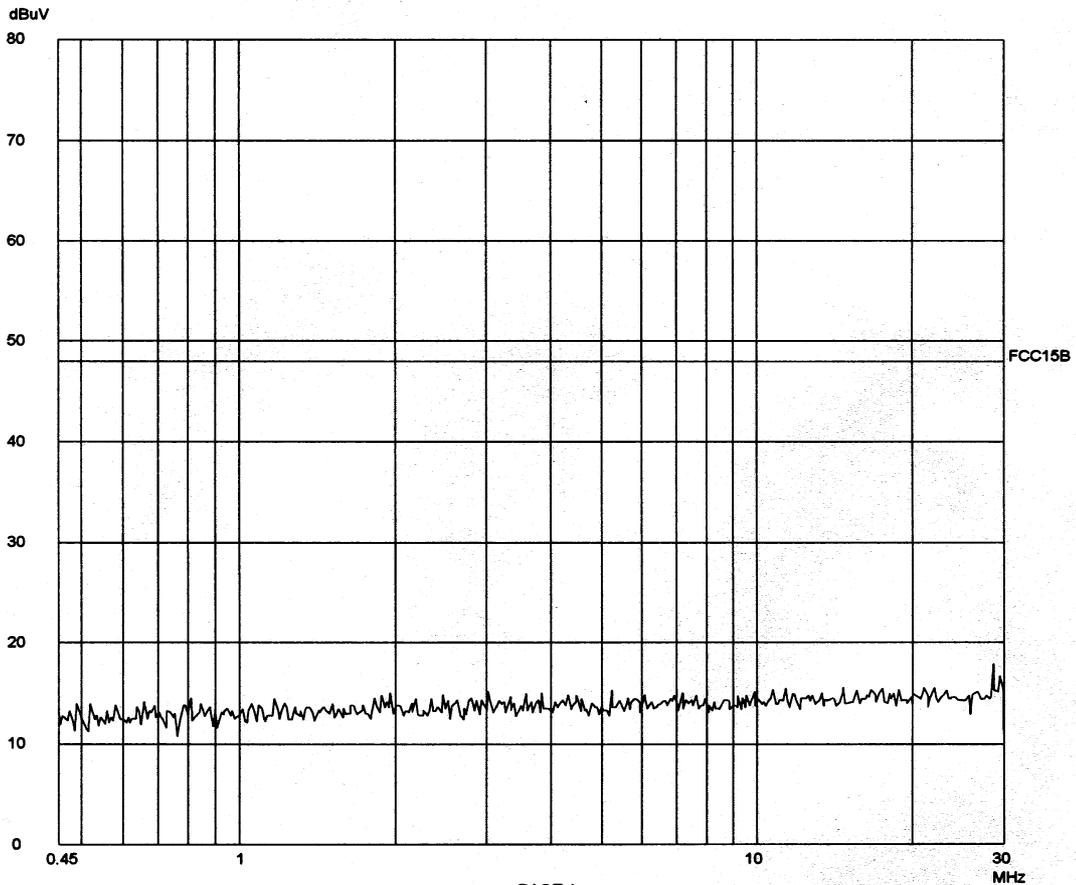
Scan Settings (1 Range)

Frequencies			Receiver Settings					
Start	Stop	Step	IF BW	Detector	M-Time	Atten	Preamp	OpRge
450k	30M	5k	10k	PK	20ms	AUTO	LN OFF	60dB

Final Measurement: x QP

Meas Time: 1 s
Subranges: 16
Acc Margin: 20dB

Transducer No.	Start	Stop	Name
3	9k	30M	EI078

Final Measurement Results:

no Results

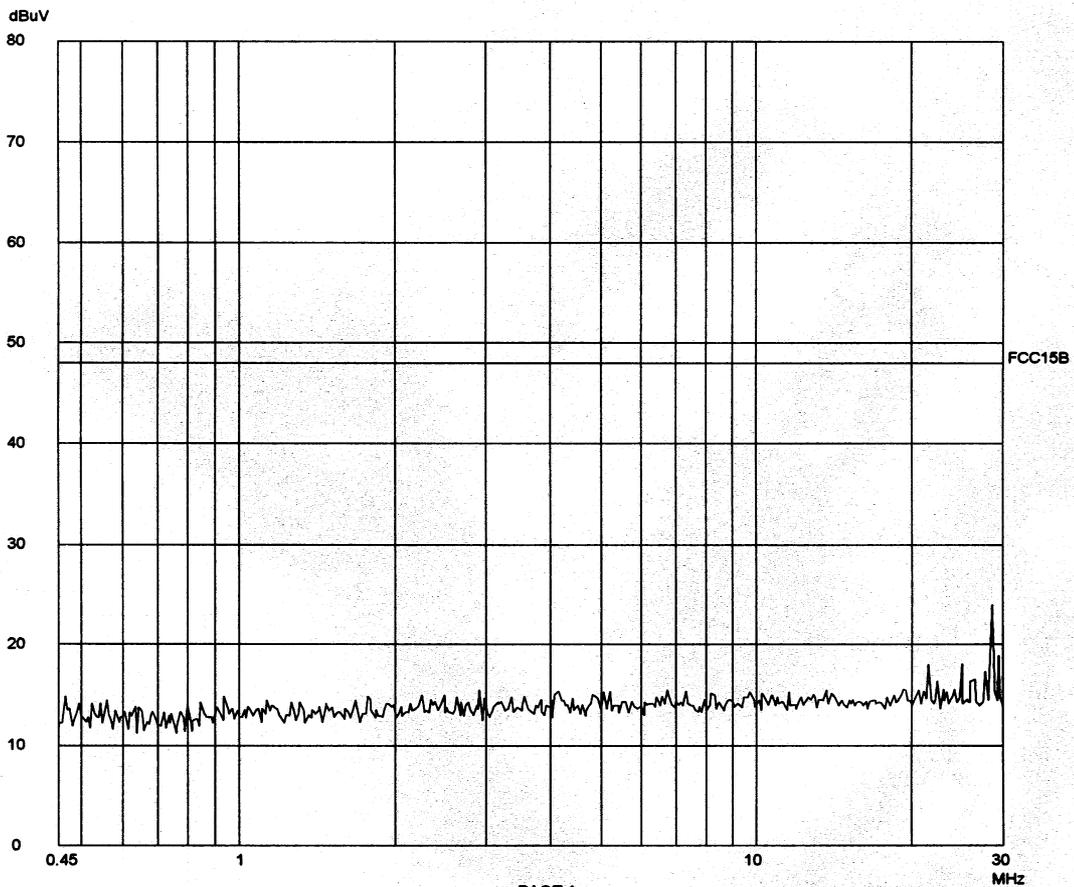
Mode = Charging

Frequencies			Receiver Settings					
Start	Stop	Step	IF BW	Detector	M-Time	Atten	Preamp	OpRge
450k	30M	5k	10k	PK	20ms	AUTO	LN	OFF 60dB

Final Measurement: x QP
Meas Time: 1 s
Subranges: 16
Acc Margin: 20dB

Transducer No.	Start	Stop	Name
3	9k	30M	EI078

Final Measurement Results:

no Results

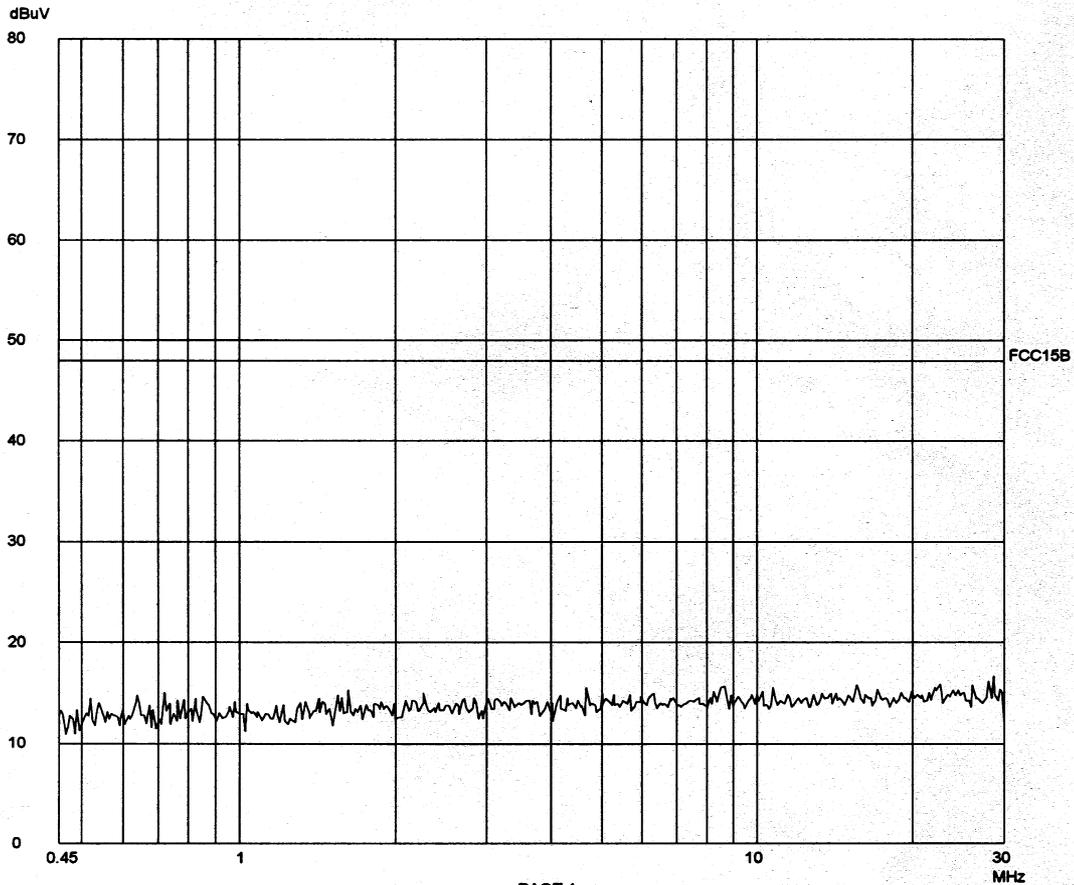
Mode = Stand by

Frequencies			Receiver Settings					
Start	Stop	Step	IF BW	Detector	M-Time	Atten	Preamp	OpRge
450k	30M	5k	10k	PK	20ms	AUTO	LN OFF	60dB

Final Measurement: x QP

Meas Time: 1 s
Subranges: 16
Acc Margin: 20dB

Transducer No.	Start	Stop	Name
3	9k	30M	EI078

Final Measurement Results:

no Results
