**APPENDIX 3: Photographs of test setup**

**Radiated Spurious Emission**

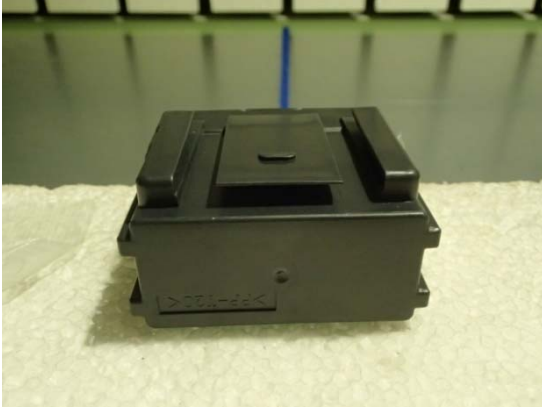
**ECU**  
Below 30 MHz  
X-axis  
Above 30 MHz  
Horizontal: X-axis / Vertical: X-axis  
X-axis

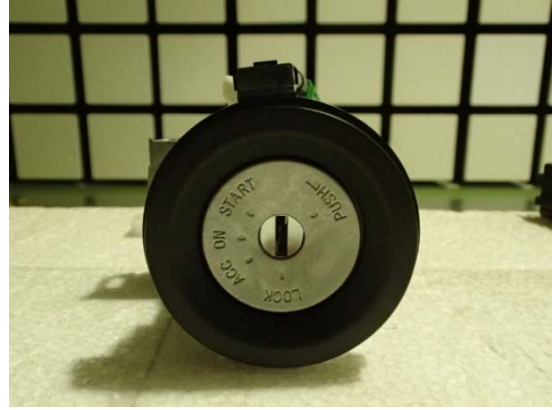
**Immobilizer**  
Below 30 MHz  
Z-axis  
Above 30 MHz  
Horizontal: X-axis / Vertical: X-axis  
X-axis

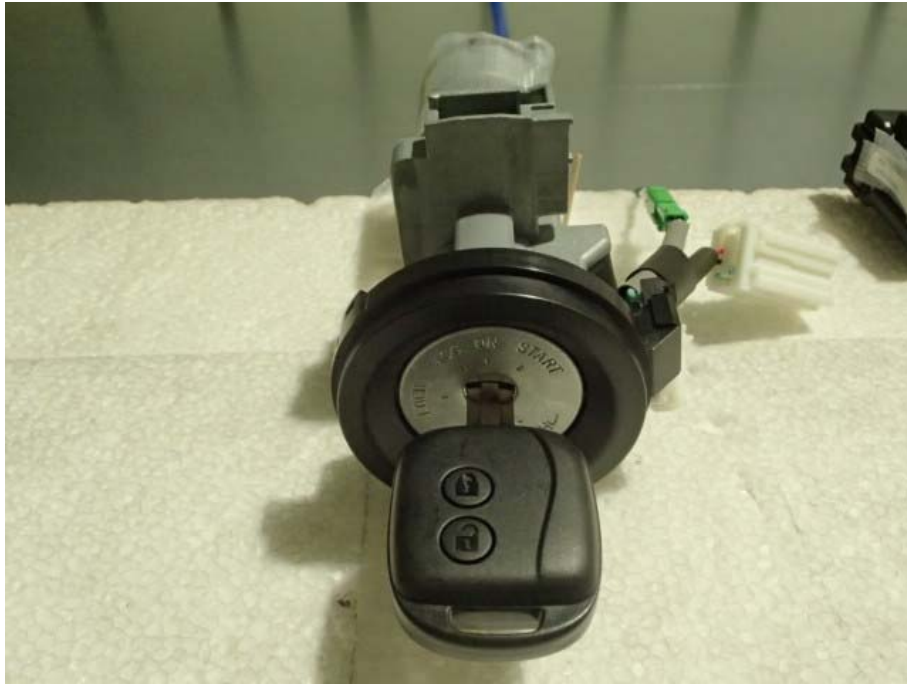
**With key**

**Worst case position**

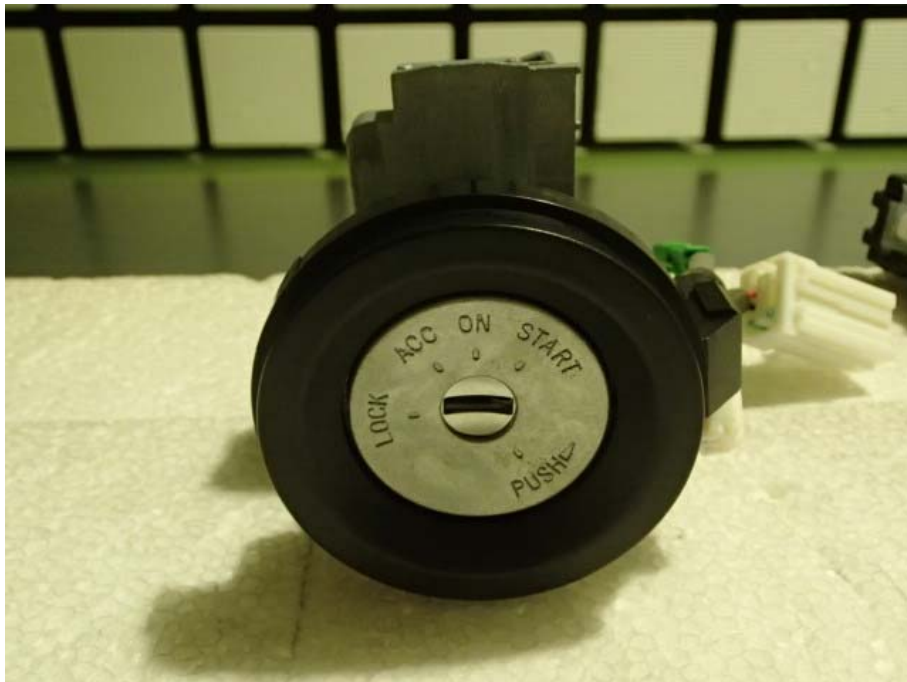
**Without key (Worst)**
