Photographs of the Furuno AIS Transponder FA-50 to Reveal Equipment Construction and Layout (FCC Rule, 2.1033)

1.1 AIS Transponder FA-50

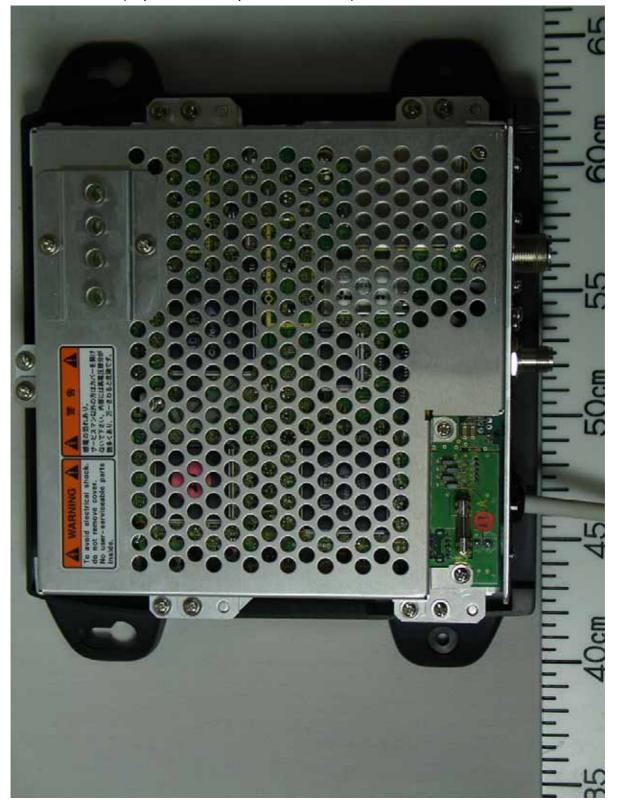
1.1.1 Inside View (Top side, with Top Cover removed)

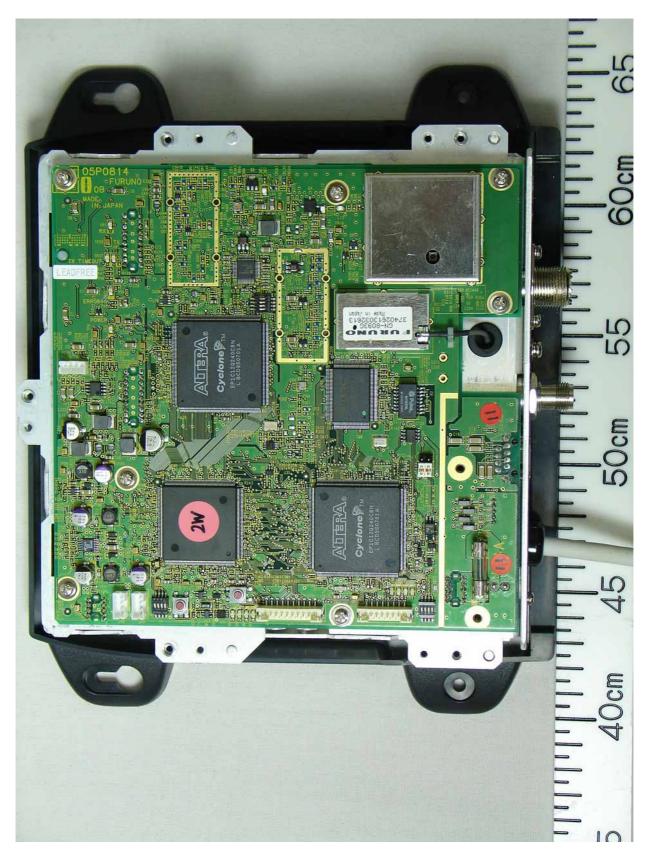
1.1.2 Inside View (Top side, with Shield-cover removed, showing Main & TX & GPS Board 05P0814 front side)

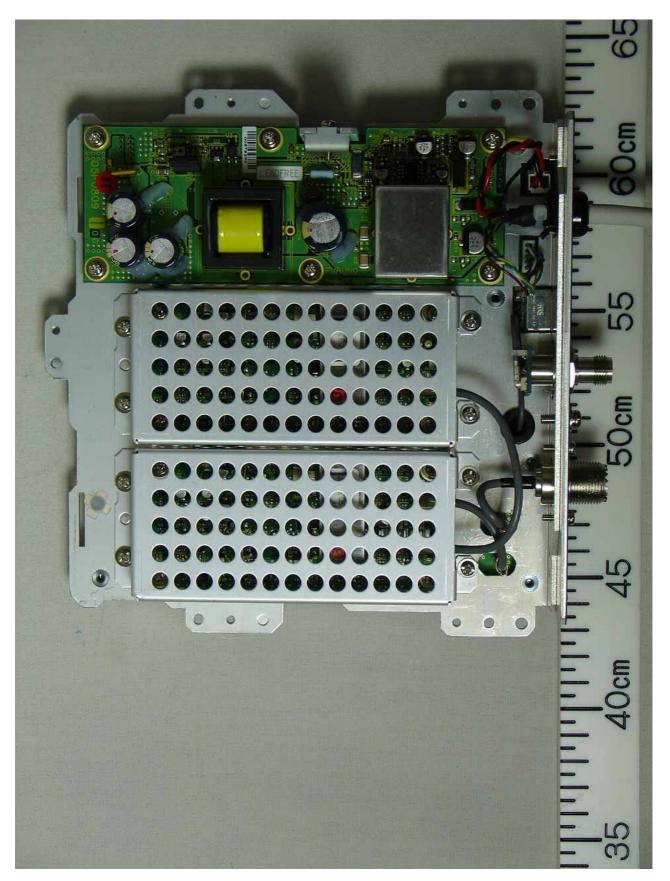
1.1.3 Inside View (Bottom side, showing PWR 05P0809 (upper) and RX 05P0808 (lower) Boards with Shield-covers)

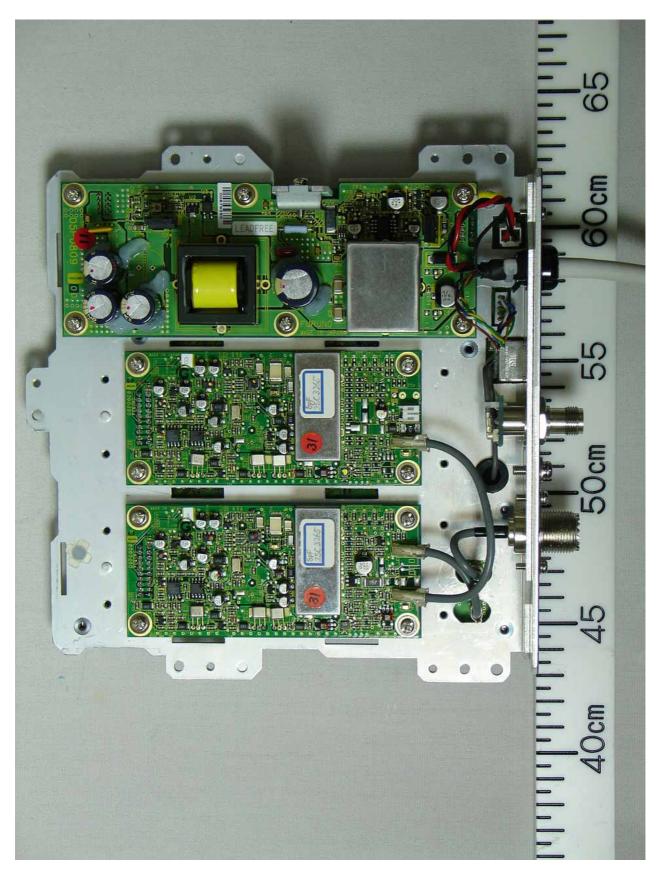
1.1.4 Inside View (Bottom side, showing PWR 05P0809 (upper) and RX 05P0808 (lower) Boards with Shield-covers removed)
