Photographs of the Furuno Radar FR-8062 with Transceiver RTR-085 included

1.1 Antenna unit RSB-0073

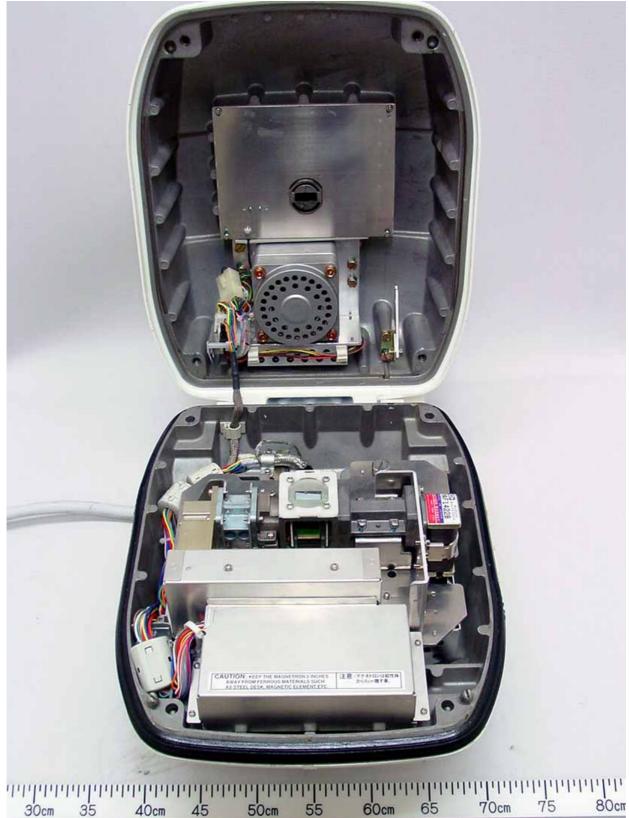
1.1.1 Inside View (with Top cover opened, showing Scanner Motor (upper) and Transceiver RTR-085 (lower))

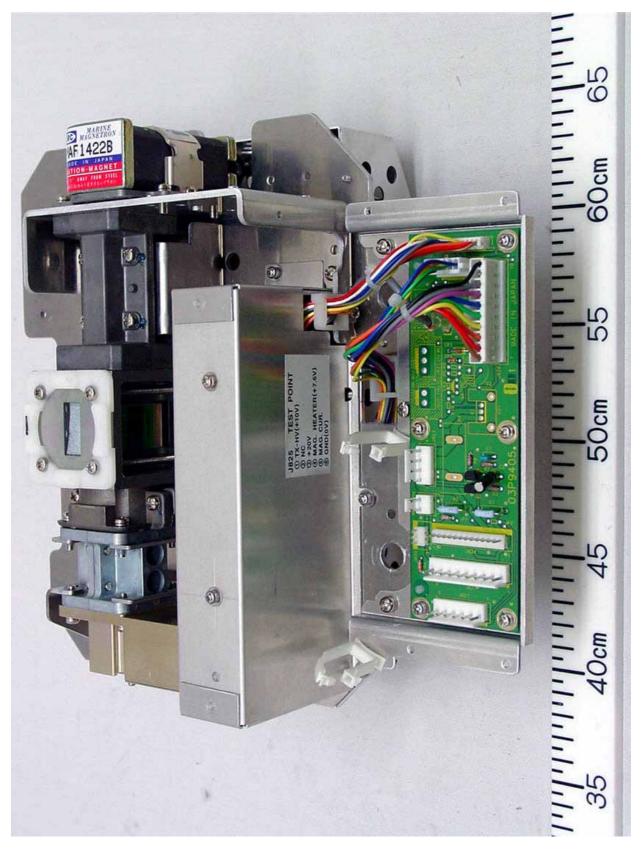
1.1.2 Transceiver Top View (with shield-cover removed, showing RTB Board 03P9405 (right), IF AMP Board enclosed by shield-cover (center), Magnetron (top left), Circulator (center left), Limiter (lower left) and Mic (bottom left))

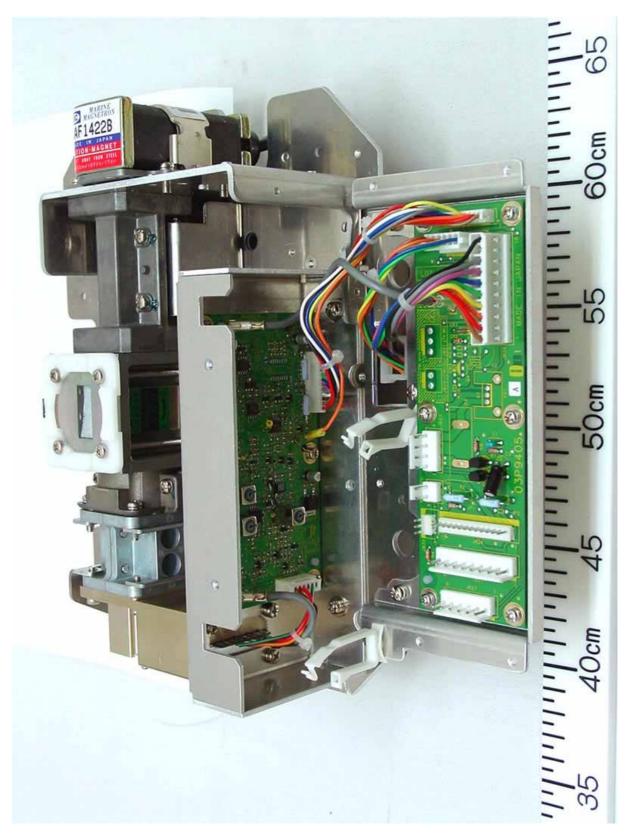
1.1.3 Transceiver Top View (with IF AMP's shield-cover removed, showing IF AMP Board 03P9404 (center))

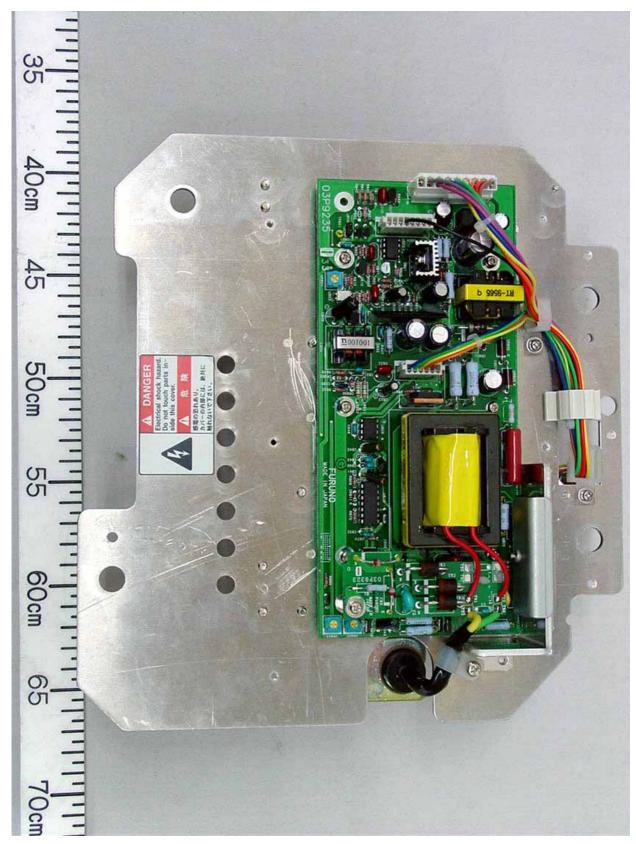
1.1.5 Transceiver Bottom View (with shield-cover removed, showing MD 03P9235 and RRV 03P9323 (on MD Board) Boards Front side)
