## Photographs of the Furuno Radar FR-8122 with Transceiver RTR-086 included

## 1 Internal View

## 1.1 Antenna unit RSB-0073

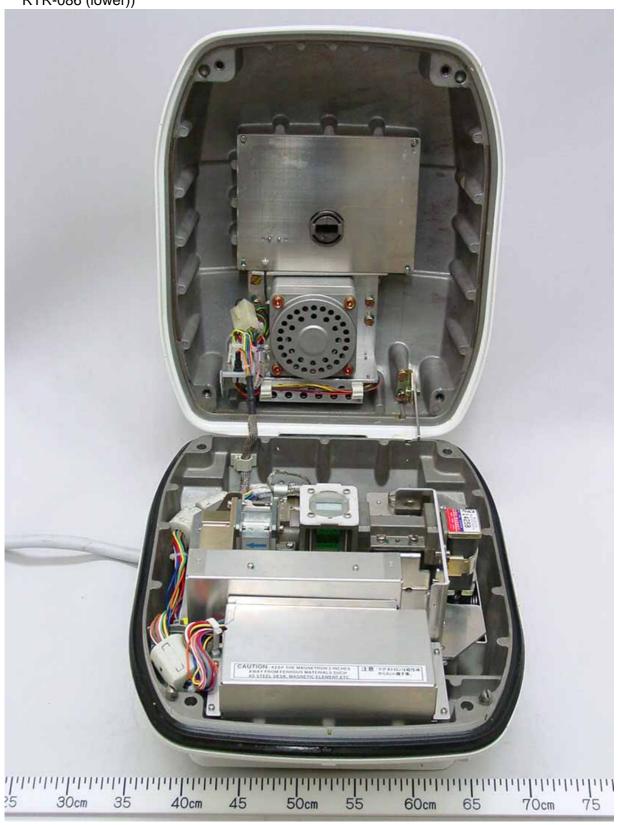
1.1.1 Inside View (with Top cover opened, showing Scanner Motor (upper) and Transceiver RTR-086 (lower))

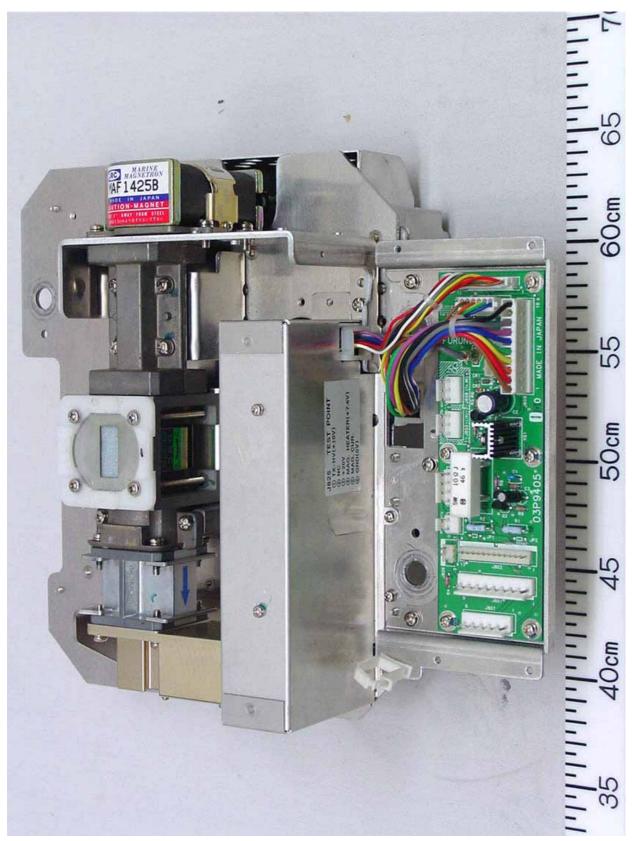
1.1.2 Transceiver Top View (with RTB shield-cover removed, showing RTB Board 03P9405 (right), IF AMP Board enclosed by shield-cover (center), Magnetron (top left), Circulator (center left), Limiter (lower left) and MIC (bottom left))

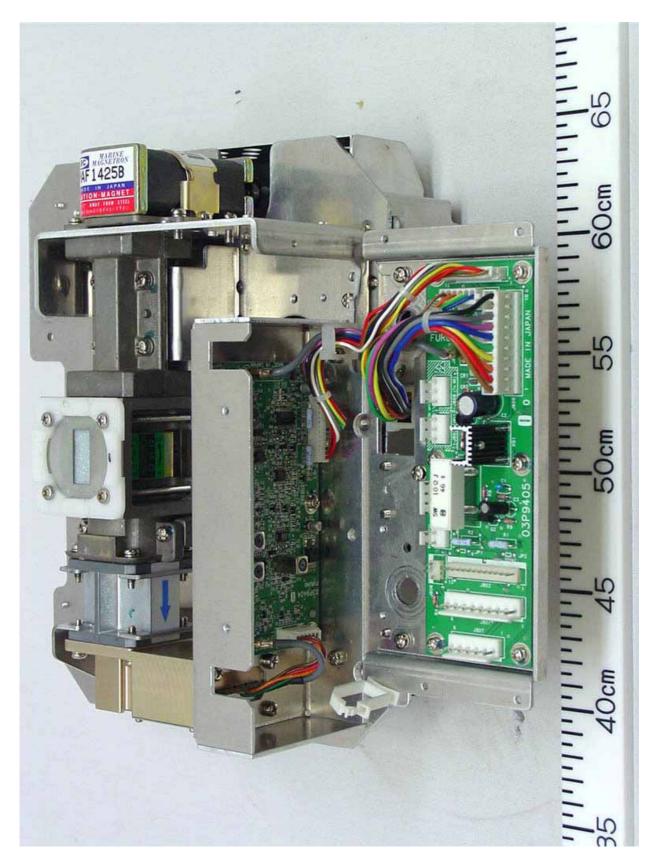
1.1.3 Transceiver Top View (with IF AMP's shield-cover removed, showing IF AMP Board 03P9404 (center))

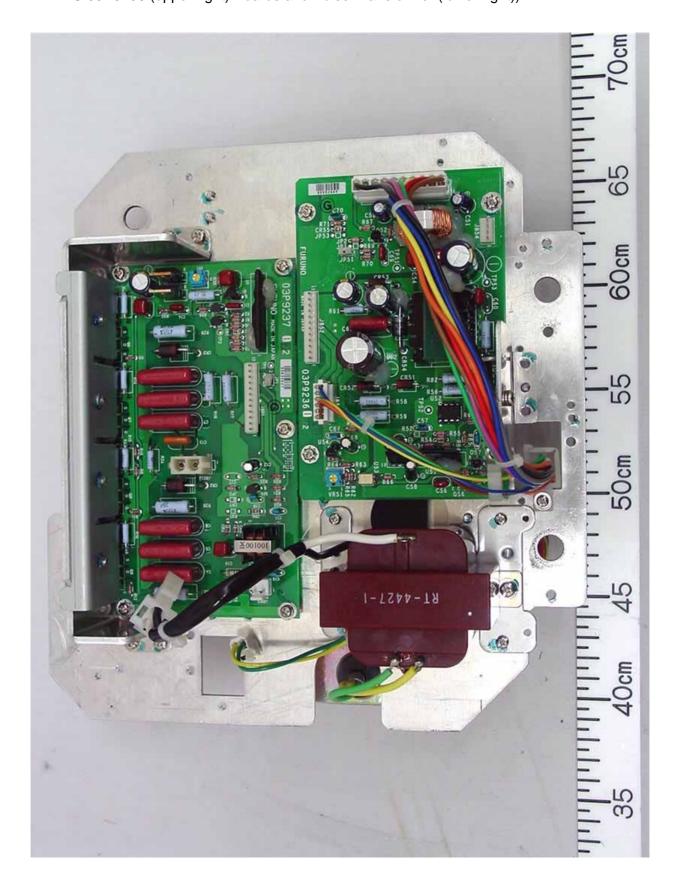
1.1.5 Transceiver Bottom View (with shield-cover removed, showing MD 03P9237 (left), PTU 03P9236 (upper right) Boards and Pulse Transformer (lower right))
