Photographs of Furuno Radar Sensor DRS4A with Transceiver RTR-092A

1 Internal View

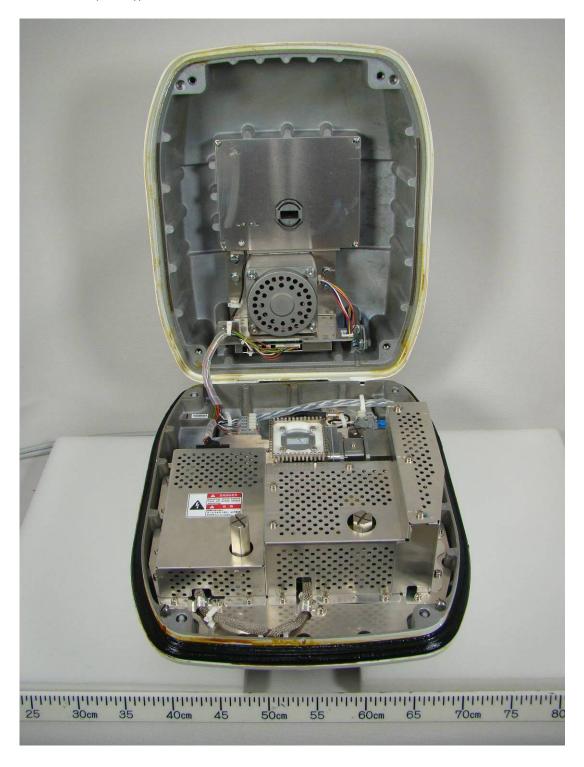
1.1 Inside View (with Top cover opened, showing Scanner Motor (upper) and Transceiver RTR-092A (lower))

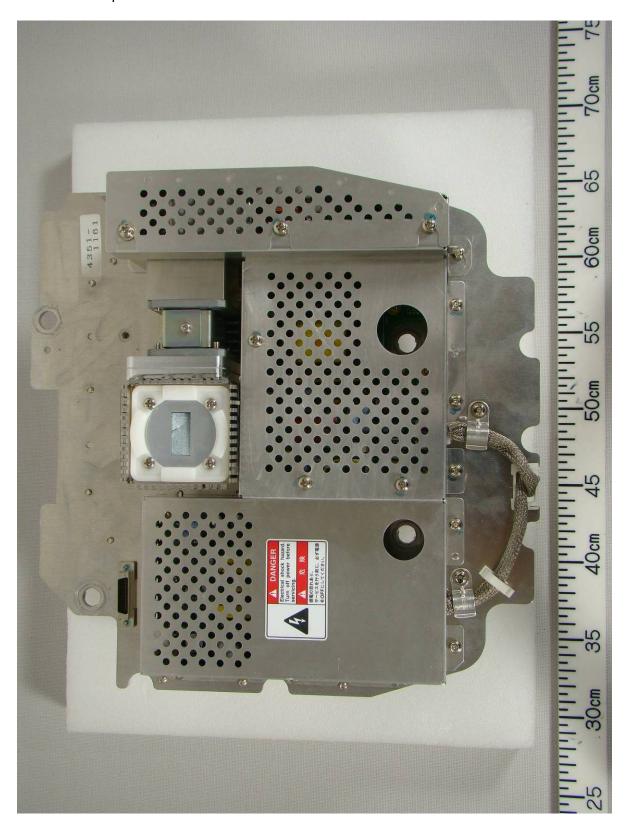
1.2 Transceiver Top View

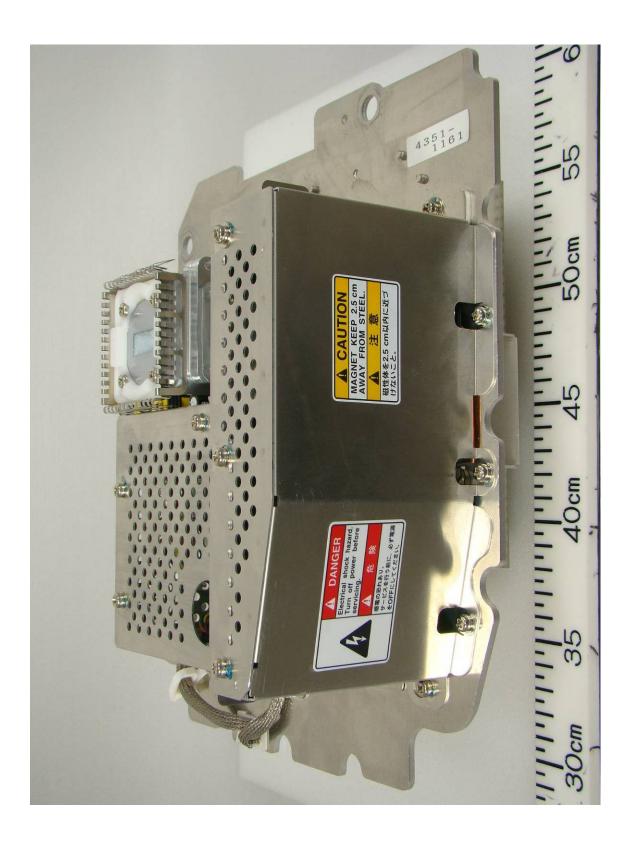
1.3 Transceiver Right Side View

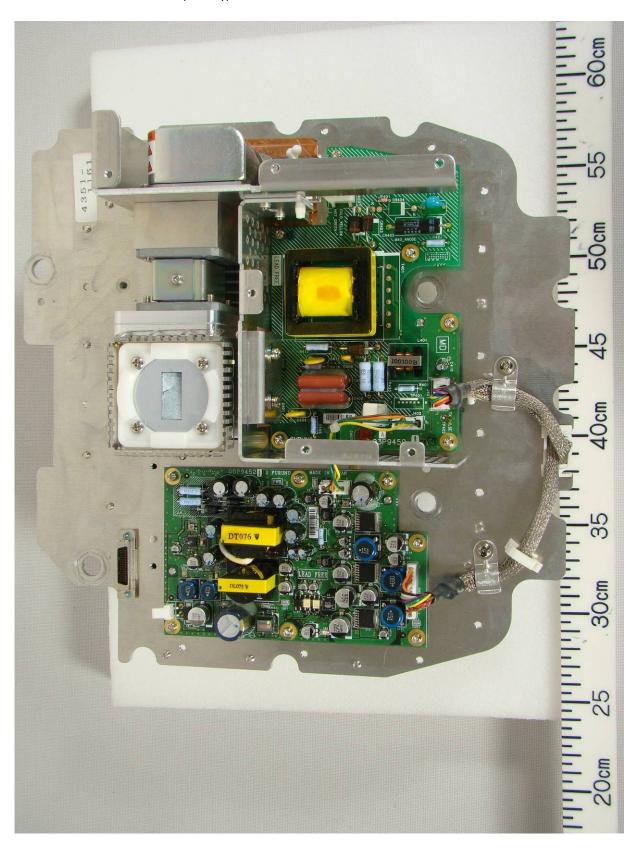
1.4 Transceiver Top View (with Shield-cover removed, showing MD Board 03P9450 (upper) and PWR Board 03P9452 (lower))

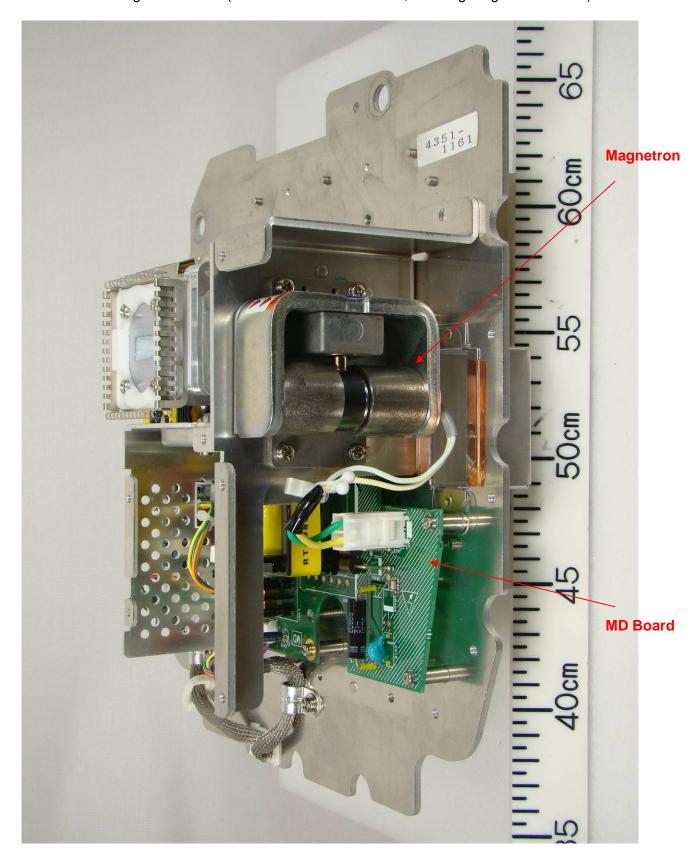
1.5 Transceiver Right Side View (with Shield-cover removed, showing Magnetron E3571)

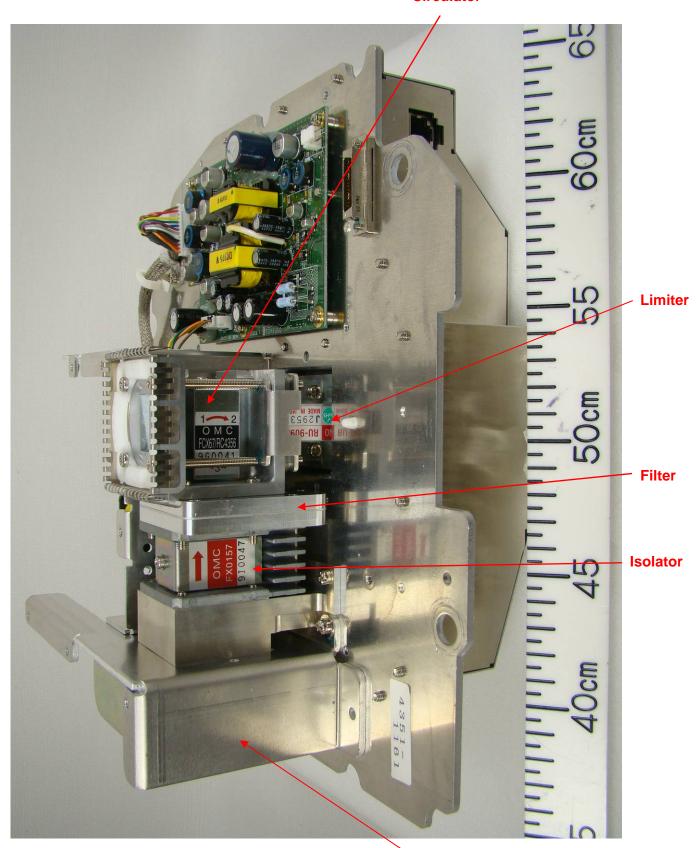
1.6 Transceiver Rear side View

Circulator

Magnetron (Inside)

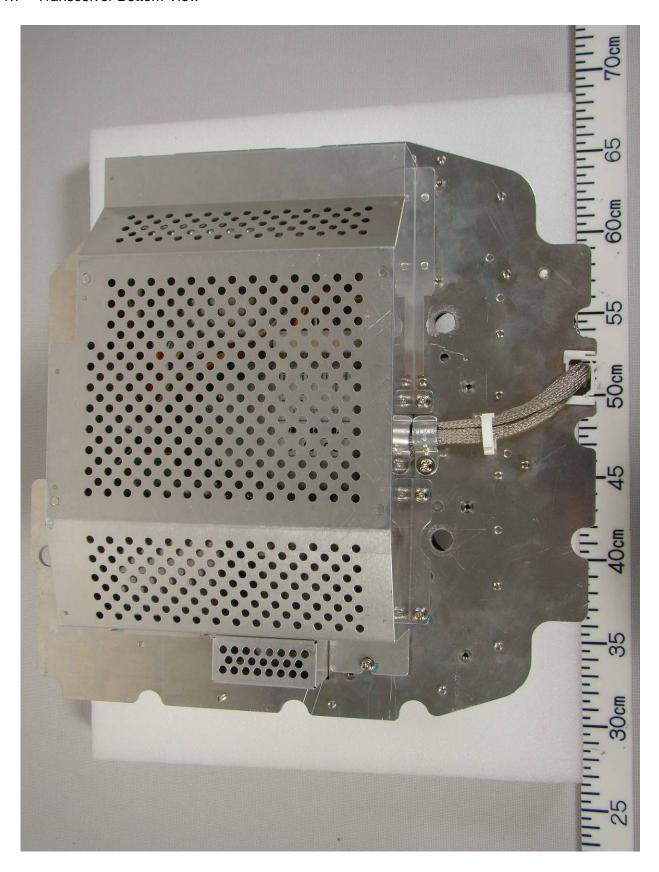
1.7 Transceiver Bottom View

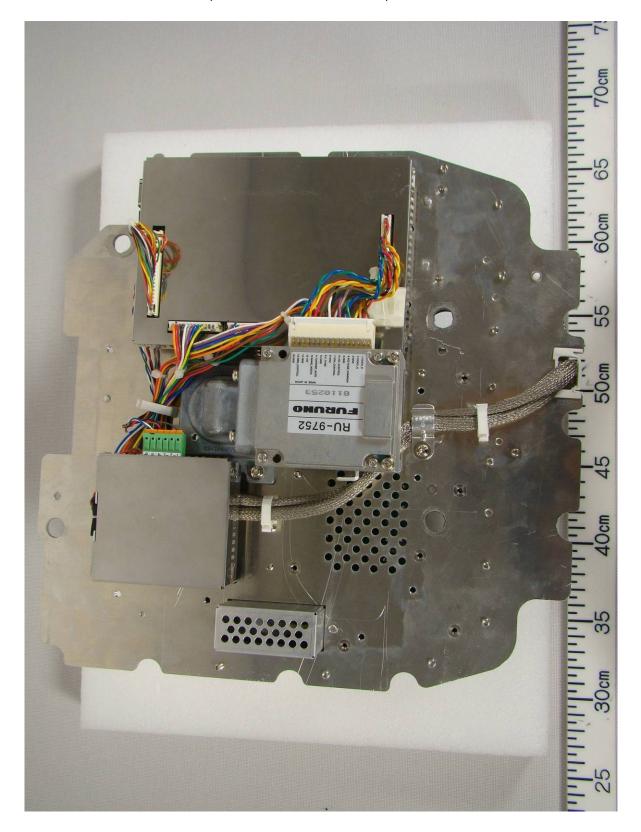
1.8 Transceiver Bottom View (with Shield-cover removed)

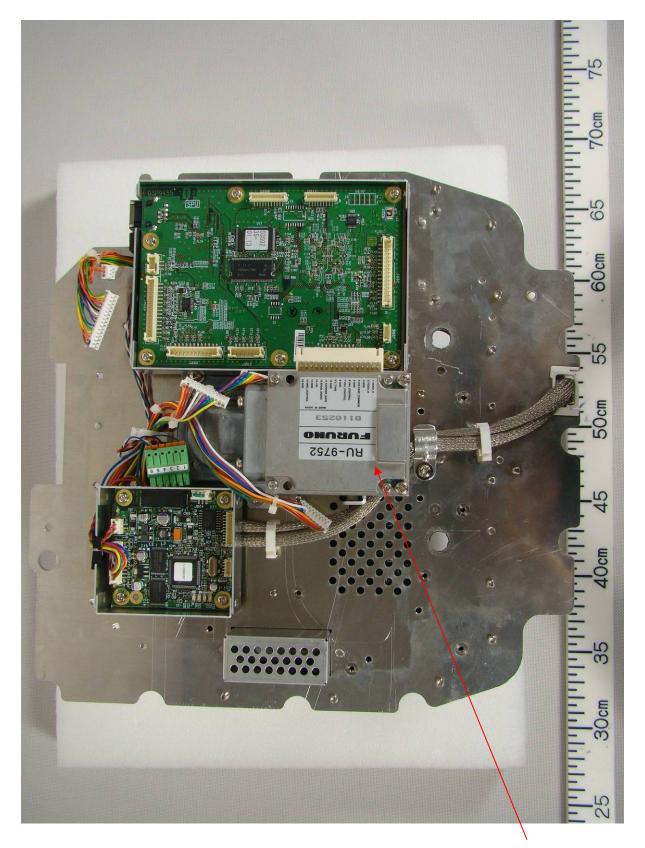
1.9 Transceiver Bottom View (with shield-covers removed, showing SPU Board 03P9455 (upper) and NMEA2000 Board 03P9462 (lower))

RXM Module
