# Photographs of Furuno Radar Sensor DRS12A with Transceiver RTR-094A

## 1 Internal View

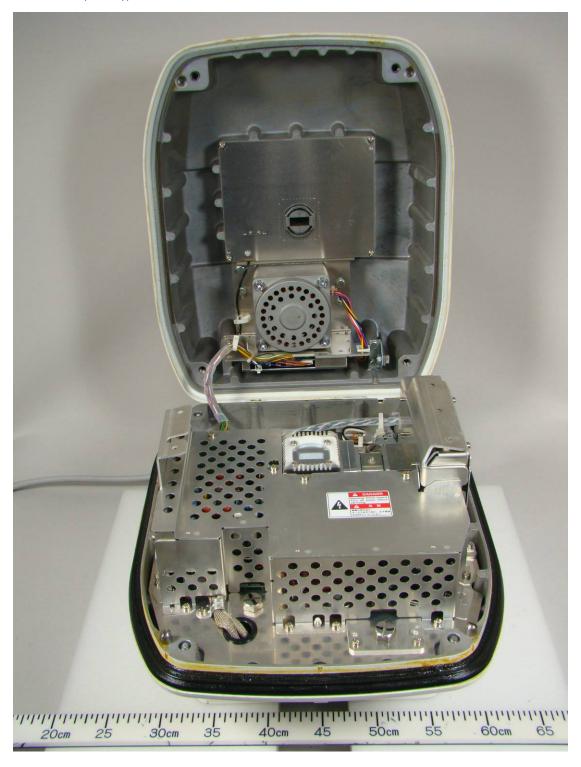
1.1 Inside View (with Top cover opened, showing Scanner Motor (upper) and Transceiver RTR-094A (lower))

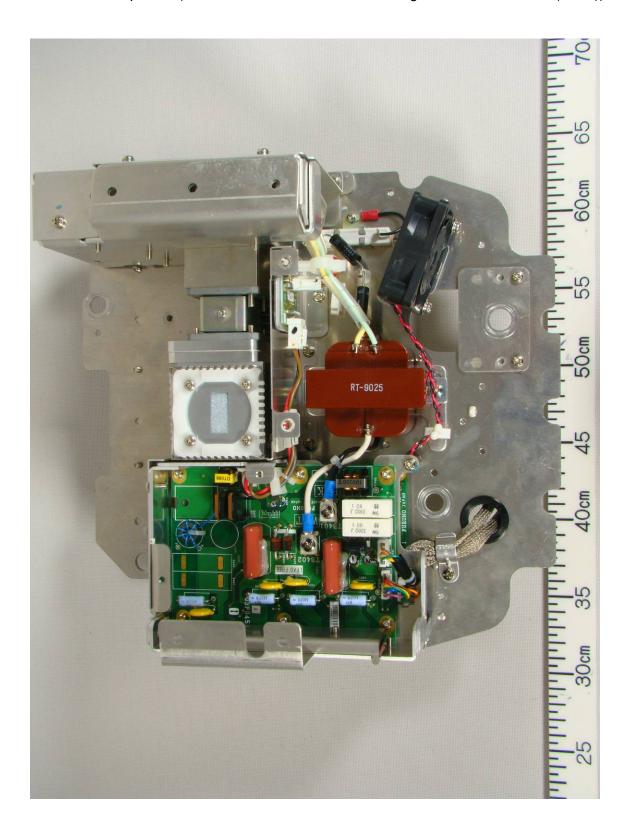
1.3 Transceiver Top View (with Shield-cover removed, showing MD Board 03P9451 (lower))

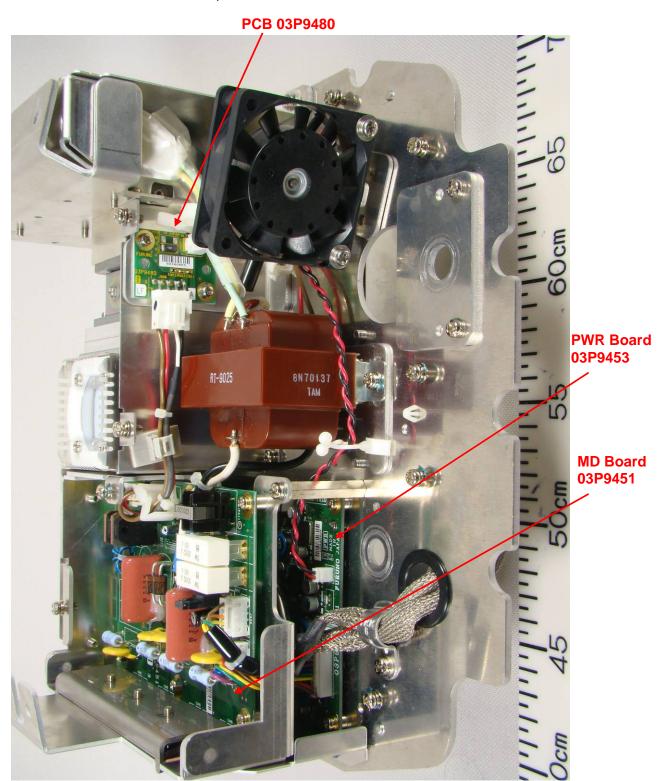
1.4 Transceiver Front View (with Shield-cover removed, showing PCB 03P9480, MD Board 03P9451 and PWR Board 03P9453)

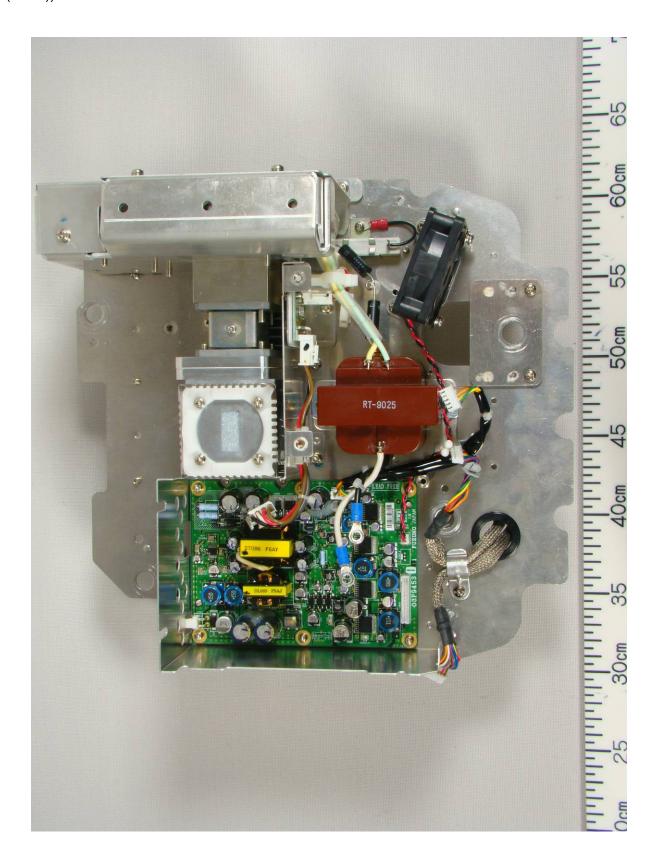
1.4 Transceiver Top View (with MD Board 03P9451 removed, showing PWR Board 03P9453 (lower))

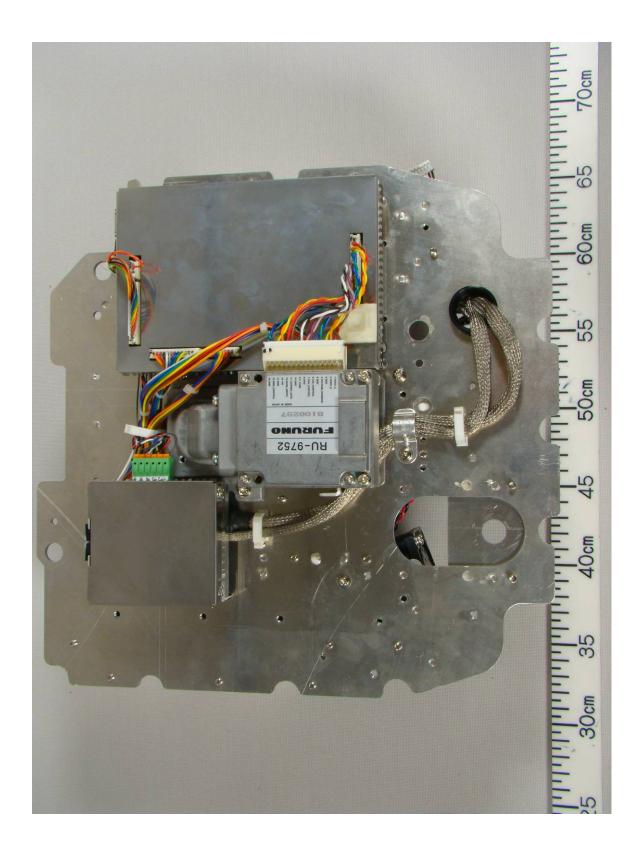
# 1.7 Transceiver Bottom View (with Shield-cover removed)

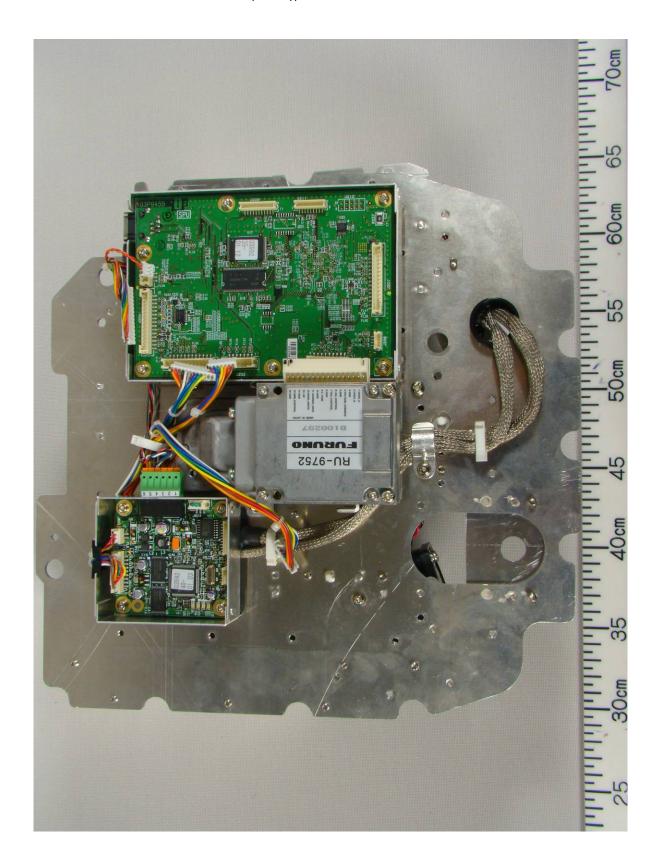
1.8 Transceiver Bottom View (with shield-covers removed, showing SPU Board 03P9455 (upper) and NMEA2000 Board 03P9462 (lower))
