Photographs of the Transceiver RTR-101 for Furuno Radar FAR-1528

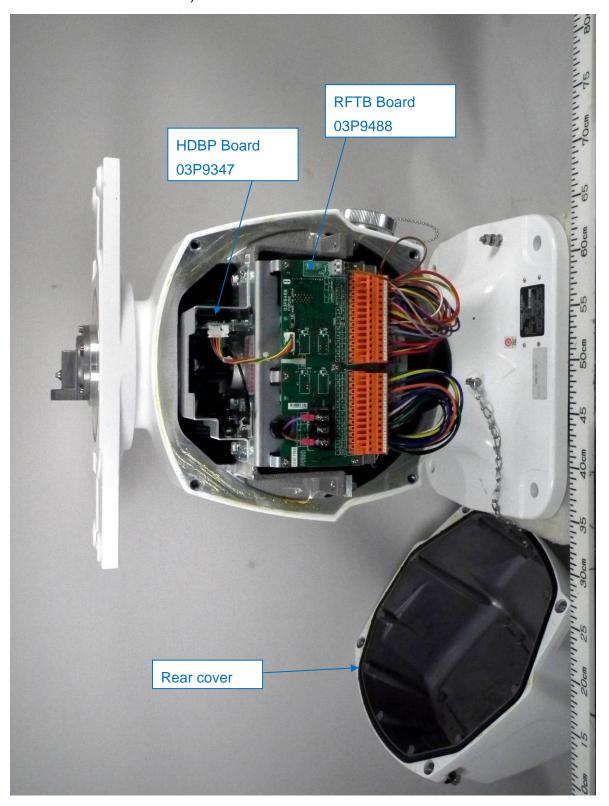
1.1 Inside Rear View (with Scanner rear cover removed, showing Scanner Motor Gear wheels and RFTB Board 03P9488)

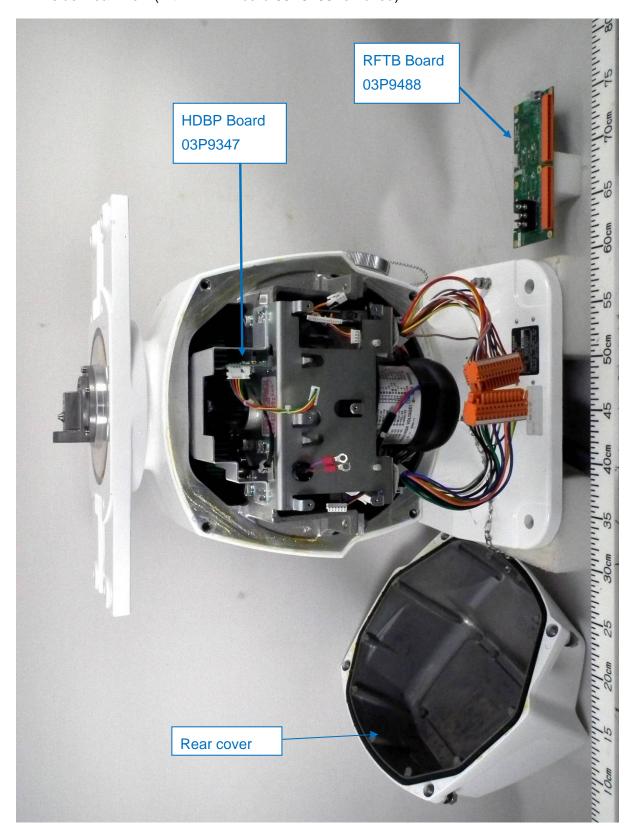
1.2 Inside Rear View (with RFTB Board 03P9488 removed)

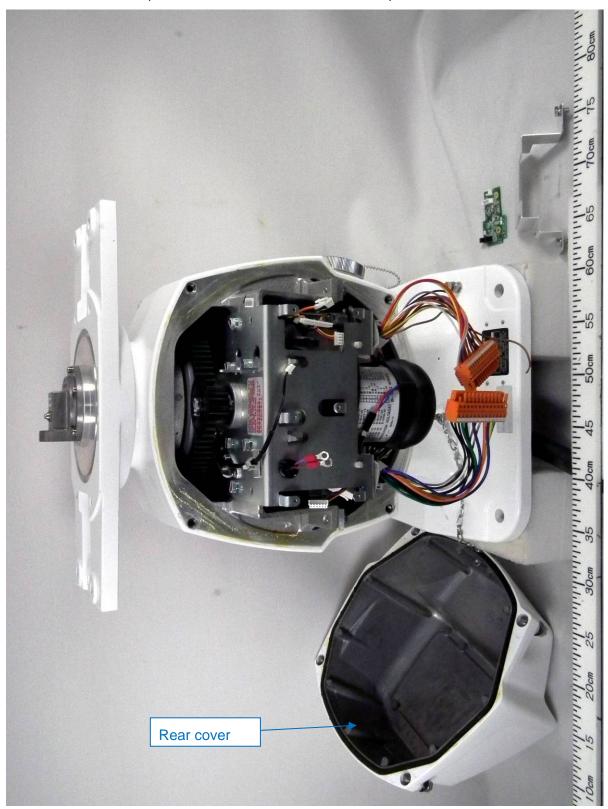
1.3 Inside Rear View (with HDBP Board 03P9347 removed)

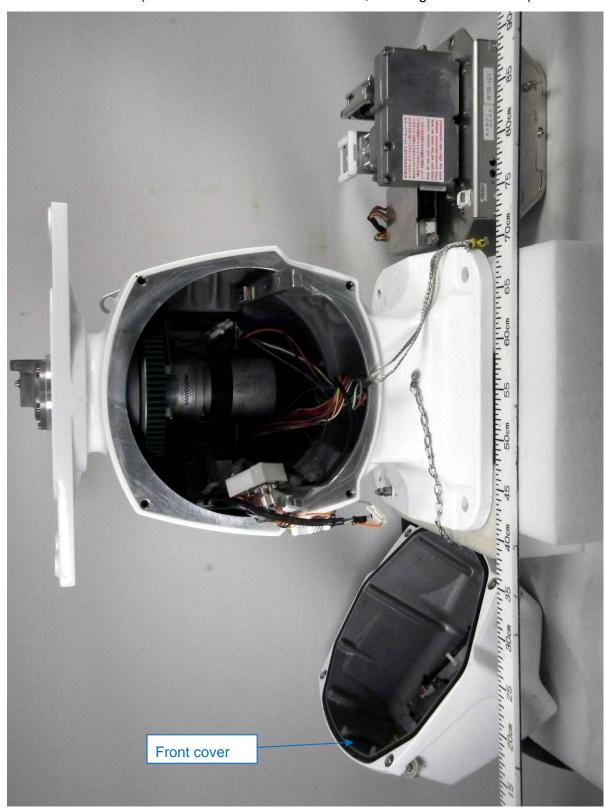
1.4 Inside Front view (with Transceiver module removed, showing Scanner Motor)

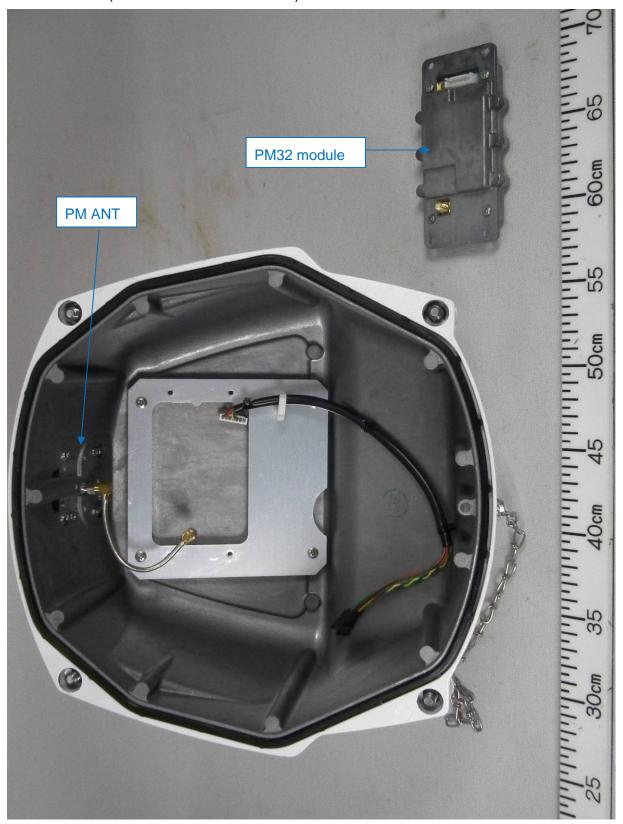
1.5 Front cover (with PM32 module removed)

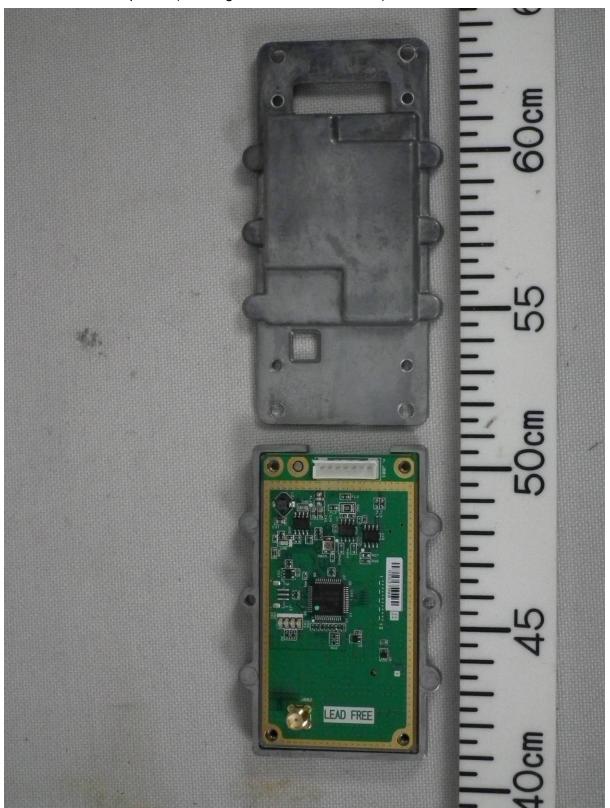
1.6 PM32 module opened (showing PM32 Board 03P9559)

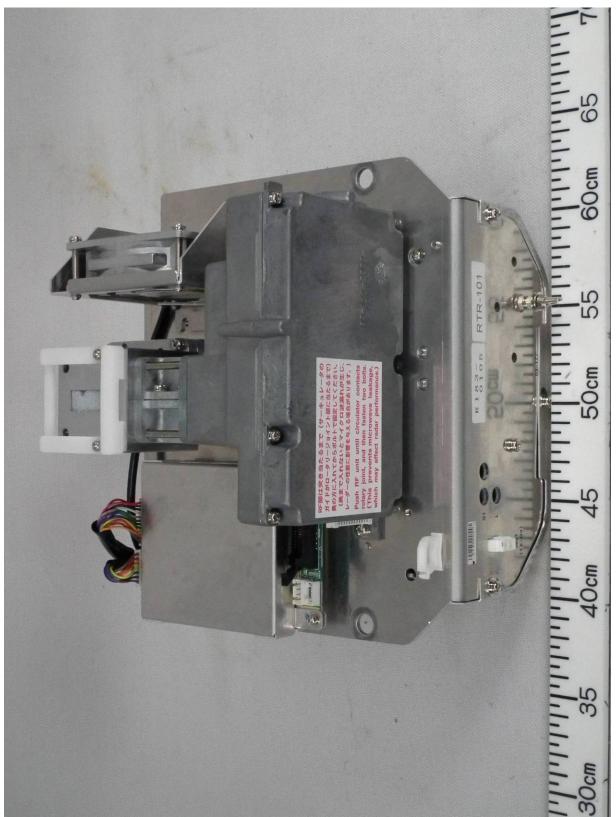
2.1 Outside Front view

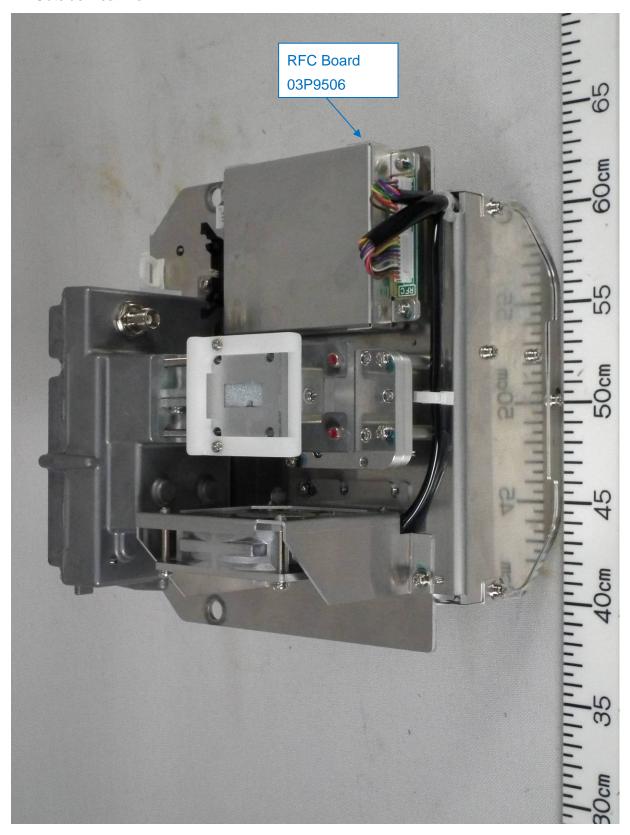
2.2 Outside Rear view

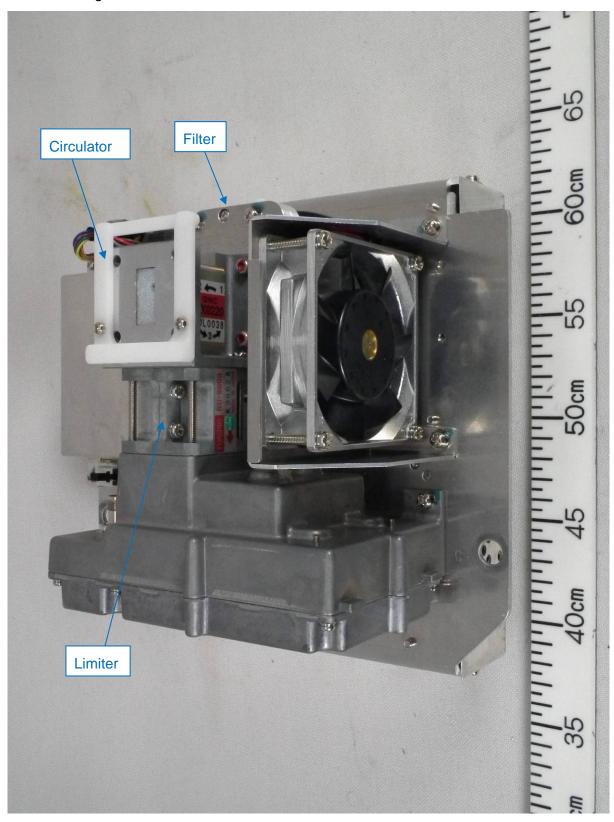
2.3 Outside Right view

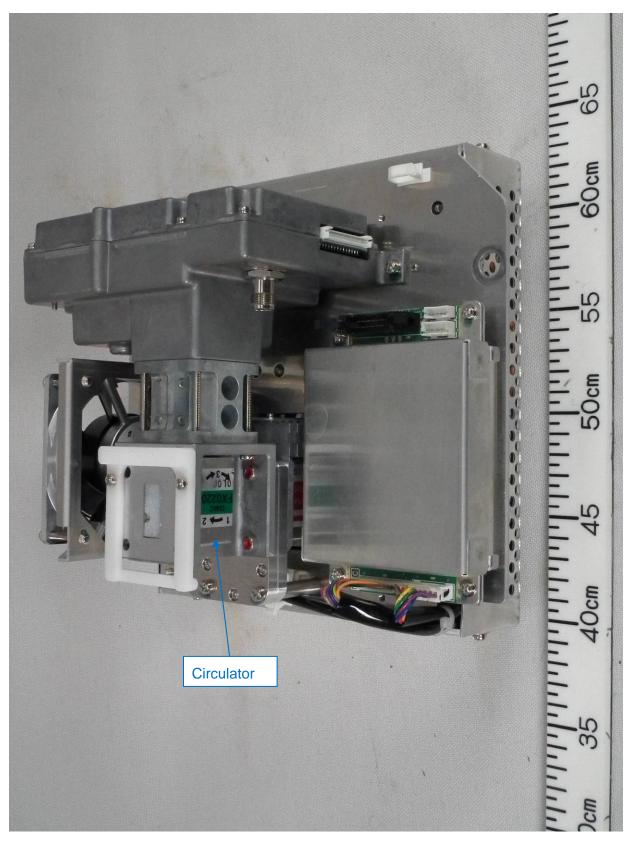
2.4 Outside Left view

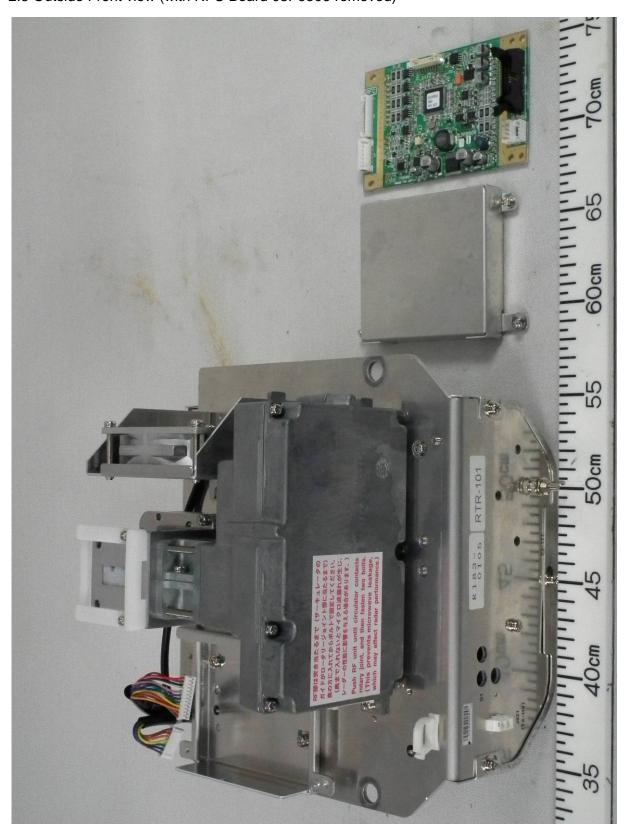
2.5 Outside Front view (with RFC Board 03P9506 removed)

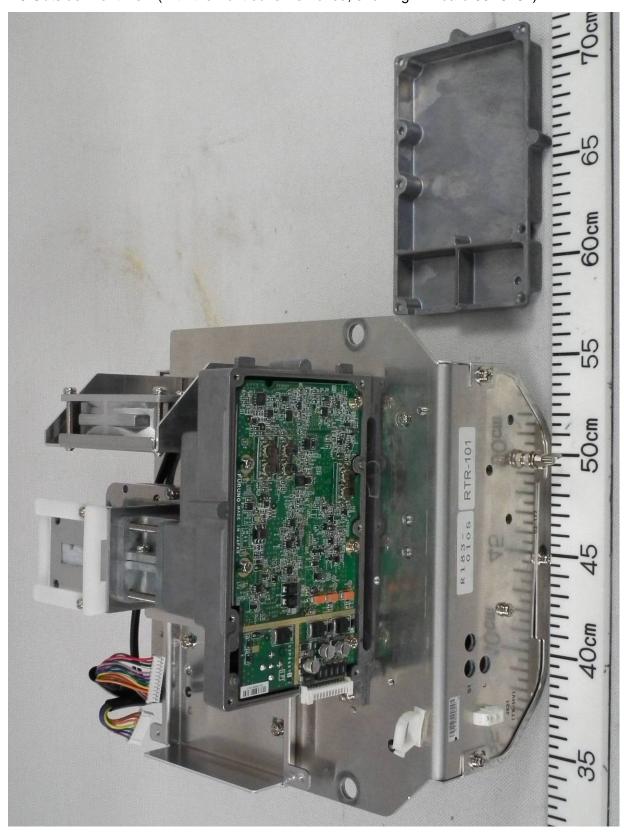
2.6 Outside Front view (with the front cover removed, showing IF Board 03P9487)

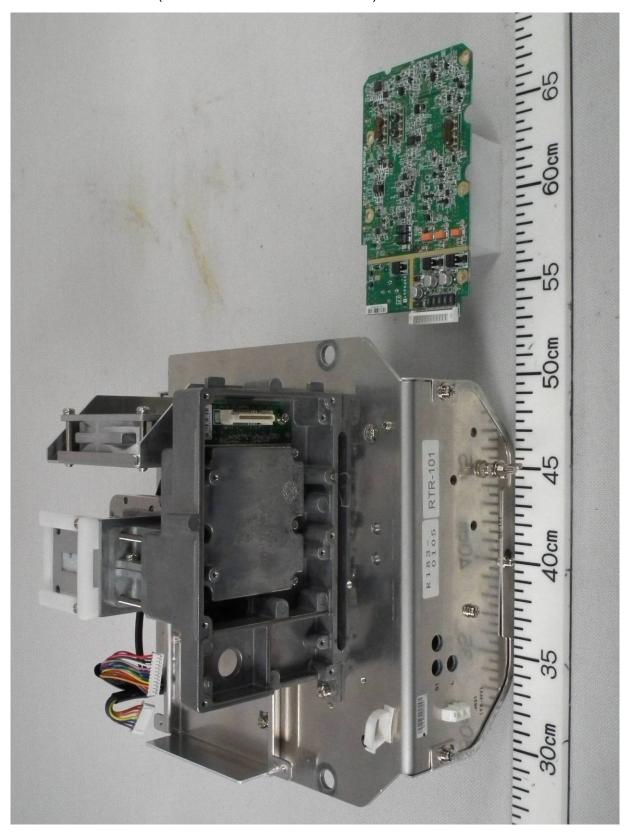
2.7 Outside Front view (with IF Board 03P9487 removed)

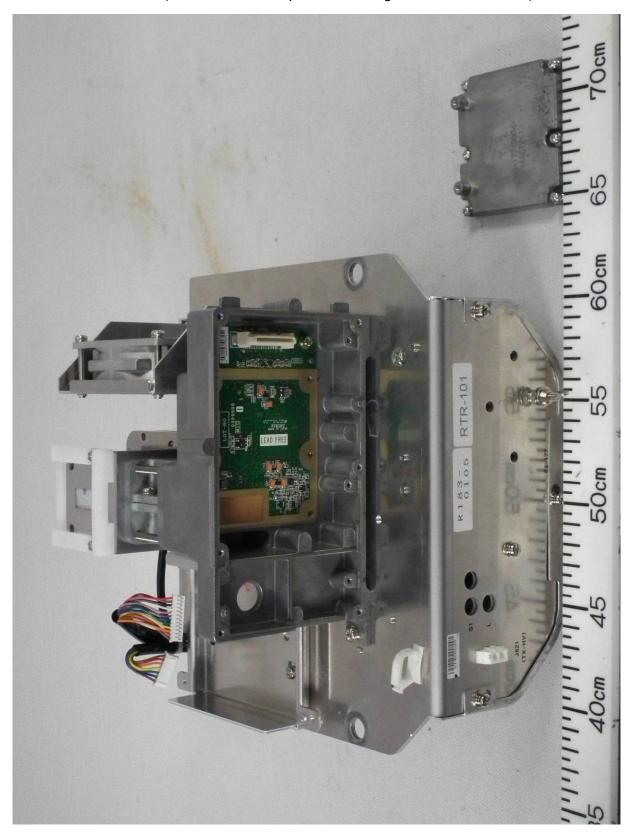
2.8 Outside Front view (with shield cover opened, showing MIC Board 03P9505)

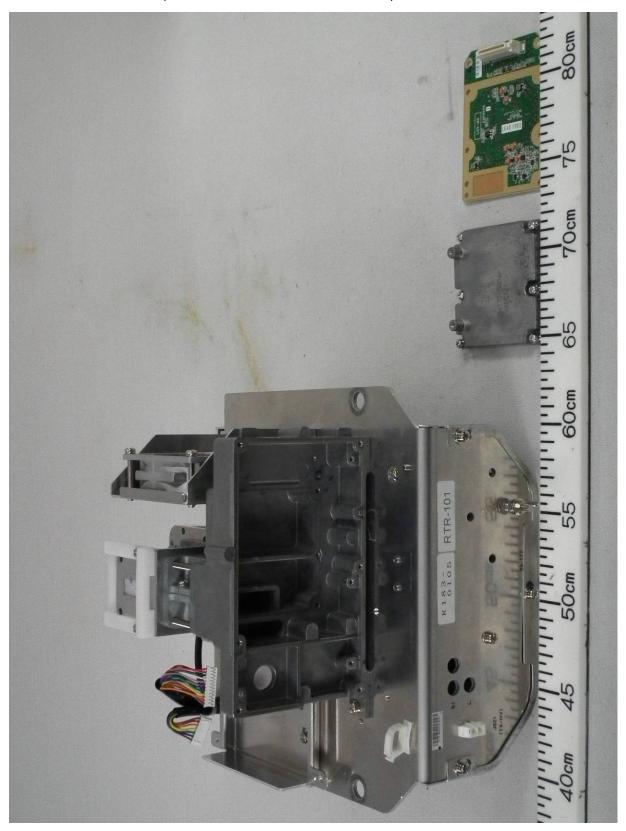
2.9 Outside Front view (with MIC Board 03P9505 removed)

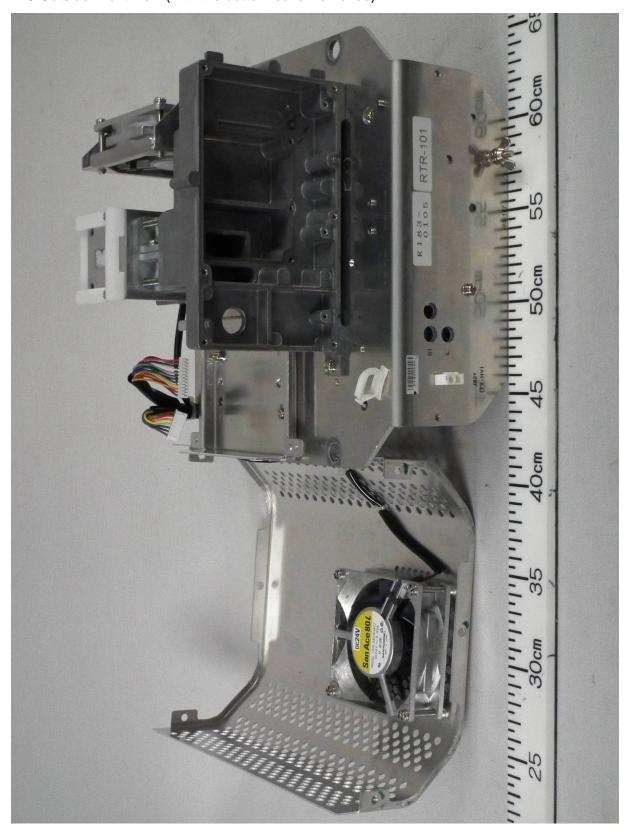
2.10 Outside Front view (with the bottom cover removed)

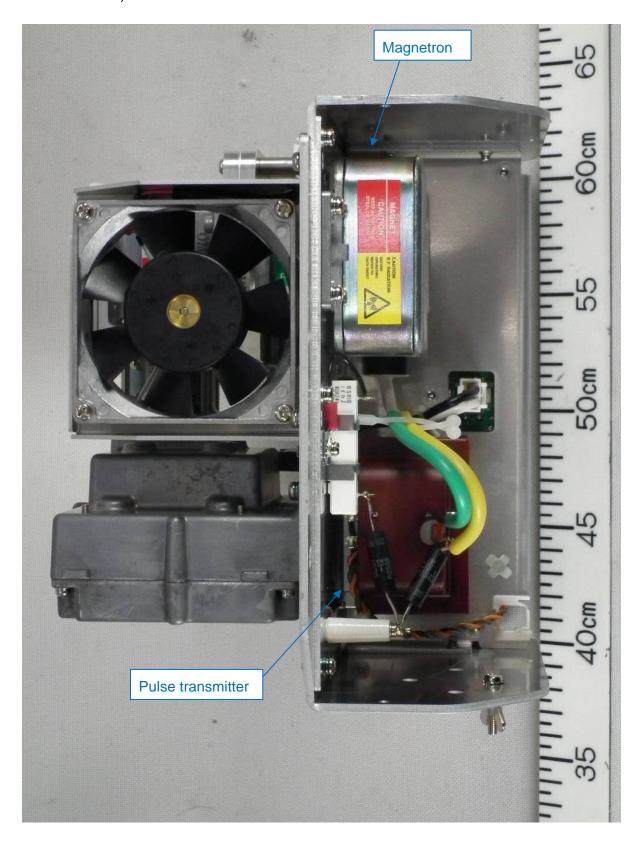
2.11 Outside Front view (with the bottom cover removed, showing Magnetron and Pulse transmitter)

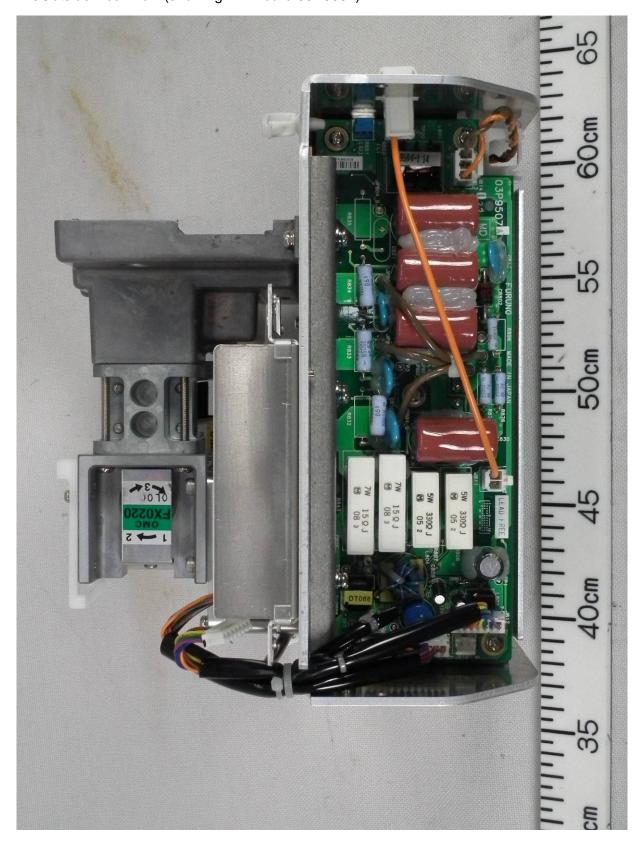
2.13Outside Rear view (showing MD Board 03P9507)

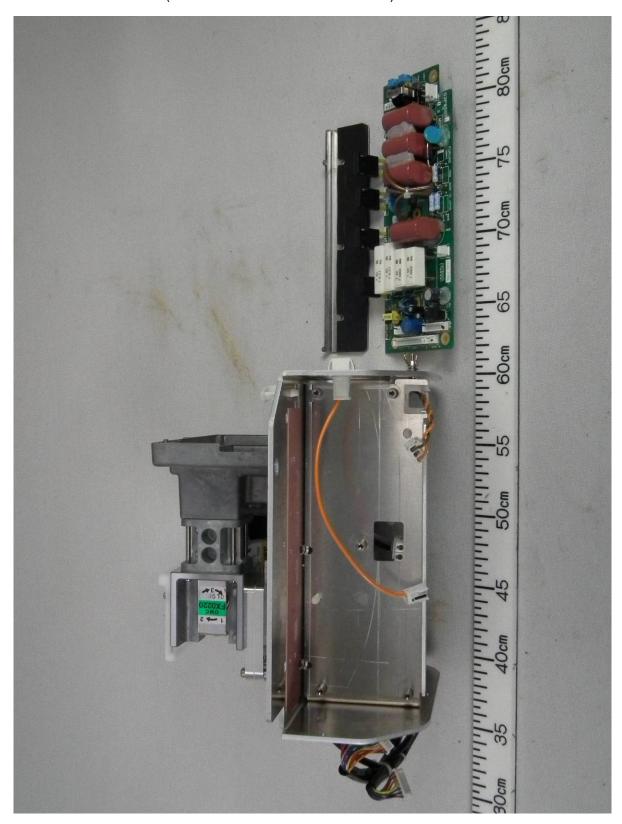
2.14 Outside Rear view (with MD Board 03P9507 removed)
