TYPE OF EXHIBIT: CLIPPER FILTER RESPONSE

MODEL: RLR-460

TYPE OF UNIT: UHF FM Repeater

FCC ID: AIERIT15-460

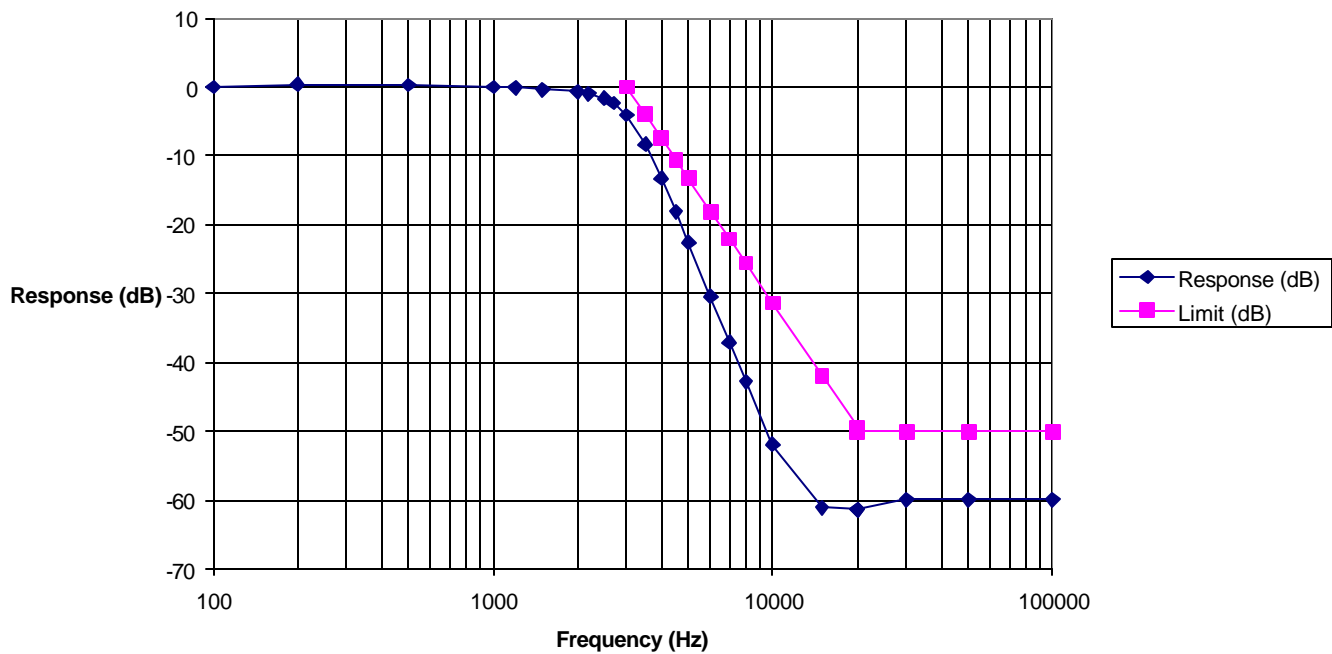
Clipper Filter Response

RESULTS:

1. The first resistor in the low-pass filter following the clipper, R349 was removed and replaced with a 100 uF electrolytic capacitor with the positive end connected to the input of the clipper and the negative end connected to the audio generator output of an HP 8920 RF Test Set. This allows a direct input to the clipper. The generator level was set to a value just below that which would cause clipping in the clipper filter.

2. The output of the last modulation clipper filter stage, U305-D, pin 14 was connected to the audio input of the HP 8920. Audio filters inside the HP 8920 were set to be off to prevent the filtering inside the instrument from affecting the test results. The audio generator was set for a frequency of 1 kHz. The level of the signal out of the clipper filter was noted and set as a 0 dB reference. The audio generator frequency was swept from 100 Hz to 100 kHz and the response noted and plotted.
