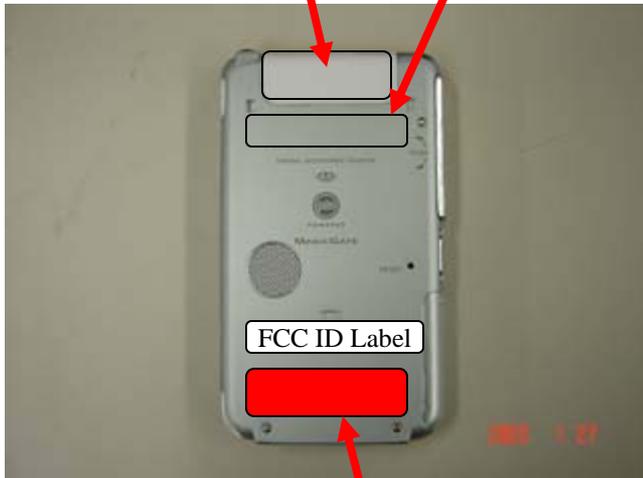
1.Back Surface A of PEG-TG50/U

If Label Statement is attached or printed to Back Surface A, it will touch the Cradle and come off.

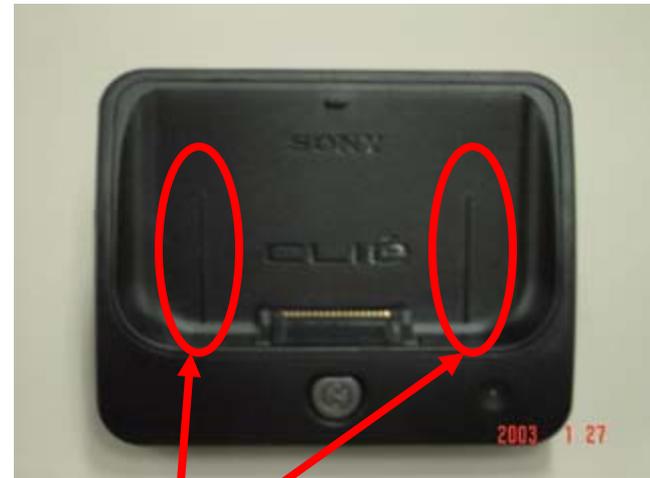
Every time, user set the product on the cradle, red circular part of cradle will touch the Back Surface A. Therefore, Label or Print of Back Surface A will come off and not last for a long time.

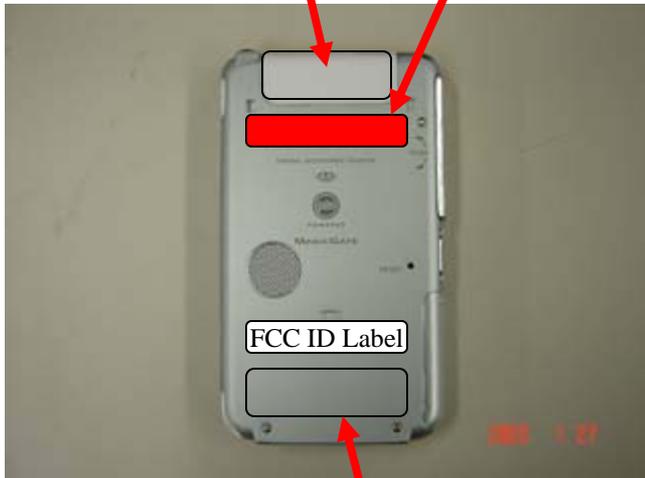
2.Back Surface B of PEG-TG50/U

Logo mark of the product “CLIE” will be on this place, so that label statement cannot be attached or printed in this area.

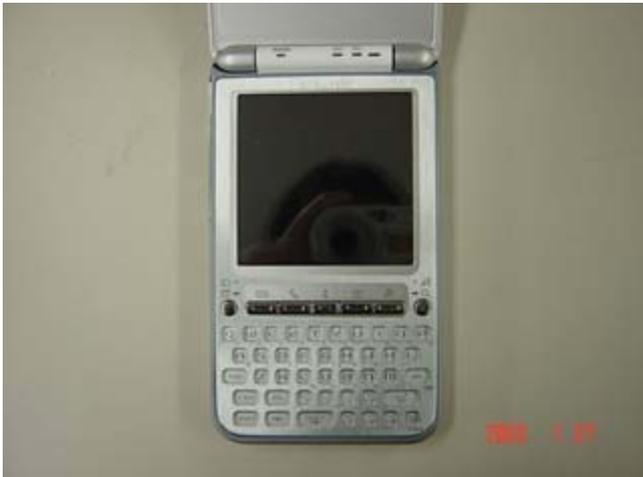
4.Foreface of PEG-TG50/U

There is no place for attaching or printing label statement foreface of this product.

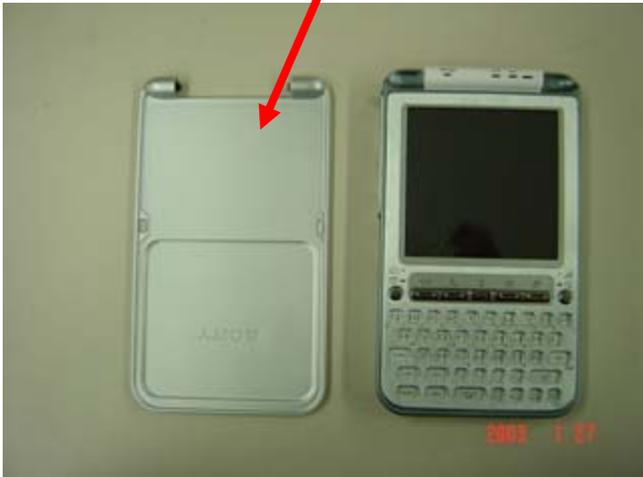
5. Front Cover of PEG-TG50/U

Front cover can be removed easily and user do not always carry the product with the front cover.
