APPENDIX 3: Photographs of test setup

Conducted Emission

Radiated Emission

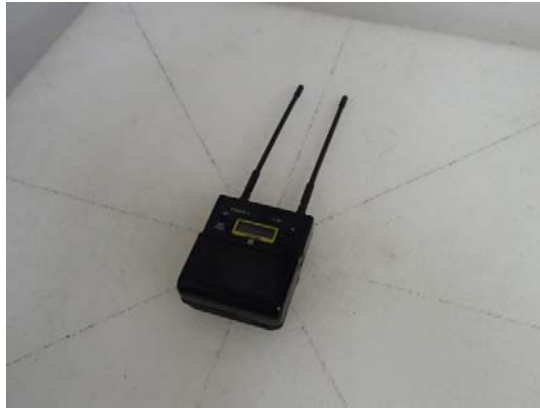
X-axis

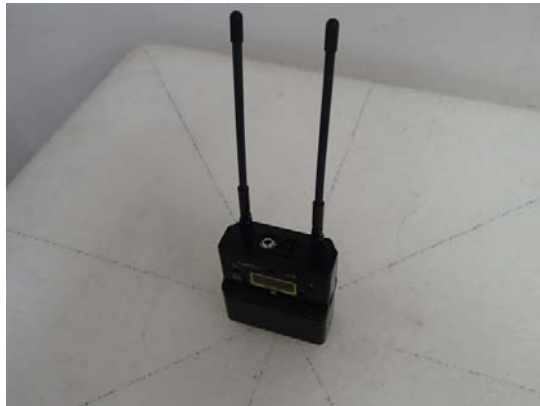
Y-axis

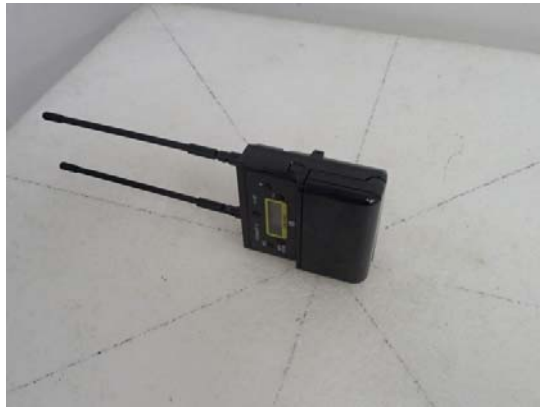
**Below 30 MHz (Receiver: Z-Axis / MODE: USB)
Above 30 MHz (Receiver: (Horizontal: Y-Axis / Vertical: Y-Axis) /
MODE: MI-Shoe power Supply)**

Z-axis

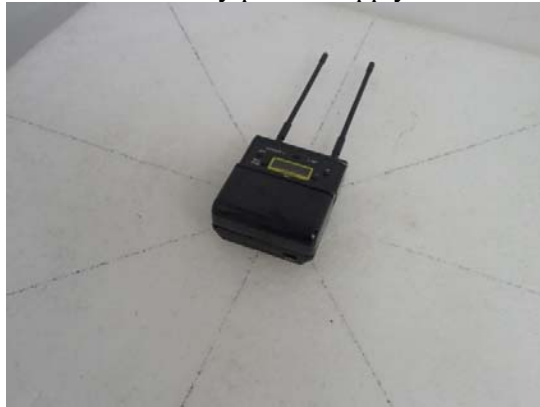
Battery power Supply

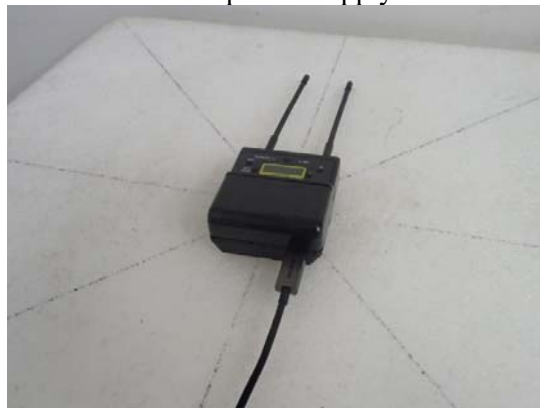
USB power Supply

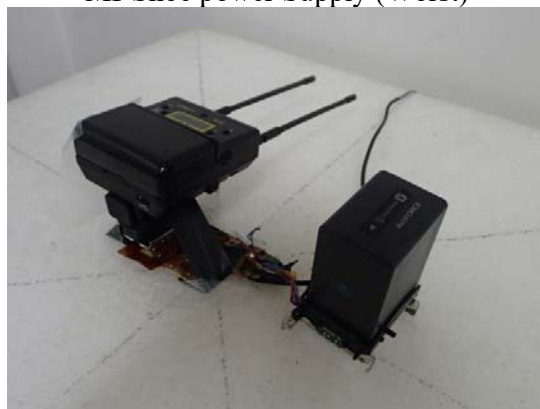
MI-Shoe power Supply (Worst)

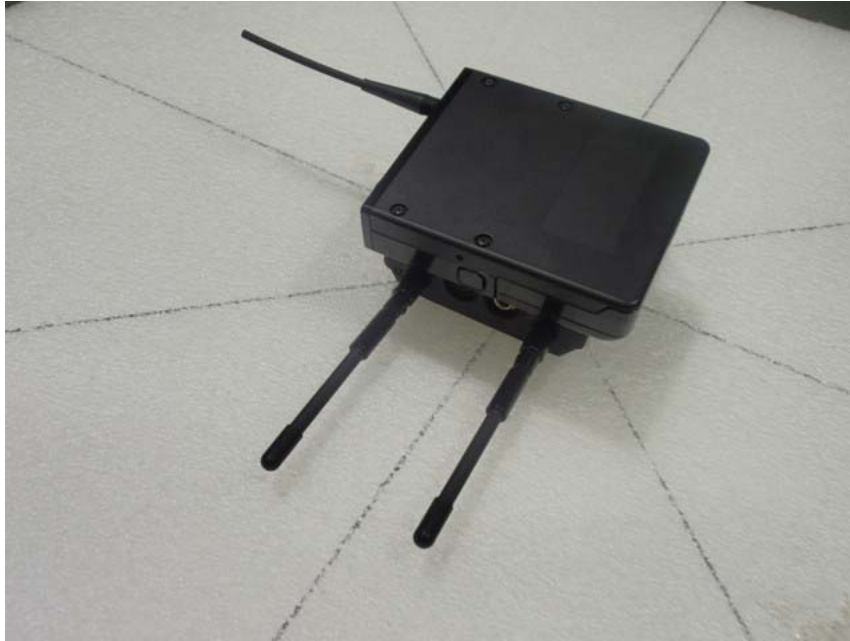
With Tag

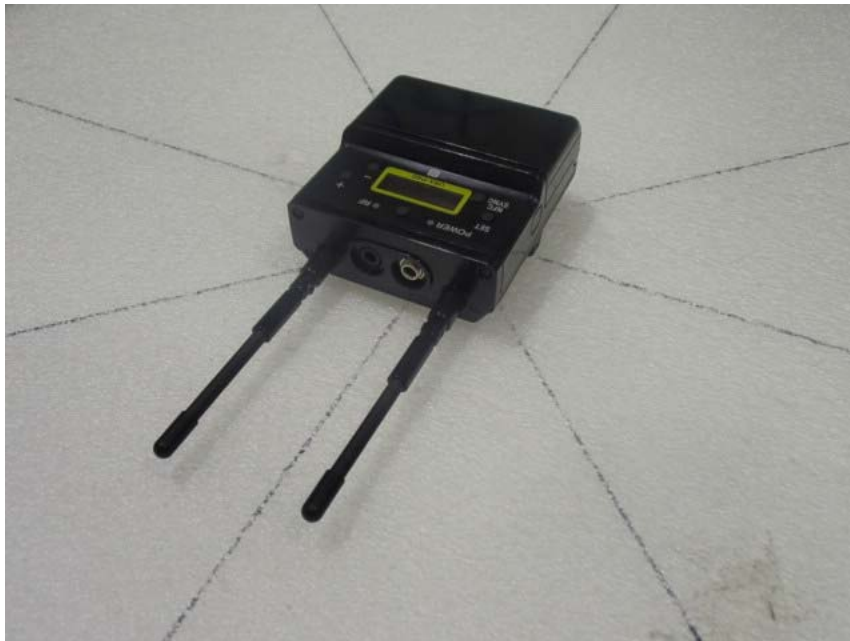
Without Tag (Worst)
