APPENDIX 3: Photographs of test setup

Radiated Spurious Emission

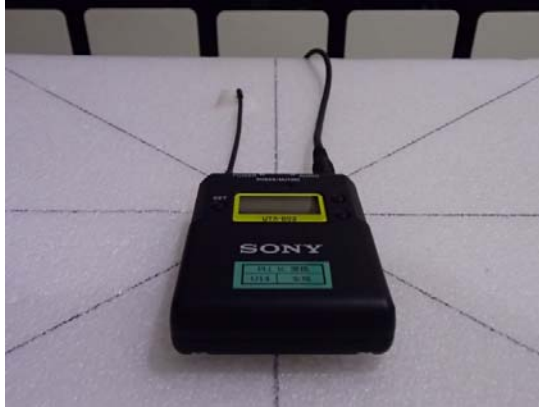
X-axis

Worst Case Position

**Below 1 GHz (Horizontal: X-axis/ Vertical: X-axis)
Above 1 GHz (Horizontal: Z-axis/ Vertical: Y-axis)**
