6. Photographs of test setup

The following photographs show the arrangement of the worst-case.

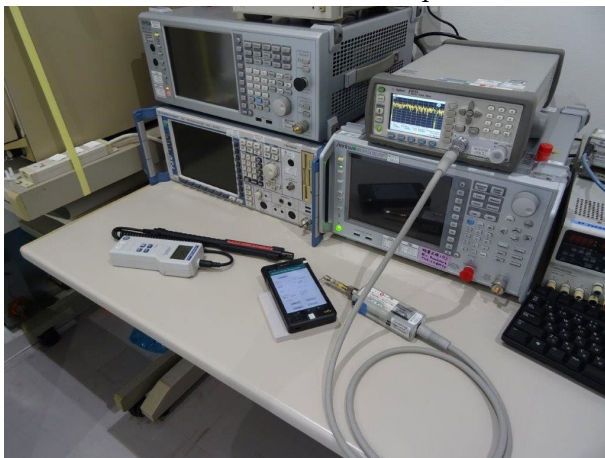
6.2. Antenna-port Conducted Measurements Photo(s)

Maximum Peak Conducted Output Power

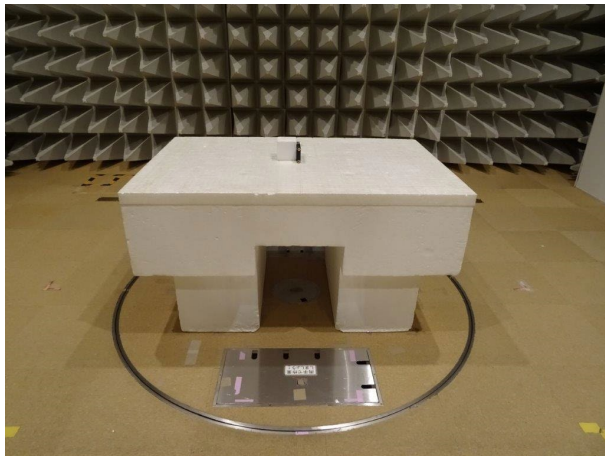
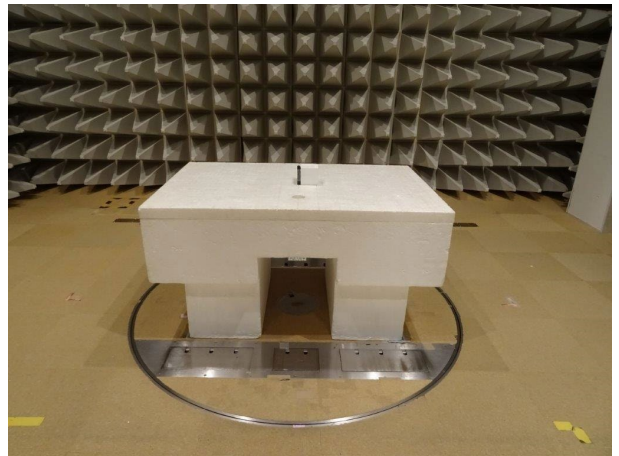
6.3. Radiated Spurious Emissions Photo(s)

[Overview of measurement]

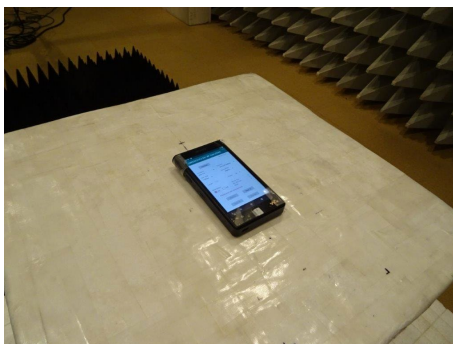
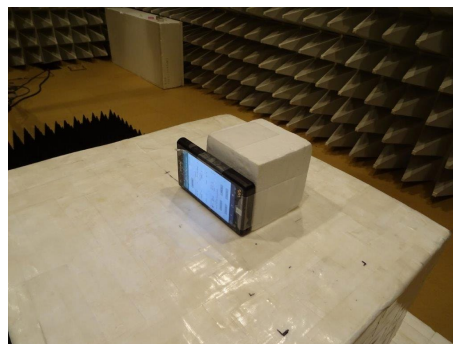
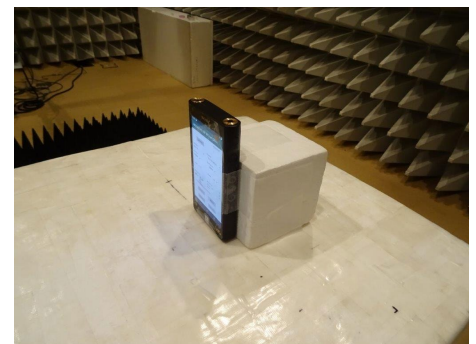
< EUT Axis >

X

Y

Z
